Identifying Habitat of the Brook Floater (*Alasmidonta varicosa*) in the Shediac Bay Watershed

Prepared for:
NB Wildlife Trust Fund
Habitat Stewardship Program for Species At Risk

March 2019

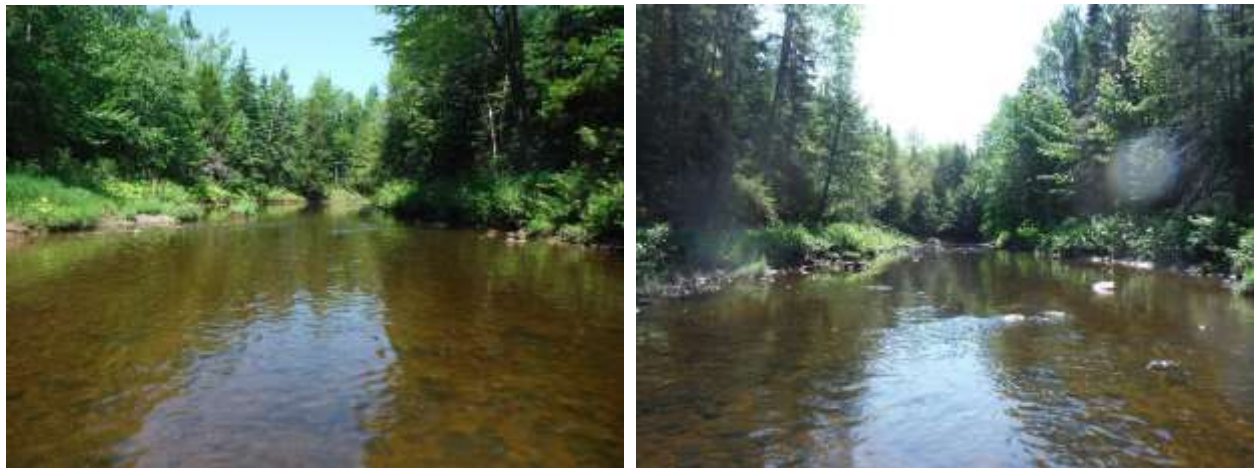
The habitat upstream from the access of the private property (ShdD-A), is a beautiful site for freshwater mussels; a mix of mostly rubble, gravel and sand. Water levels ranged from 25-50 cm in depth, and is perfectly clear giving great visibility of the riverbed. There are multiple sand bars along ShdD-A, and they were carefully inspected for visible valves of burrowed mussels. The habitat is rich in common freshwater mussels; count surveys were done in previous years but not in 2017. This area was of high priority; 30 brook floater mussels were reported to have been found in this area in the 2006 report¹. This area was visited twice in the season.

Figure 4: Site photos of ShdD-A survey site, upstream view (left), downstream view (right)

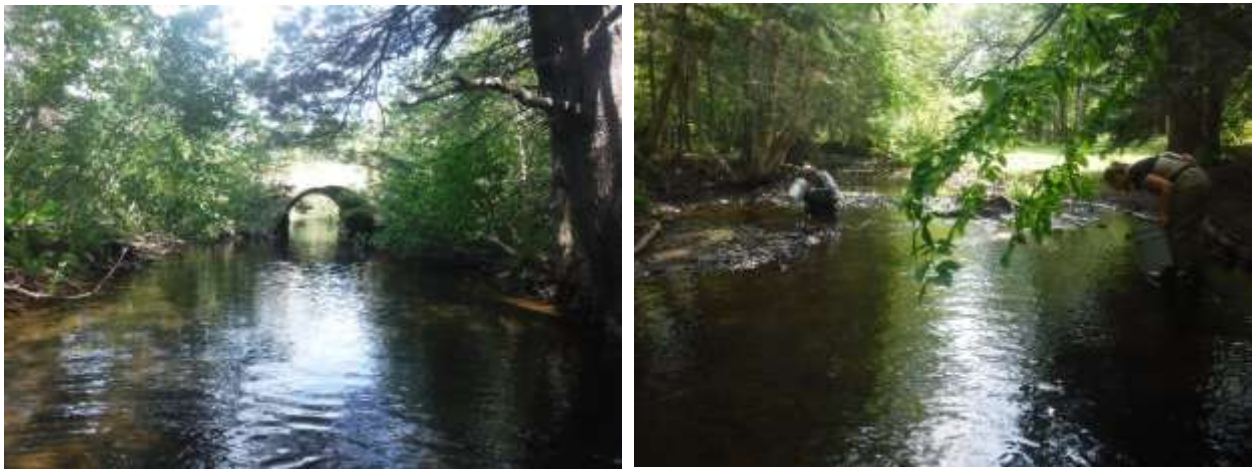
The habitat upstream (ShdM-A) is in good condition, the substrate composed of mostly rocks and sand with good vegetation cover along the banks. However, there is some erosion nearby on a riverfront property owner's land, due to a lack of vegetation. That area would be a good place to create stewardship with the landowner for erosion control. There are a lot of common mussels here. Two eDNA samples were collected in this area.

Figure 26: Site photos of ShdM-A survey site, upstream view (left), downstream view (right)

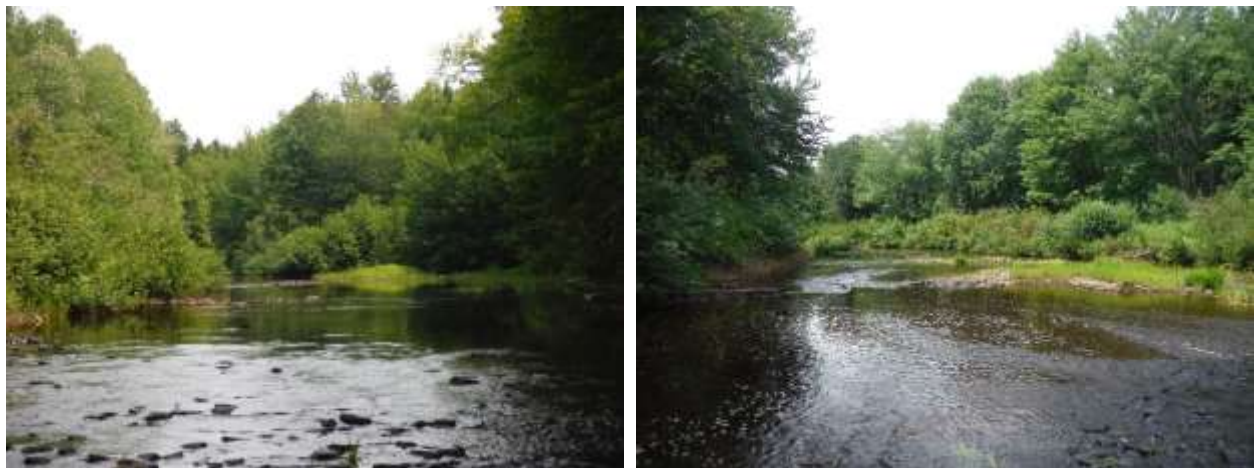
The habitat suitable for freshwater mussels begins a short distance away from the access point. The substrate is comprised of a mix of rocks, rubble, and sand, with some sections of bedrock. The riparian zone is healthy without any sign of severe erosion (mild natural erosion), and has good mixed forest vegetation on both sides. In addition to the common Eastern Pearlshell mussel (*Maragaritifera margaritifera*), there is a second species commonly found in the Scoudouc River; the Eastern Elliptio mussel (*Elliptio complanata*).

Figure 32: Site photos of ScdD-A survey site, upstream view (left), downstream view (right)

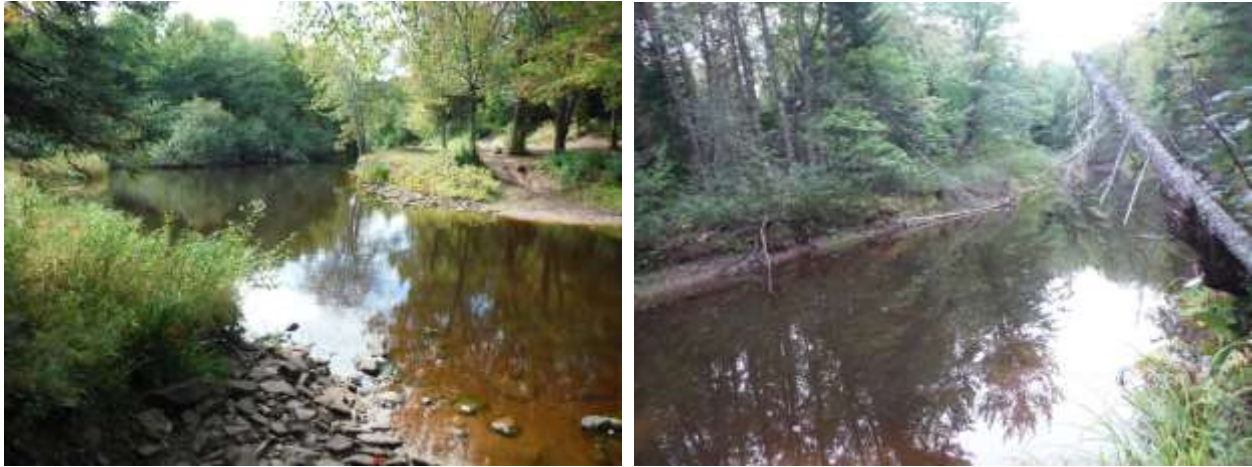
The habitat here, going downstream (ScdF-1) was surveyed in 2016 and was found not to be suitable for freshwater mussels; the substrate is comprised mostly of large flat rocks and boulders. There were no mussels seen during that survey, and at the time, the water was too deep for wading upstream (ScdF-A). In September of 2017, water levels were low enough to allow the team to walk upstream and observed freshwater mussels with underwater viewers. The water was still too deep to be able to pick up and identify the freshwater mussels. In 2018, eDNA samples were collected at this location in the hopes that it would detect a positive signal from Brook Floater mussels upstream. No additional searches were done considering the difficulties and safety conditions from previous years. This area is still a good access point to freshwater mussel habitat in the Scoudouc River.

Figure 34: Site photos of access site ScdF-A survey site, upstream view (left), downstream view (right)

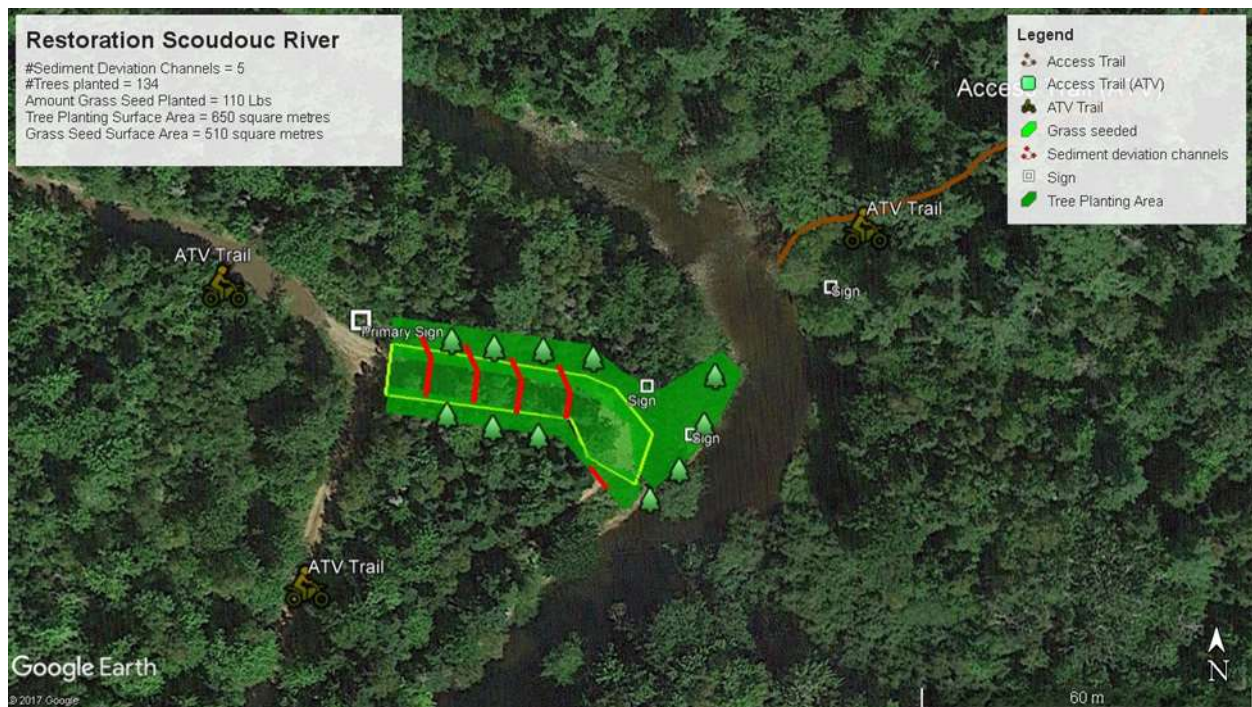
An area in the Scoudouc River was selected for remediation due to erosion and sedimentation problems in 2017. This year, the restoration of this site was continued. There was a bit of damage from the spring's canoe and ATV run. The fourth log, at the bottom of the hill, had been taken off and thrown to the side of the trail. This summer, the log was retrieved and reinstalled at the same location as well as a new piece of geotextile. The restoration also involved in the maintenance of the channel stabilizers, by digging trenches towards the woods, where fine sediments had accumulated on the logs over the winter and spring.

Figure 37: Map showing where restoration work was done at the Scoudouc River in 2017-2018

Fall rye was planted all over the restoration site again this year due to the destruction made by this year's ATV run. It is important to establish a good amount of fall rye on the trail to further stabilize the soil that was disturbed by the creation of this project.

Additional native trees were planted. Some of the trees planted in 2017 didn't survive the winter, and others were damaged by ATVs. Approximately 15 native trees were planted in the fall of 2018 to help replace the ones that died. It was important to replace the trees that didn't survive by the river. These will help to stabilize the eroding river bank. Large trees were selected to help ATV drivers to see them more clearly and not trample over them. The trees used were provided by the wood lot of "Vert l'Avenir" farm.

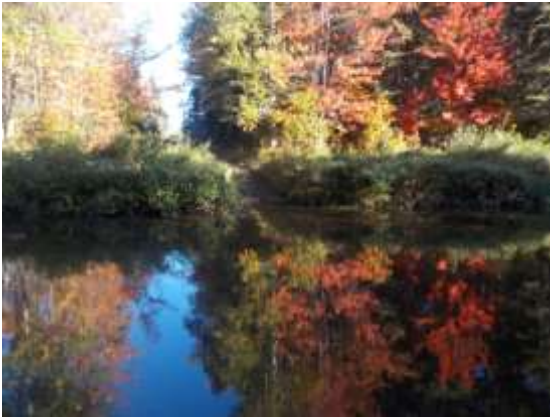
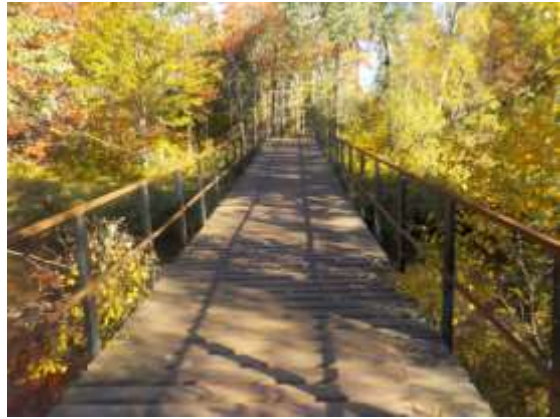
Figure 41: Images of the old crossing and new bridge

In the fall of 2018, the SBWA initiated talks with the local ATV club, who were most receptive to the idea of putting up a barrier to discourage crossing through the river, thus encouraging the use of their bridge. They donated and installed the 4 large posts. The Shediac Bay Watershed Association bought the cables and clamps, and subsequently designed and installed signage.

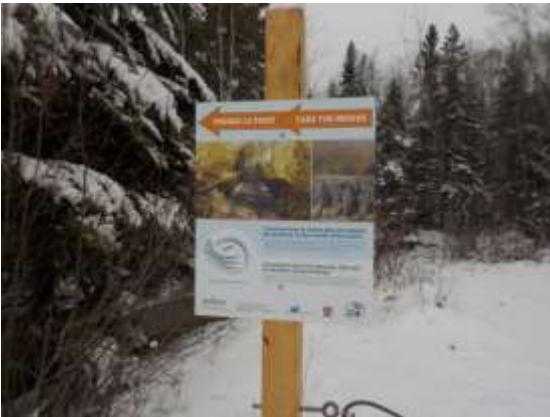
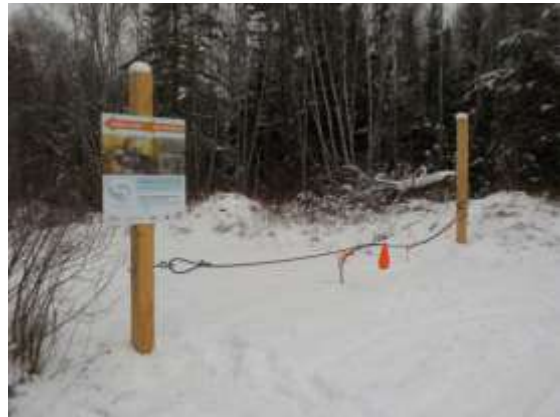
Figure 42: Images of the signage and trail closure

The same signs and cables were placed on both sides of the river. The cable gate has a lock so the cable can be unhooked to allow passage of the trail groomer in the winter. This was a great partnership to help protect river habitat from unwanted access by all-terrain and other off-road vehicles. The Kent ATV club was super supportive of our initiative and provided lots of in-kind and monetary partnership assistance.

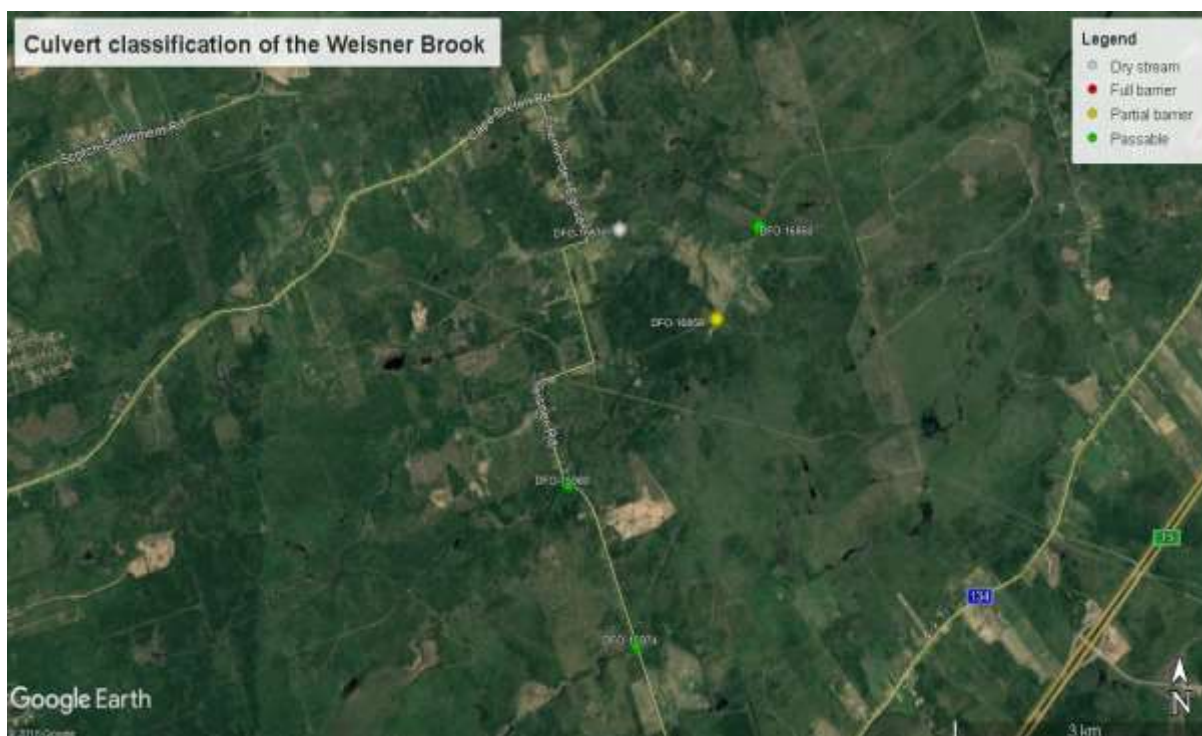
The Weisner Brook is an important tributary of the Shediac River in terms of salmonid habitat. Five culverts were assessed: 3 were passable culverts, one was a partial barrier, and the fifth one crossed a seasonal stream that was dry.

Figure 457: Culvert classification for the Weisner Brook, 2018

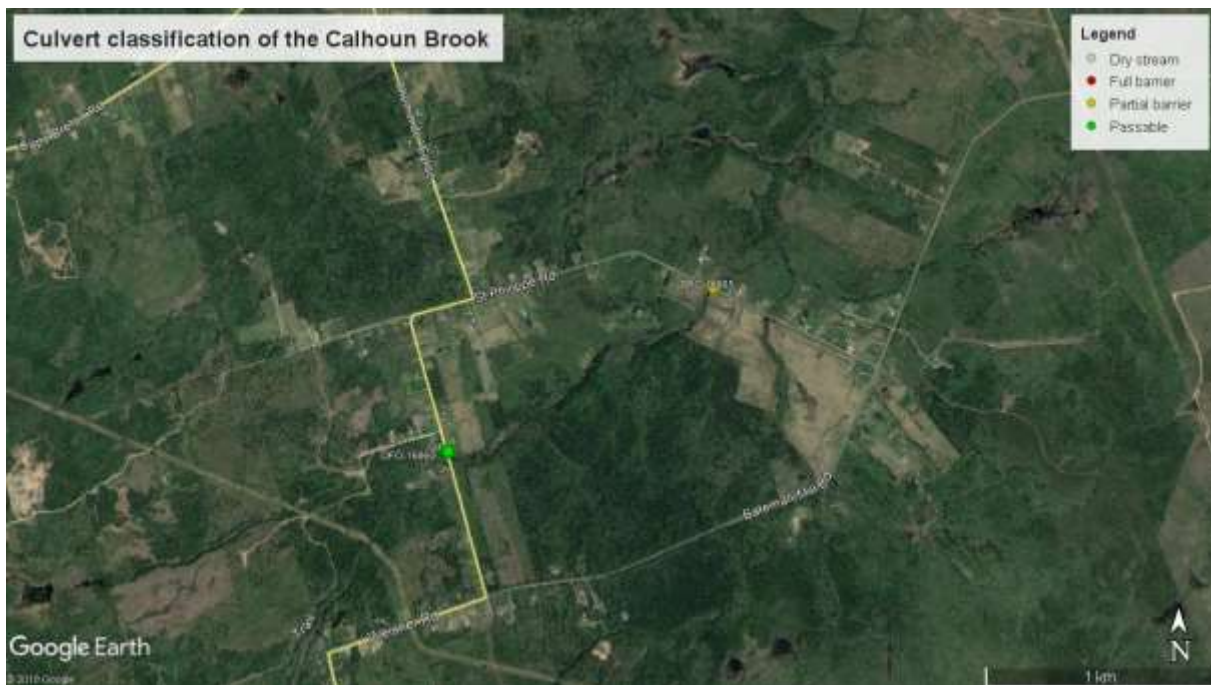
Two Culverts were assessed on the Calhoun Brook, a tributary of the Weisner Brook. One was classified as a partial barrier and the other is classified as passable for fish.

Figure 49: Culvert classification for the Calhoun Brook, 2018

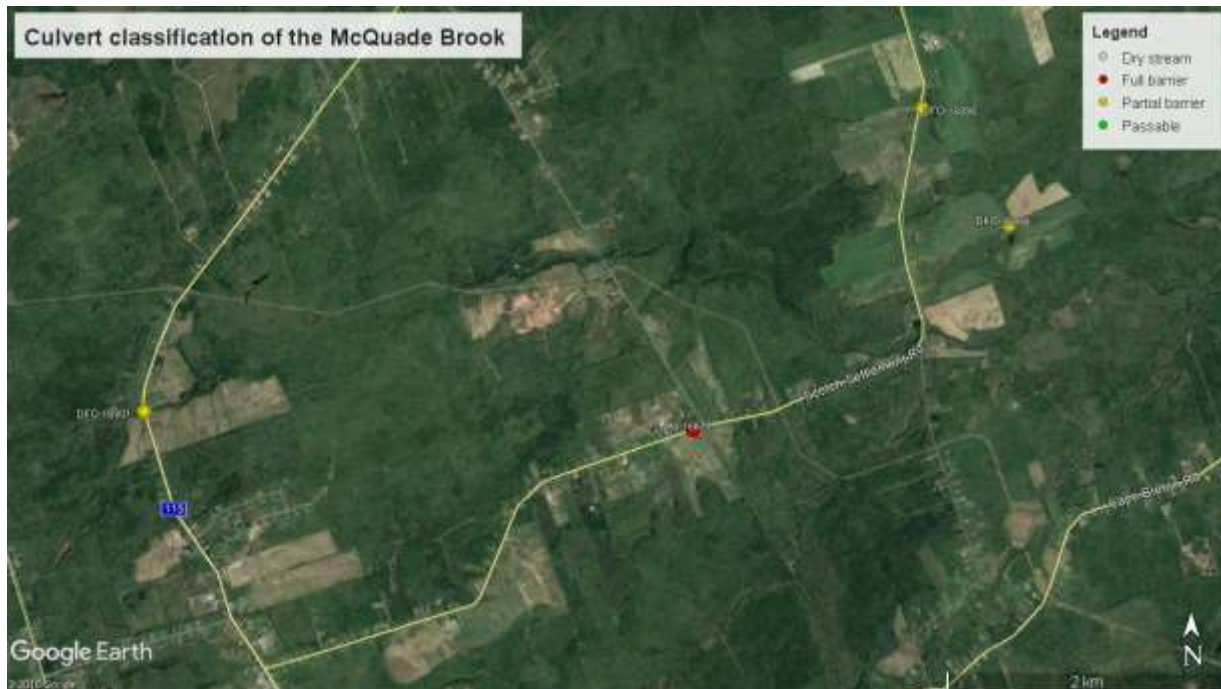
Four culverts were assessed on the McQuade Brook, an important tributary of the Shediac River in terms of salmonid habitat. One full barrier was identified and three culverts were classified as partial barriers.

Figure 50: Culvert classification for the McQuade Brook, 2018
