Shediac Bay Watershed Association

Annual Report 2017-2018

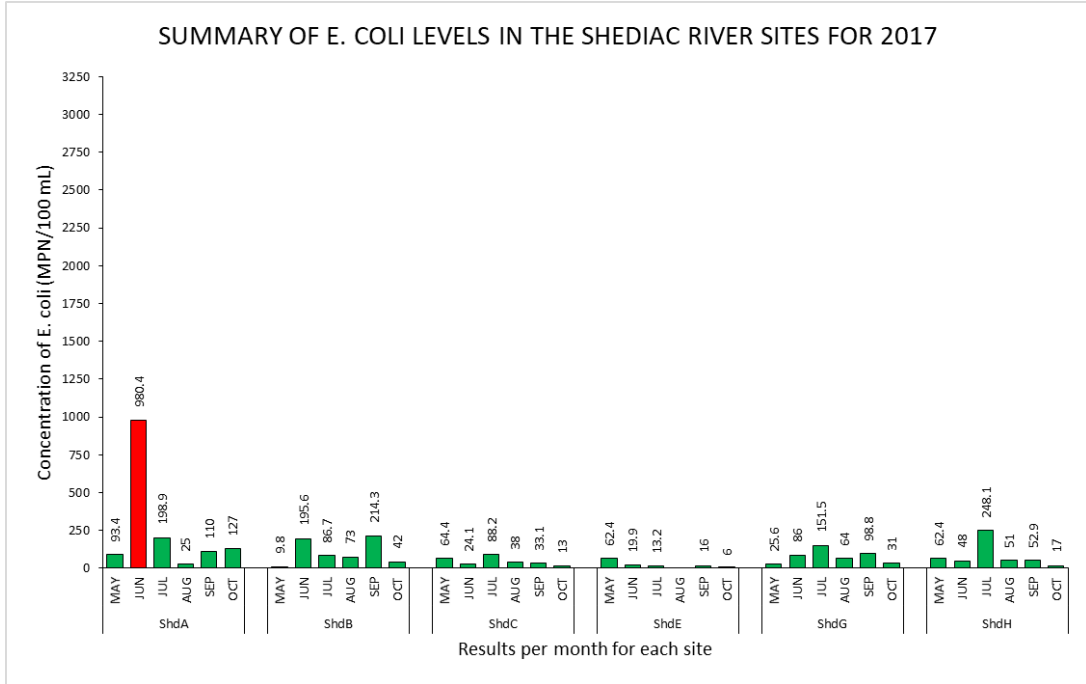
Figure 3: Summary of water quality results for E. coli, Shediac River sampling 2017

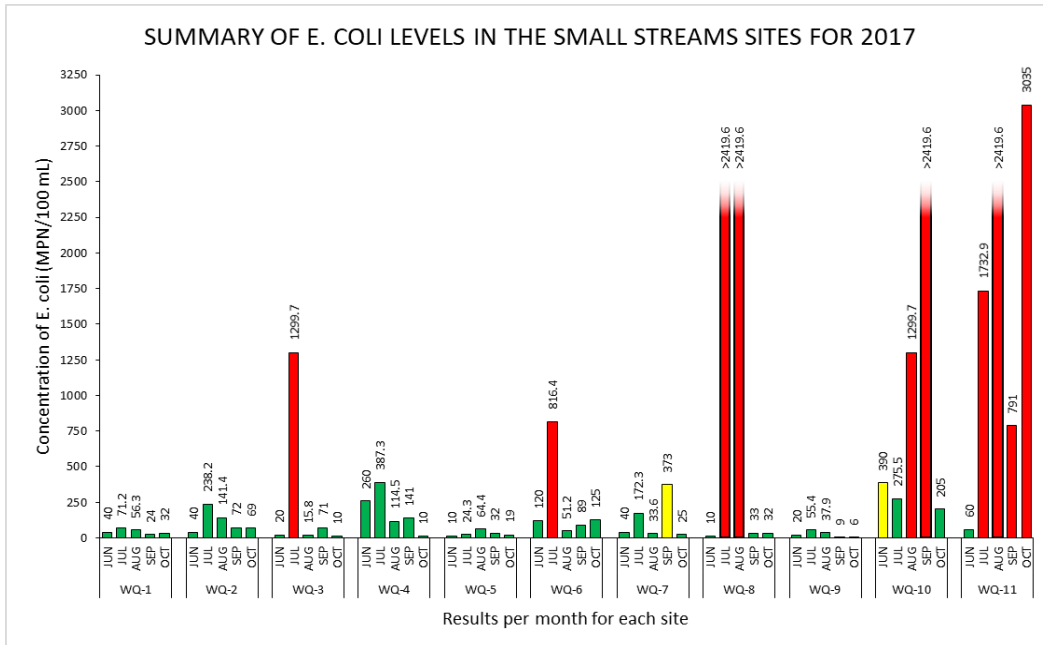
Figure 6: Summary of water quality results for E. coli, small streams sampling 2017

The sites that did not surpass the 400 MPN/100 mL limits in 2017 are; WQ-1, WQ-2, WQ-4, WQ-5, WQ-7 and WQ-9. The sites WQ-3 and WQ-6 both had only one instance of bacterial spike in the month of July. There was no rainfall in the 24 hours prior to the sampling of July. The only occurrence of light rainfall (> 5 mm) in the 24-hour period prior to a sample was for the months of June and September. Based on the bacterial levels alone, the sites demanding further investigation are; WQ-8, WQ-10 and WQ-11.

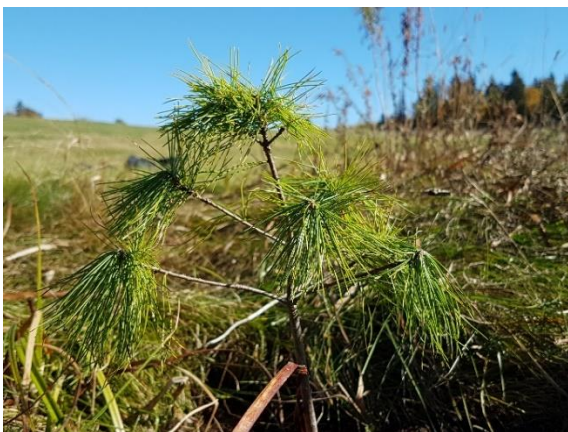
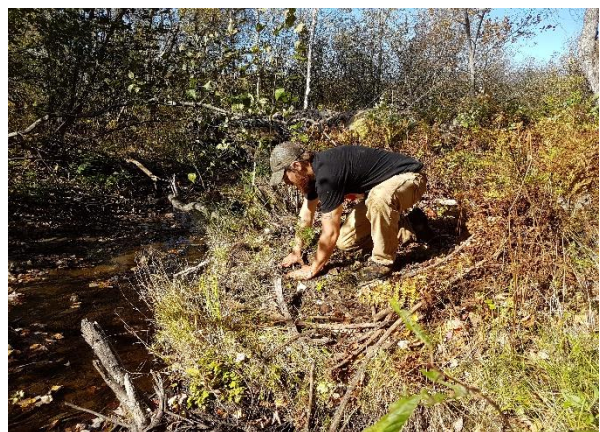
Figure 10: Wetland and tree planting, Cornwall Brook 2017

The SBWA also did restoration work at three wetland sites this year. The three sites were the Cornwall Brook Marsh, the Ocean Campground Marsh and the Ohio Road Marsh. Volunteers helped plant some of the trees at the Ohio Road Marsh during a TD Tree Day event. A total of 634 native trees were planted for buffer zone enhancement and bank stabilization in wetlands in 2017.

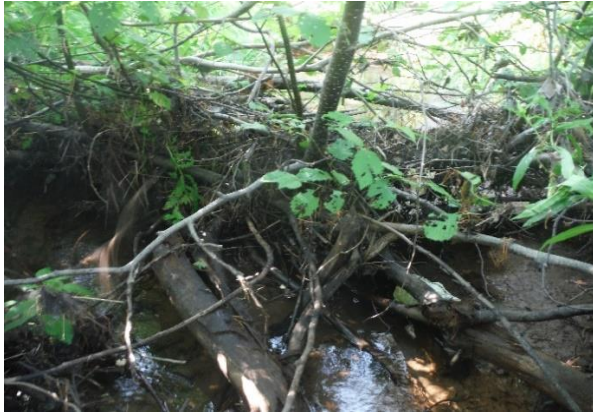
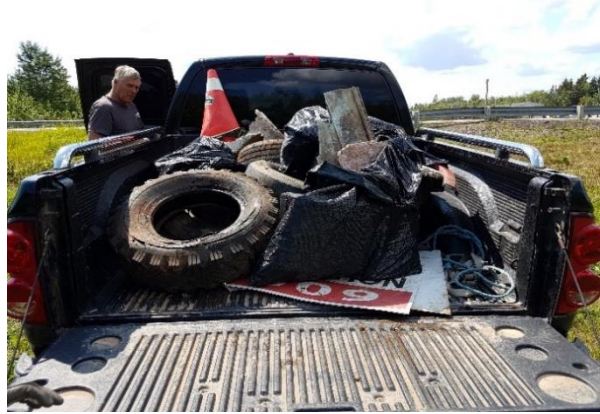
Figure 12: Woody debris and trash cleanup, 2017

Trash cleanup began from Ohio Road and ended at rue Cartier. A total of 130 kg (0.13 Metric Ton) of trash was removed from a 345 m section of the brook. Trash found in the brook consisted of: tires, road signs, road construction cones, bottles and cans, and other assorted plastics and scrap metal. Trash was brought to *Eco360* sanitary landfill.

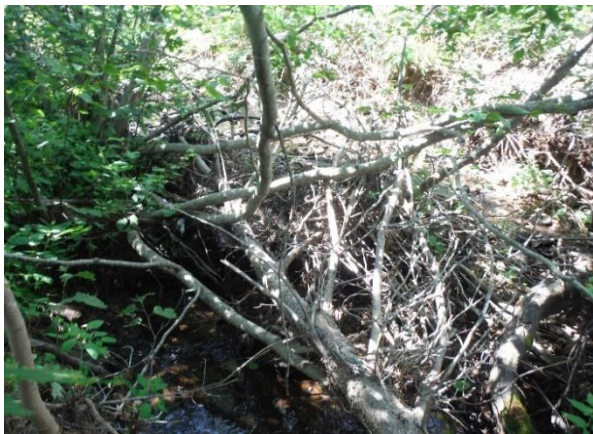
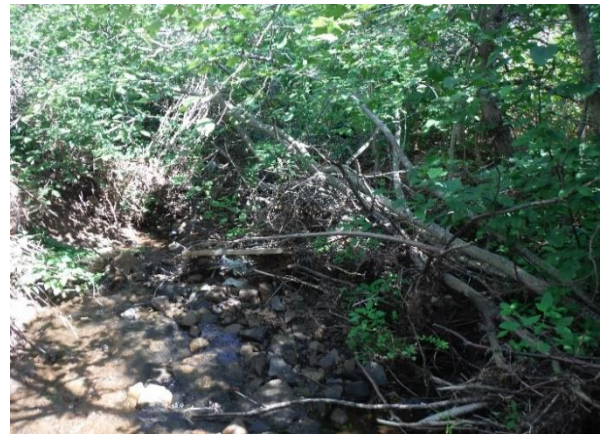
Figure 13: Before photos of a debris cleanup, Cornwall Brook 2017

The SBWA team used the wood that was cut from the alder trimming and the debris cleanup to build 8 waddle fences each side of the stream. Waddle fences are built by weaving branches around wooden posts hammered in the soil, and filling the back with additional wooden debris. These structures help to protect the banks from further erosion and will also capture sediment over time and rebuild the eroded banks. An additional benefit of the waddle fences is the creation of shelter for fish.

To further help protect the eroding banks, native trees were planted along the stream. Native trees were also planted where an agricultural fields began next to one part of the stream to establish a healthier buffer zone. The SBWA team planted a total of 231 native trees around the Cornwall Brook.

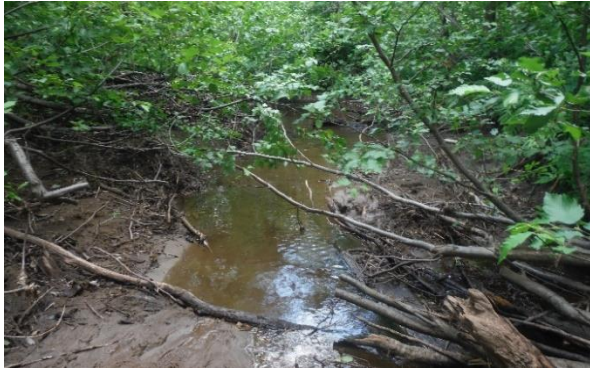
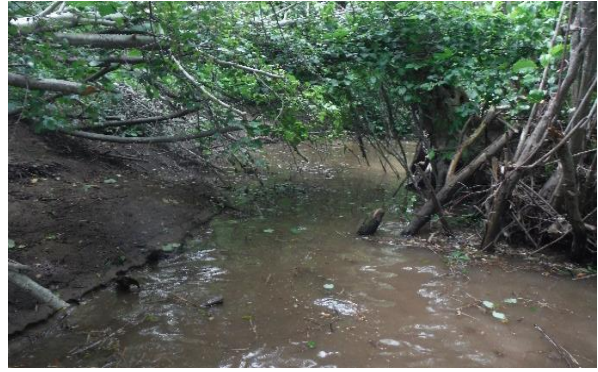
Figure 14: After photos of a debris cleanup, Cornwall Brook 2017

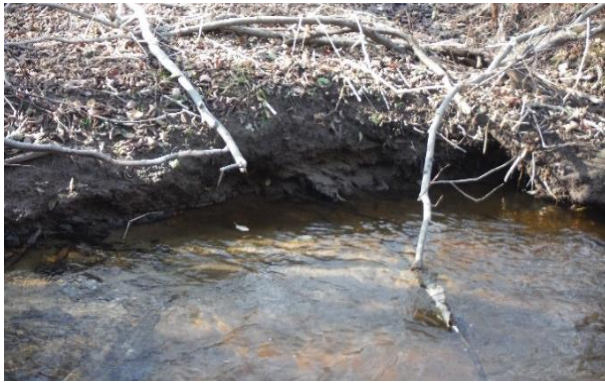
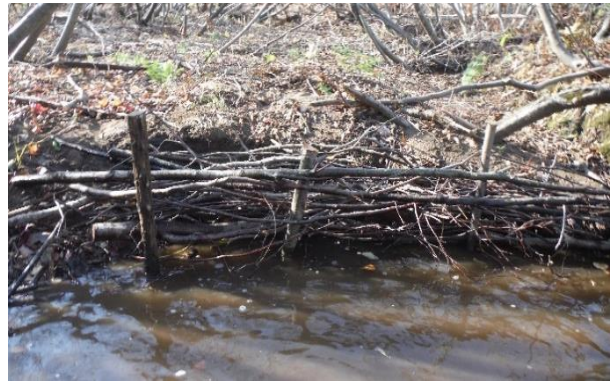
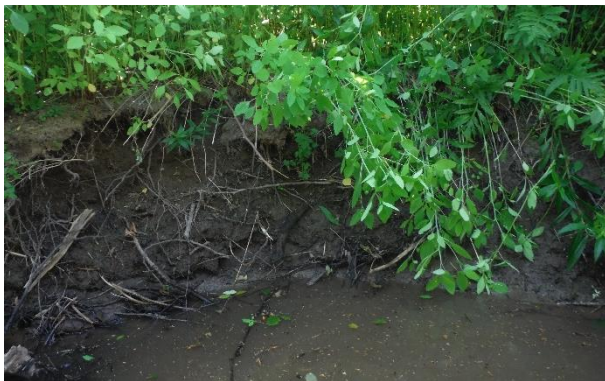
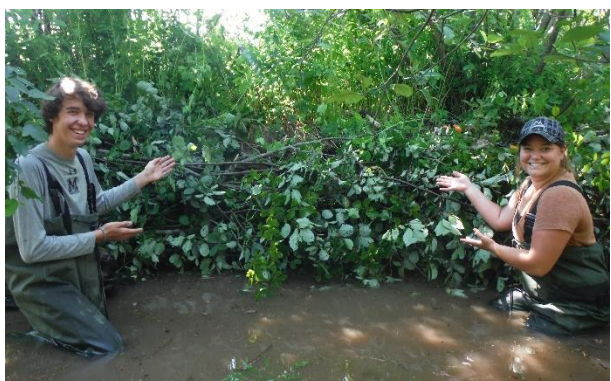
Figure 15: Before and after photos of the construction of waddle fences, Cornwall Brook 2017

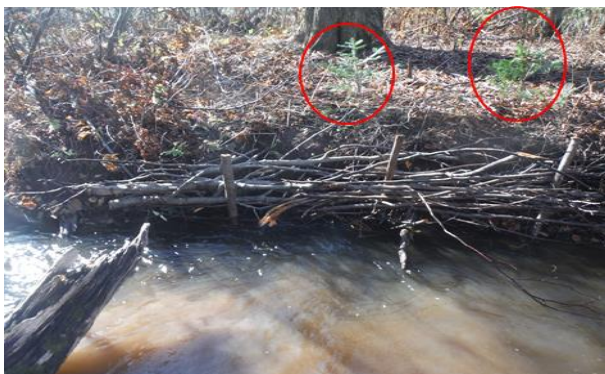
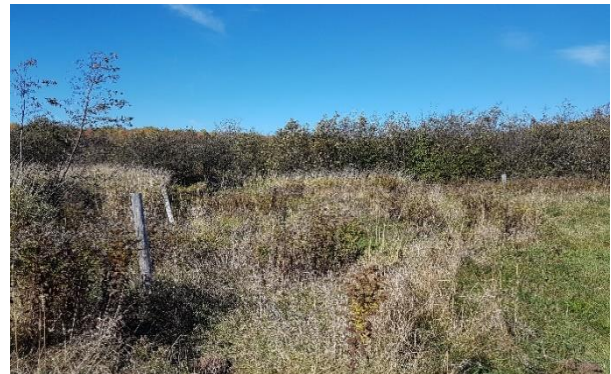
Figure 16: Wattle fencing and trees planted along the Cornwall Brook, 2017

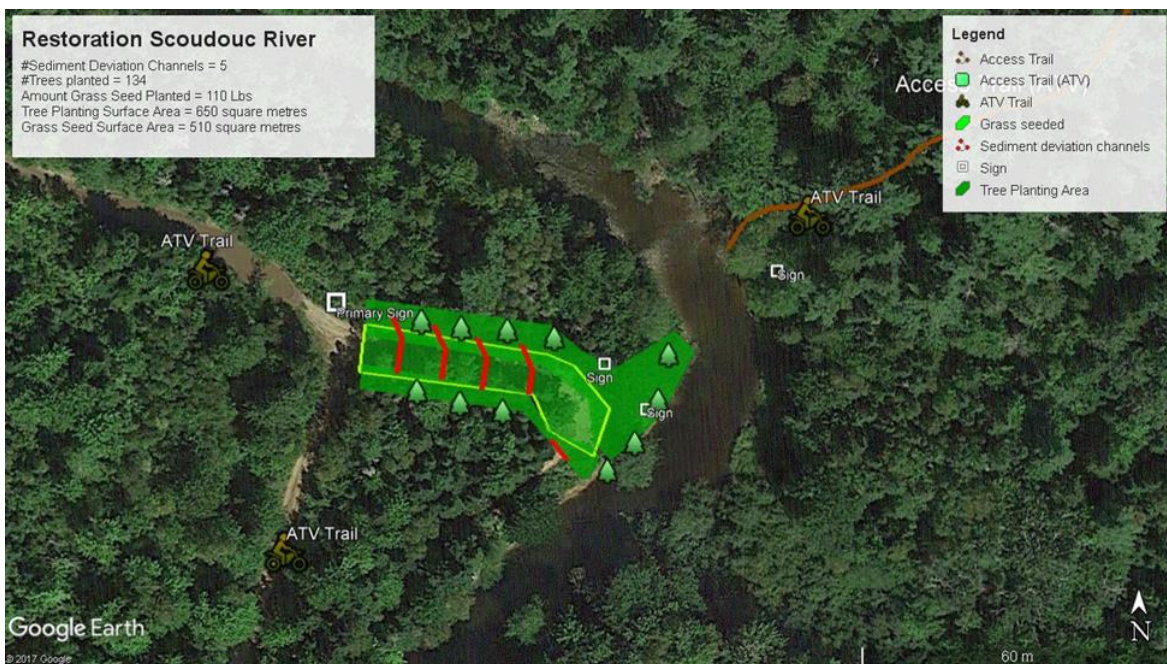
Figure 17: Map showing where restoration work was done at the Scoudouc River in 2017

An area in the Scoudouc River was selected for remediation due to erosion and sedimentation problems surrounding sensitive salmon habitat. The site is surrounded by ATV trails and is a popular stop of the annual Scoudouc River canoe and ATV run. The primary trail was causing heavy sediment to runoff in the river after rainfall events. The site is also impacted by erosion problems. The section of ATV trail in question is aligned with the Scoudouc River and has a steep slope, which causes sediment-filled runoff to flow down into the river. The purpose of the restoration work is to control sediment runoff and stabilize the eroding banks, using biotechnical techniques.

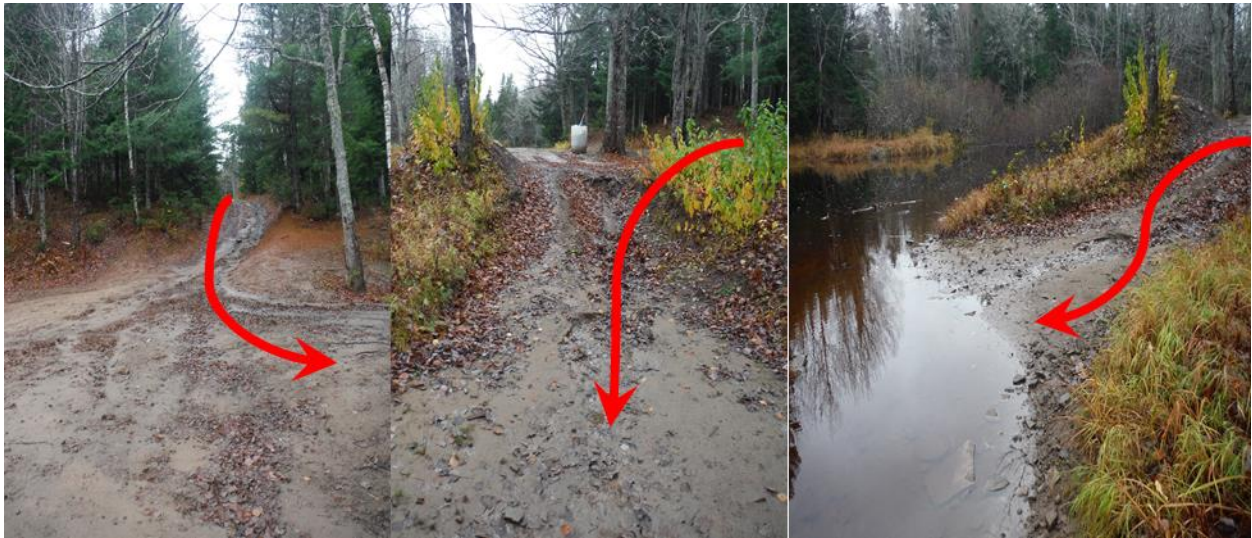
Figure 18: Before photos of the restoration area of the Scoudouc River, 2017

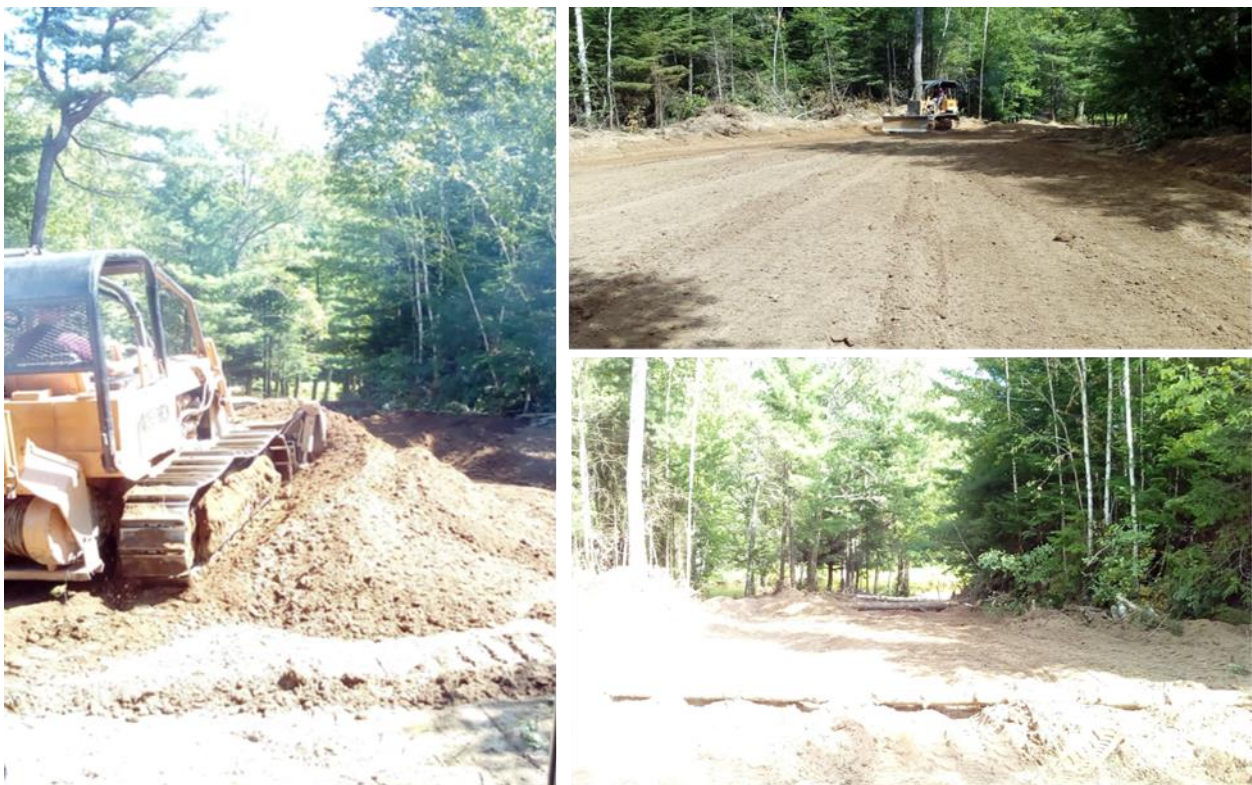
Figure 19: Work photos of machinery on the ATV trail, Scoudouc River 2017

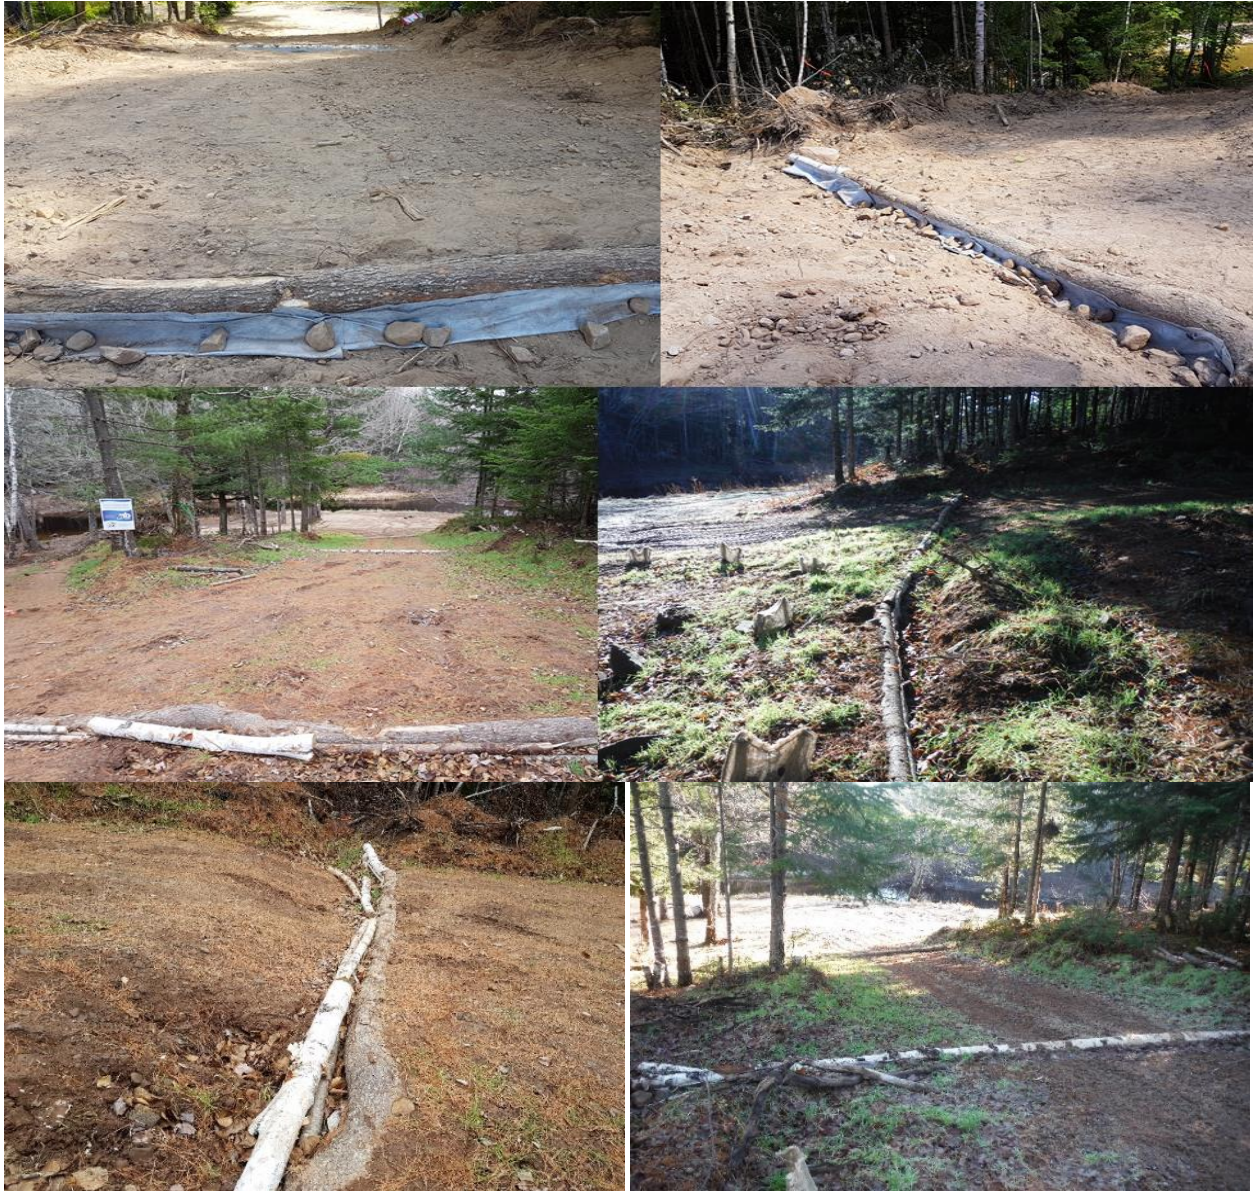
Figure 20: Photos of the sediment deflector logs at the Scoudouc River restoration site, 2017

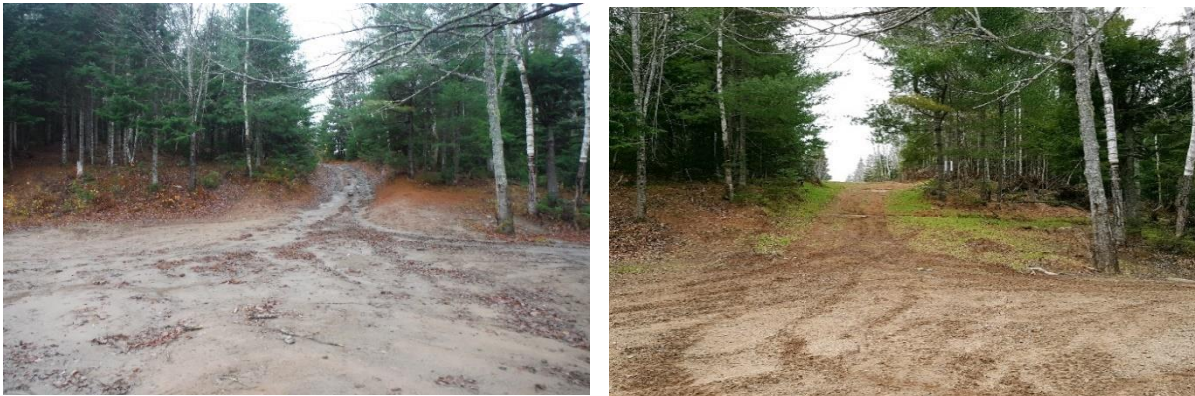
Figure 21: Before and after photos of the main ATV trail restoration, 2017

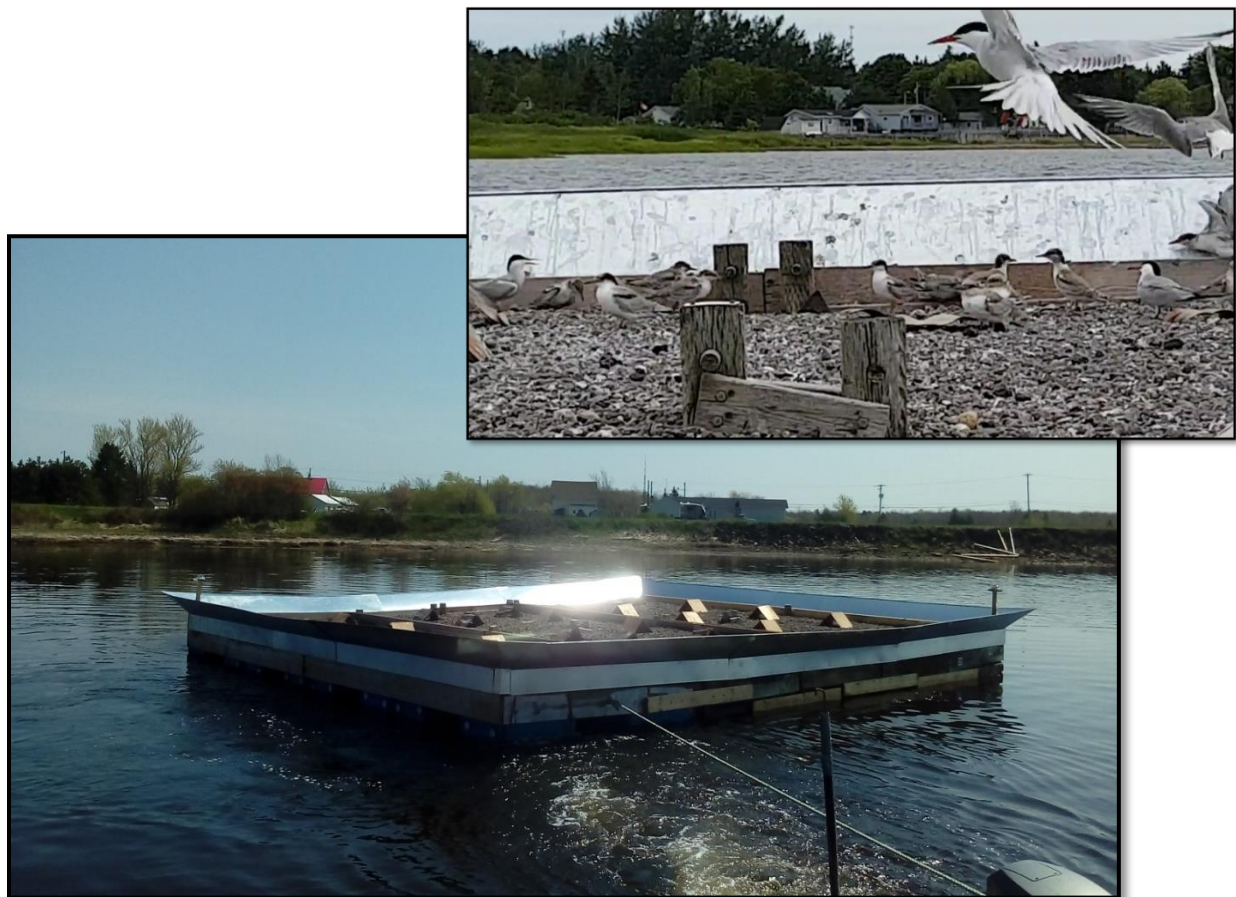
Figure 28: Tern Platform improvements (predator guards), 2017

However, in 2016, a predator attack has brought the need for improvements to the structure. In 2017, predator guards made of sheet metal was installed to protect the nests from terrestrial predators from being able to climb aboard. This year was another great success for approximately 50 nesting couples. The details of this year's improvements and the nesting survey results of each year the platform has been in operation can be found in the report titled **“Evaluation of the Health of the Shediac Bay, 2017”**, in **Reports and Archives** on our website.

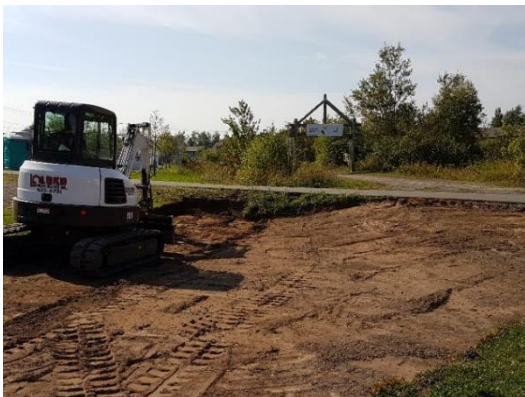
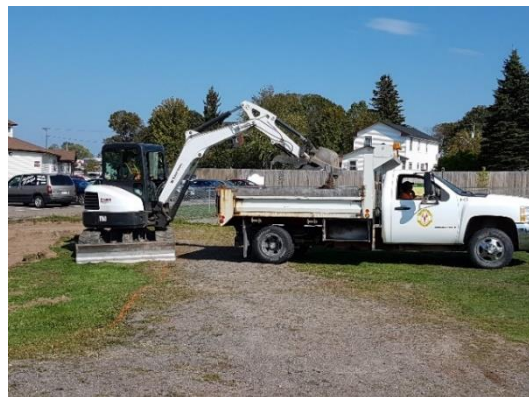
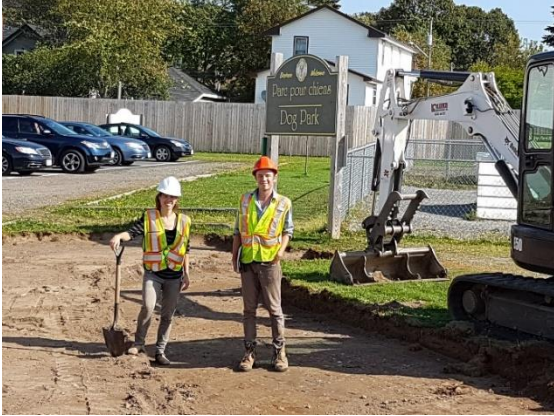
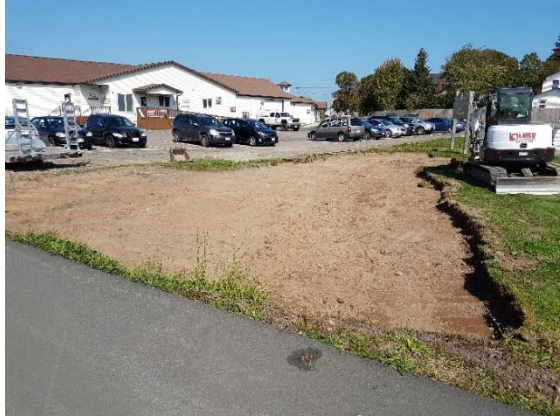
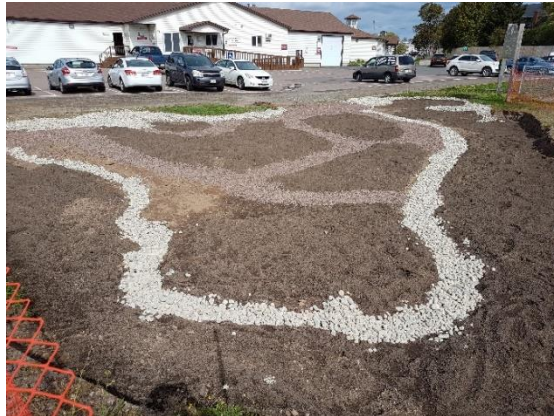
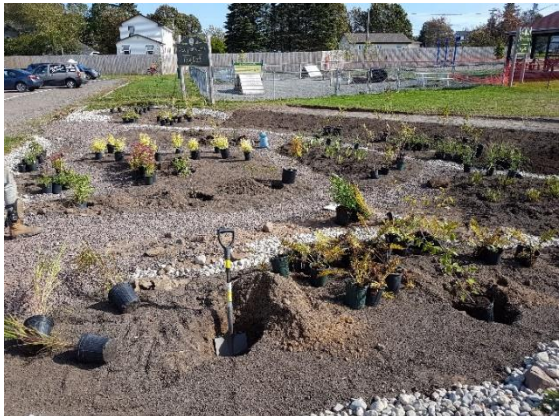
Figure 29: Rain garden construction photos, 2017

The new garden was made with the help of the Town of Shediac for disposal of the top soil, and *EOS Eco-Energy*, who was hired to plan the logistic of the construction of the garden. Plants, shrubs and trees were sources from local nurseries. An interpretation panel has been installed along the walking path.
