# Improving Water Quality in the Shediac and Scoudouc Rivers

## Final Report

**The Shediac Bay Watershed Association Inc.**

**March 1, 2019**

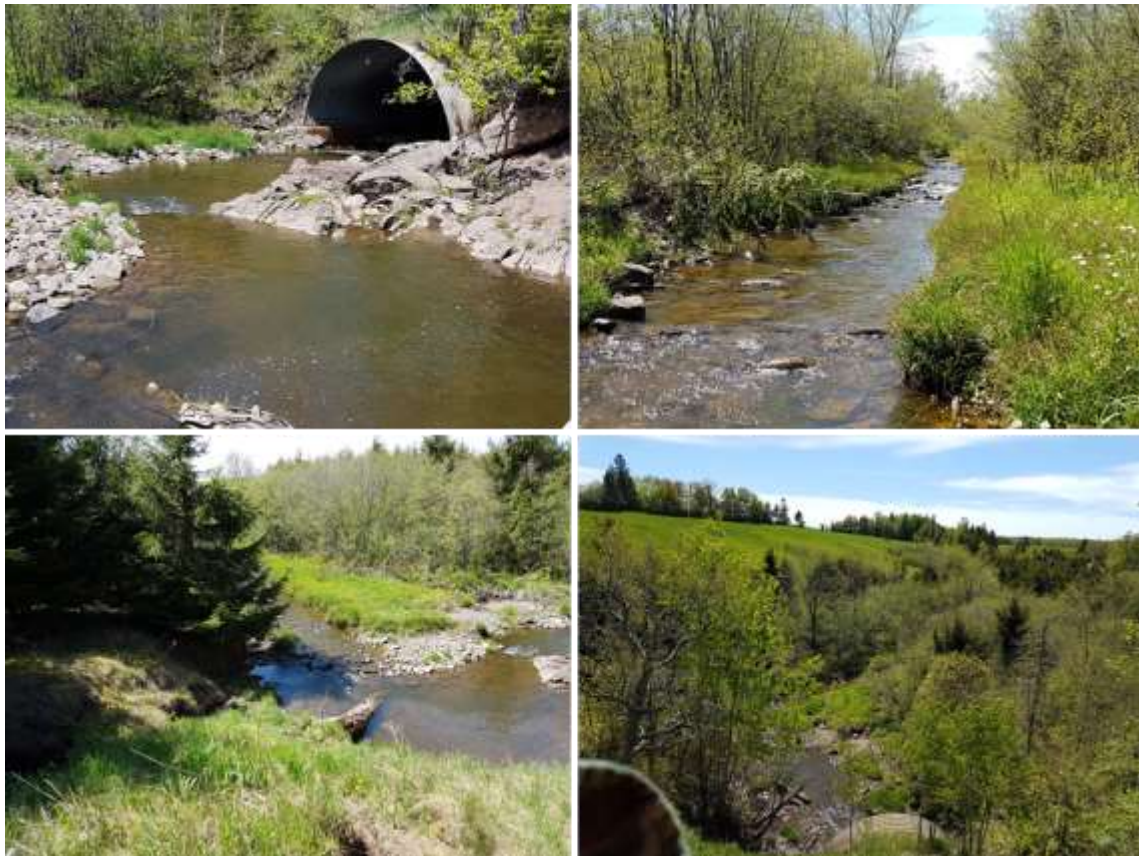
**Figure 5: Site photos for water quality sampling site ShdA, 2018**

The water sampling results for the site ShdA, for 2018, meets or exceeds all the recommendations for the survival of freshwater aquatic life based on pH and dissolved oxygen. Total phosphorus levels for long-term eutrophic conditions, according to the *CCME Guidance framework for Phosphorus*, were in the mesotrophic range (10 – 20 µg/L) from May to July, down to the Oligotrophic range (4-10 µg/L) in August, then an increase to the eutrophic range (35 – 100 µg/L) in September. Aluminum exceeded the guidelines in September (102 µg/L), when the recommendation is 100 µg/L when the pH value is ≥ 6.5. Iron also exceeded the guidelines in September (400 µg/L), when the recommendation is 300 µg/L. Bacterial levels did not exceed the maximum concentration of *E. coli* from the Health Canada recreational guideline (≥ 400 MPN/100 mL).

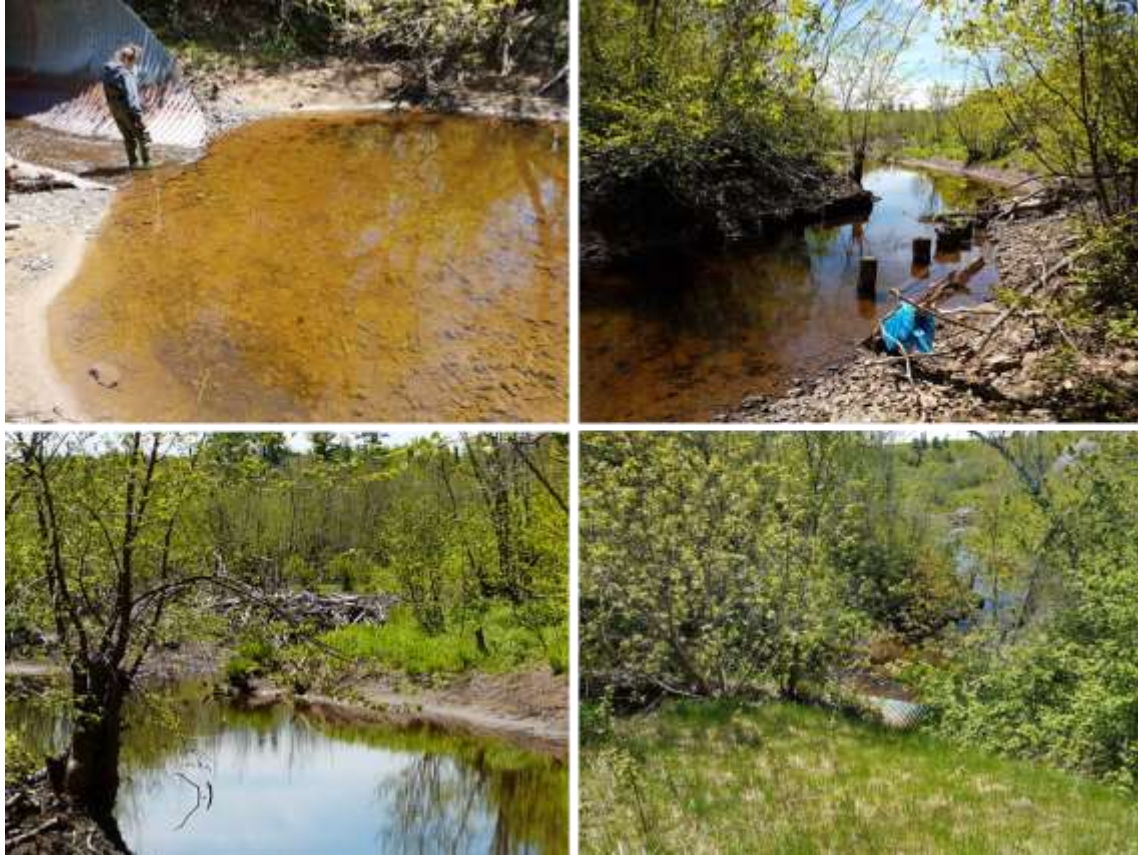
**Figure 7: Site photos for water quality sampling site ShdB, 2018**

The water sampling results for the site ShdB, for 2018, meet the recommendations for the survival of freshwater aquatic life based on pH. However, levels of dissolved oxygen dropped below the recommendation (6.5 mg/L) for general cold water organisms in July (3.50 mg/L) and August (5.54 mg/L). Low levels of DO can be explained by the presence of beaver dams around this site, causing disruptions in the natural flow and creating warm, stagnant water with low DO saturations. The water temperature reached the limit for thermal stress in salmonids (22.5°C) in July (23.80°C).

Total phosphorus levels for long-term eutrophic conditions, according to the *CCME Guidance framework for Phosphorus*, were: in the meso-eutrophic range (20 – 35 µg/L) in May and September; in the mesotrophic range (10 – 20 µg/L) in June; and in the eutrophic range (35 – 100 µg/L) in July and August. Iron exceeds the guideline (300 µg/L) in each sample except June. The highest iron concentration was in the month of July (1460 µg/L). Bacterial levels did exceed the maximum concentration of *E. coli* from Health Canada recreational guideline (≥ 400 MPN/100 mL) for the sample taken in August and September; 497.8 MPN/100 mL and 870.4 MPN/100 mL.

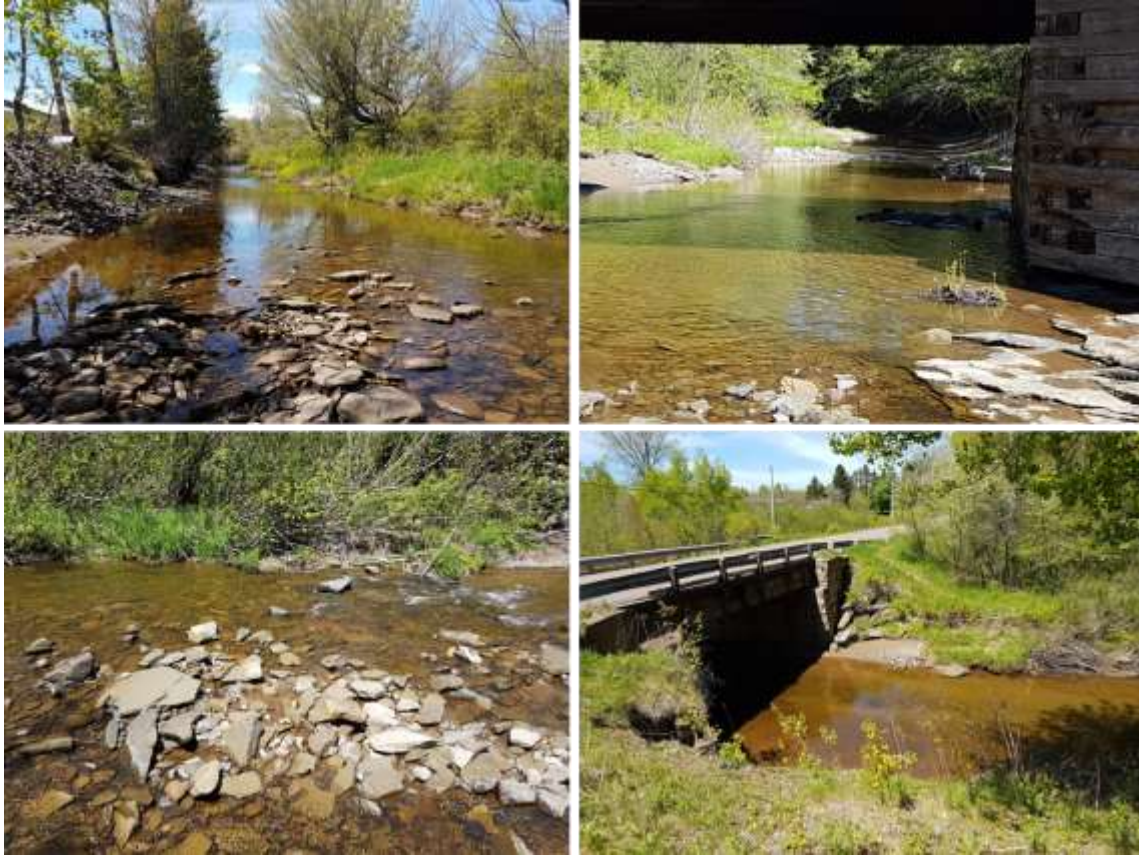
**Figure 9: Site photos for water quality sampling site ShdC, 2018**

The water sampling results for the site ShdC, for 2018, meets or exceeds all the recommendations for the survival of freshwater aquatic life based on pH and dissolved oxygen. Total phosphorus levels for long-term eutrophic conditions, according to the CCME Guidance framework for Phosphorus, were in the mesotrophic range (10 – 20 µg/L) from May to July, and in the oligotrophic range (4 – 10 µg/L) in August and September. Results did not exceed any of the recommended CCME water quality guidelines for inorganics (heavy metals and other elements). Bacterial levels did not exceed the maximum concentration of *E. coli* from the Health Canada recreational guideline ( $\geq 400$  MPN/100 mL).

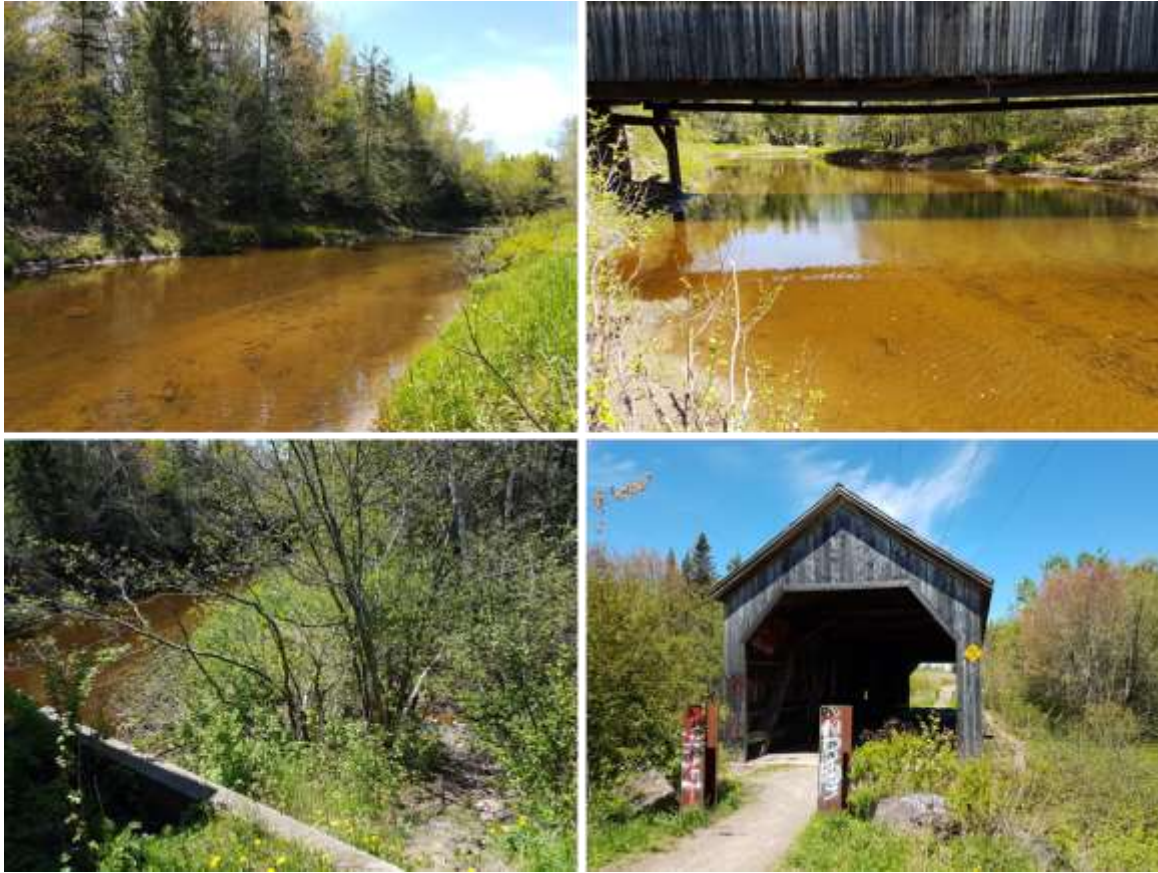
**Figure 11: Site photos for water quality sampling site ShdE, 2018**

The water sampling results for the site ShdE, for 2018, meets or exceeds all the recommendations for the survival of freshwater aquatic life based on pH and dissolved oxygen. The water temperature reached the limit for thermal stress in salmonids (22.5°C) in July (23.20°C). Total phosphorus levels for long-term eutrophic conditions, according to the *CCME Guidance framework for Phosphorus*, were in the mesotrophic range (10 – 20 µg/L) from May to July, and in the oligotrophic range (4 – 10 µg/L) in August and September. Results did not exceed any of the recommended CCME water quality guidelines for inorganics (heavy metals and other elements). Bacterial levels did not exceed the maximum concentration of *E. coli* from the Health Canada recreational guideline ( $\geq 400$  MPN/100 mL).

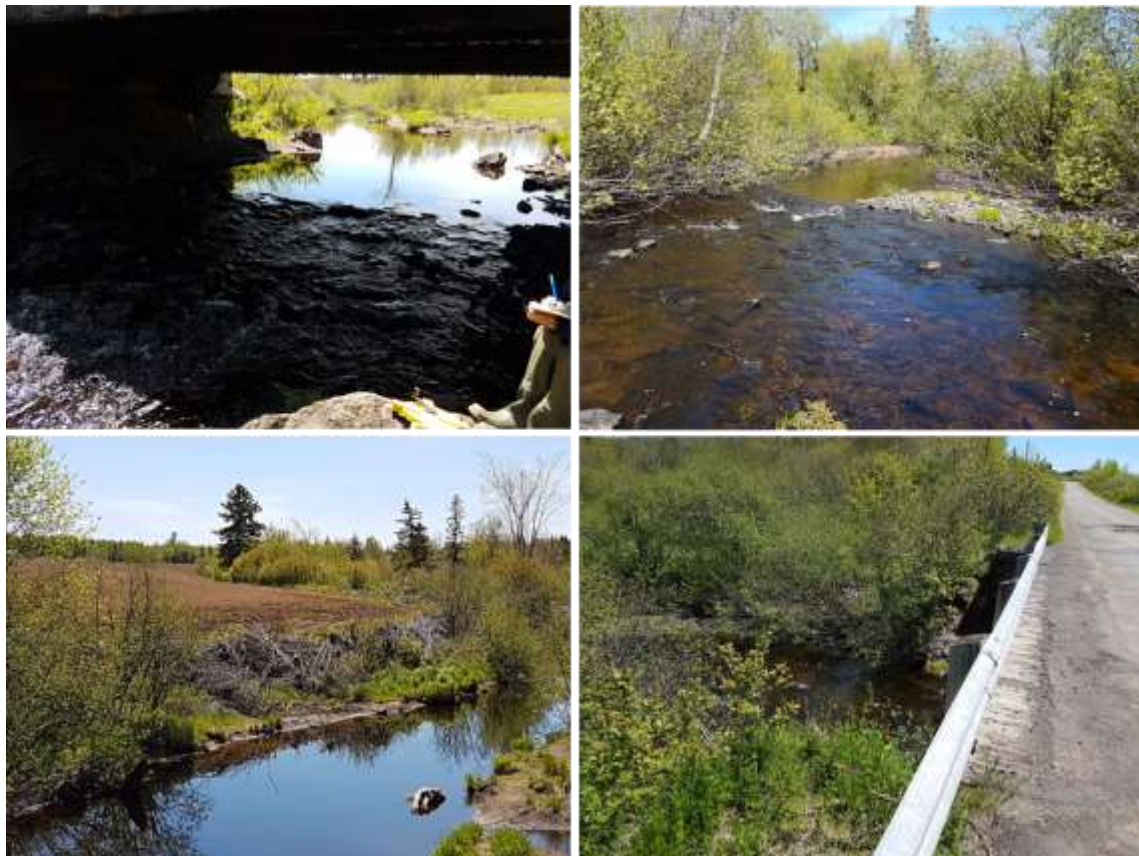
**Figure 13: Site photos for water quality sampling site ShdG, 2018**

The water sampling results for the site ShdG, for 2018, meets or exceeds all the recommendations for the survival of freshwater aquatic life based on pH and dissolved oxygen. Total phosphorus levels for long-term eutrophic conditions, according to the CCME Guidance framework for Phosphorus, were in the: meso-eutrophic range (35 - 100 µg/L) in May and June; in the mesotrophic range (10 – 20 µg/L) in July and September; and finally in the ultra-oligotrophic range (>4) in August. Concentrations of iron exceeded the CCME water quality guideline (300 µg/L) in the months of May (330 µg/L) and June (430 µg/L). Bacterial levels did not exceed the maximum concentration of *E. coli* from the Health Canada recreational guideline ( $\geq 400$  MPN/100 mL).

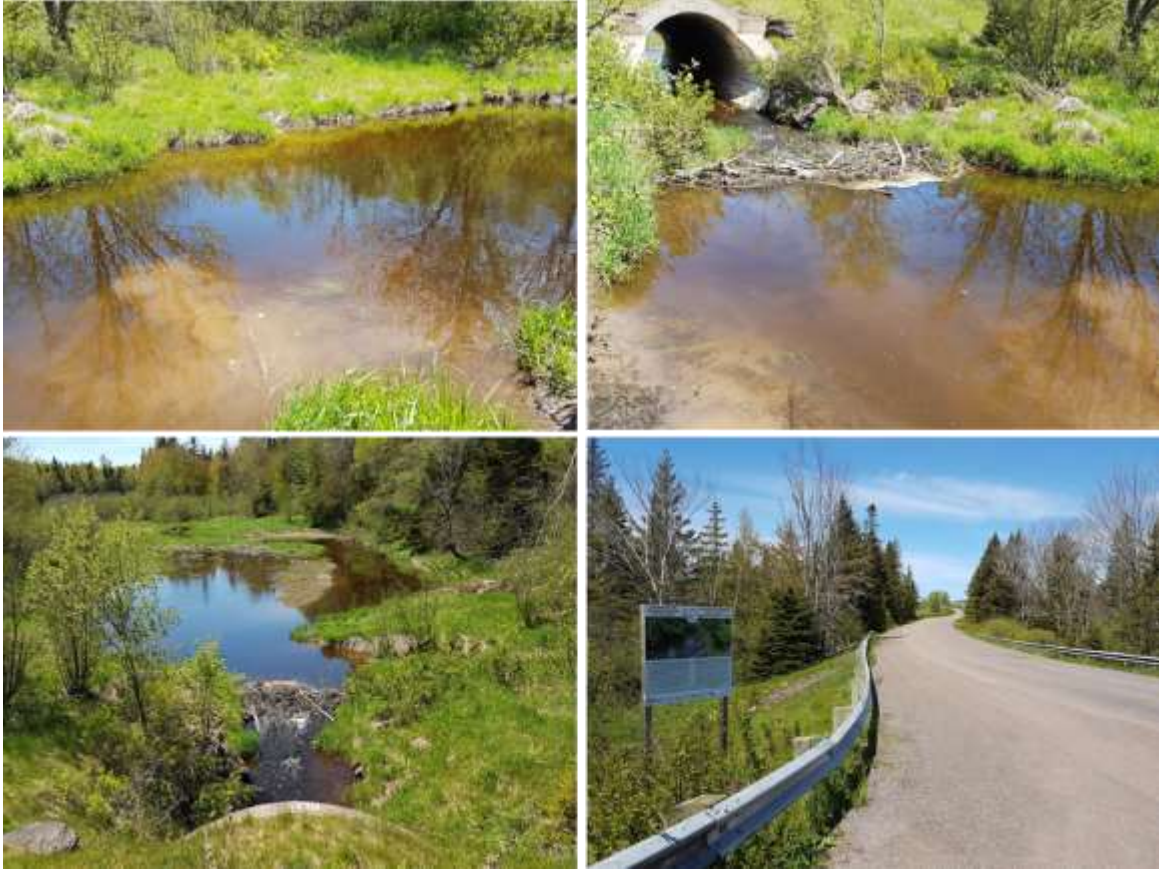
**Figure 15: Site photos for water quality sampling site ShdH, 2018**

The water sampling results for the site ShdH, for 2018, meets or exceeds the recommendations for the survival of freshwater aquatic life based on pH. However, levels of dissolved oxygen dropped below the recommendation (6.5 mg/L) for general cold water organisms in June (6.17 mg/L), July (3.37 mg/L) and August (5.68 mg/L).

Total phosphorus levels for long-term eutrophic conditions, according to the CCME Guidance framework for Phosphorus, were in the meso-eutrophic range (20 – 35 µg/L) for all samples in 2018. Concentrations of iron exceeded the CCME water quality guideline (300 µg/L) for every sample taken in 2018. The highest level of iron was measured in the month of July; 1250 µg/L, more than 4X the recommended guideline. Bacterial levels did exceed the maximum concentration of *E. coli* from Health Canada recreational guideline ( $\geq 400$  MPN/100 mL) for the sample taken in August; 449.4 MPN/100 mL.

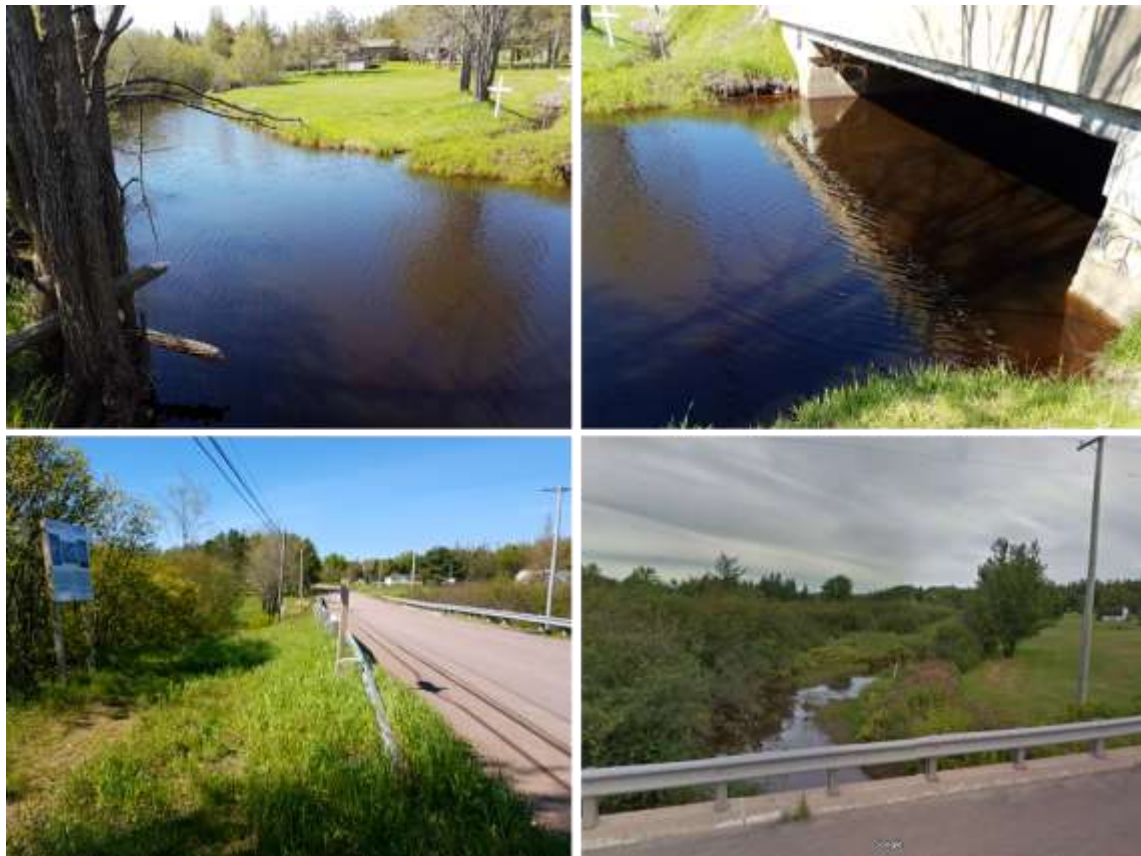
**Figure 17: Site photos for water quality sampling site ScdB, 2018**

The water sampling results for the site ScdB, for 2018, meet the recommendations for the survival of freshwater aquatic life based on pH. However, levels of dissolved oxygen dropped below the recommendation (6.5 mg/L) for general cold water organisms in July (4.65 mg/L), August (4.52

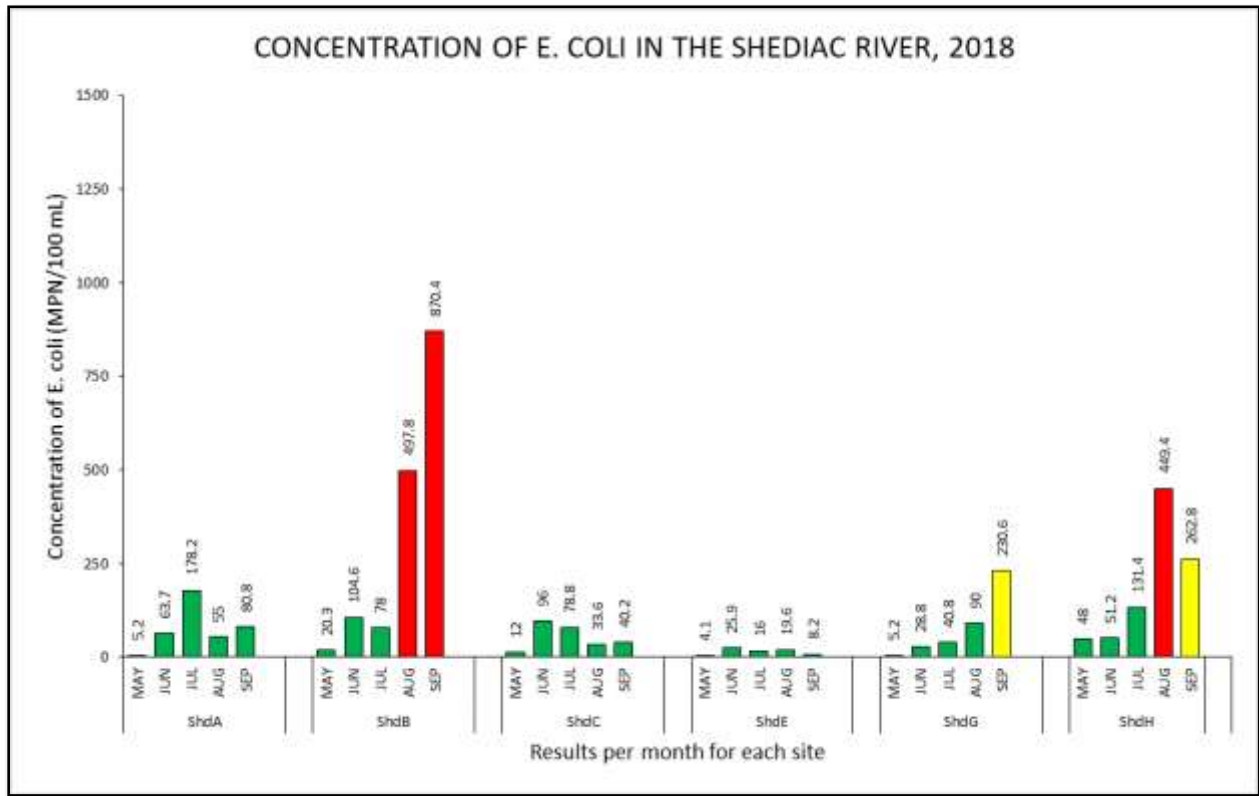
Figure 24: Summary of water quality results for *E. coli*, Shediac River sampling 2018

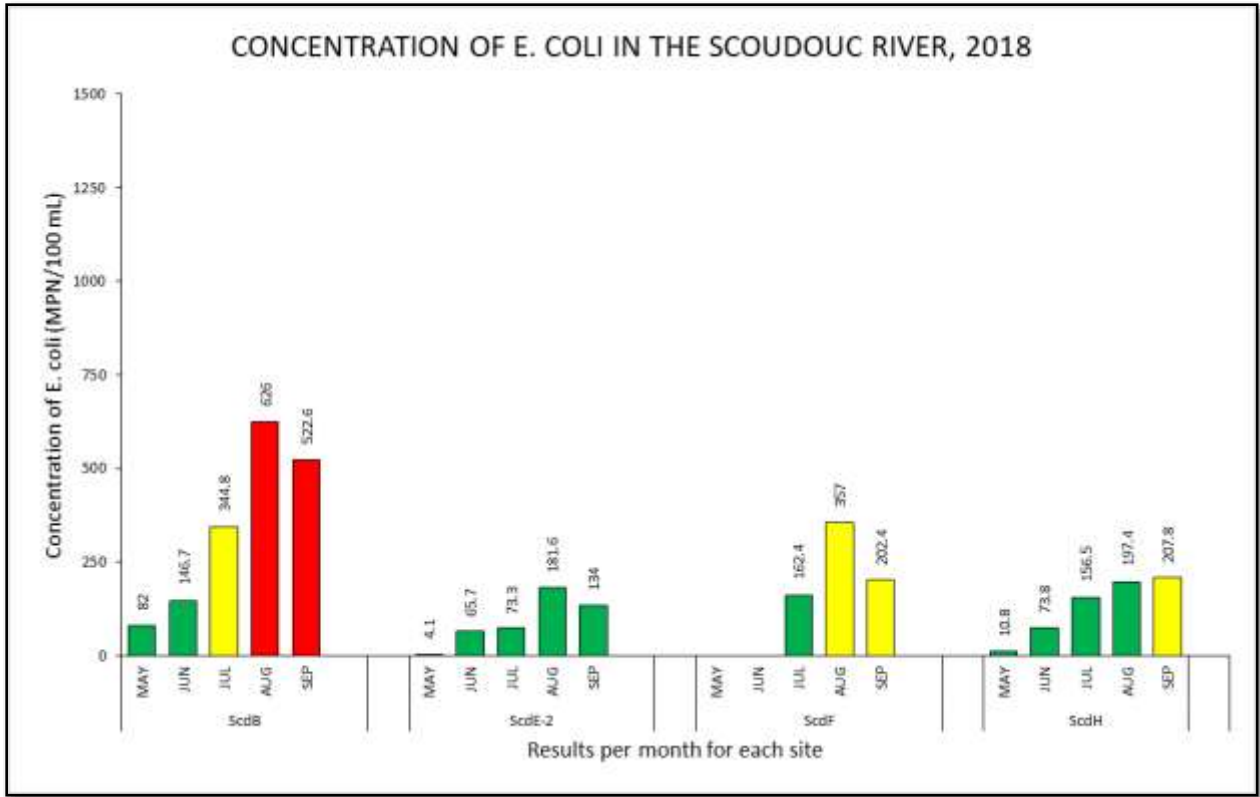
For the Scoudouc River, there are 2 samples that surpassed the Canadian Recreational Water Quality Guideline (400 MPN/100 mL); the site ScdB in August and September. As mentioned above, there was an occurrence of rainfall (> 10 mm) in the 24-hour period prior to a sample was in the month of September.

**Figure 25: Summary of water quality results for E. coli, Scoudouc River sampling 2018**

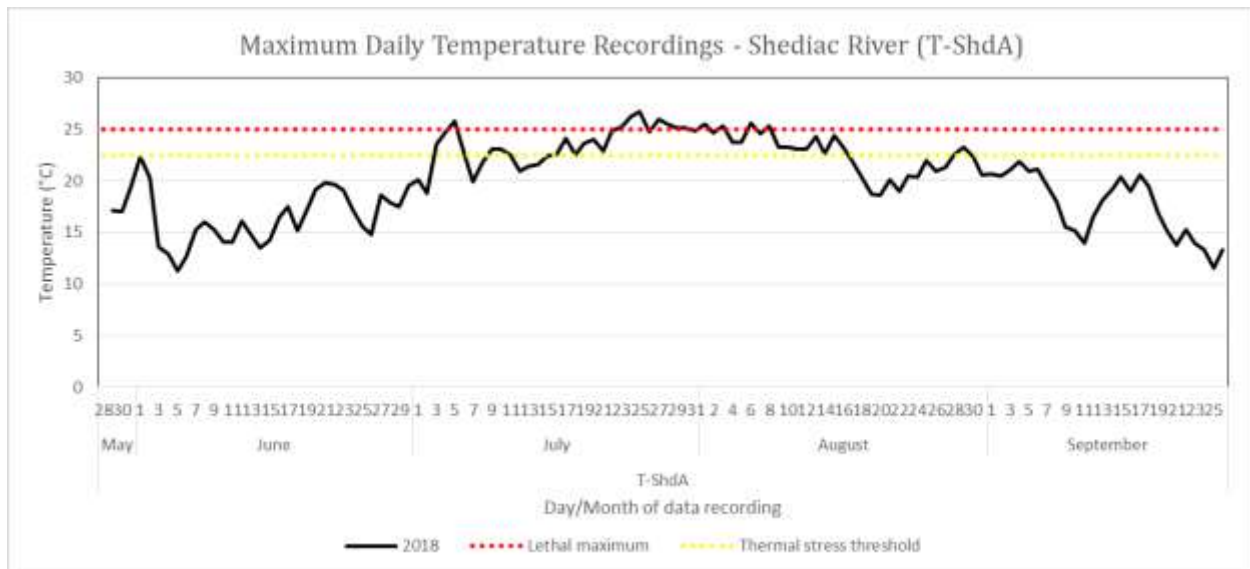
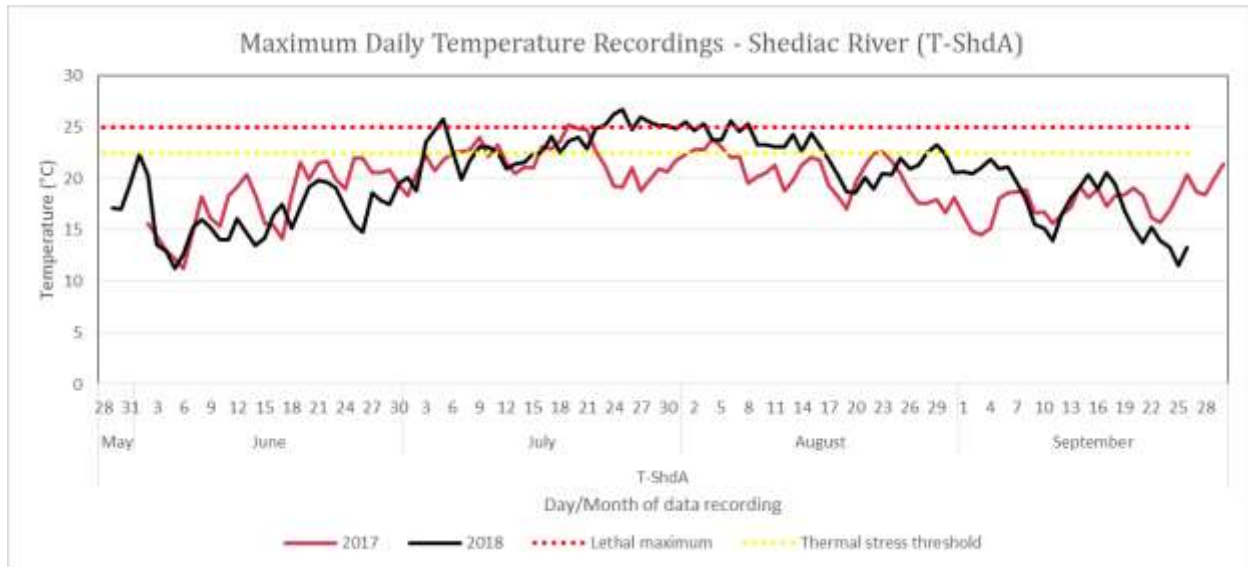
Considering that 2018 was a warmer year than 2017, there is a considerable increase in temperature readings in 2018. In 2017, maximum temperatures exceeded the threshold on 25 days, of only 7 were consecutive, and exceeded the lethal limit only once.

Figure 28: Thermograph data chart for monitoring station ID T-ShdA, Shediac River 2018

**Figure 29: Thermograph data chart for monitoring station ID T-ShdA, Shediac River 2017-2018**

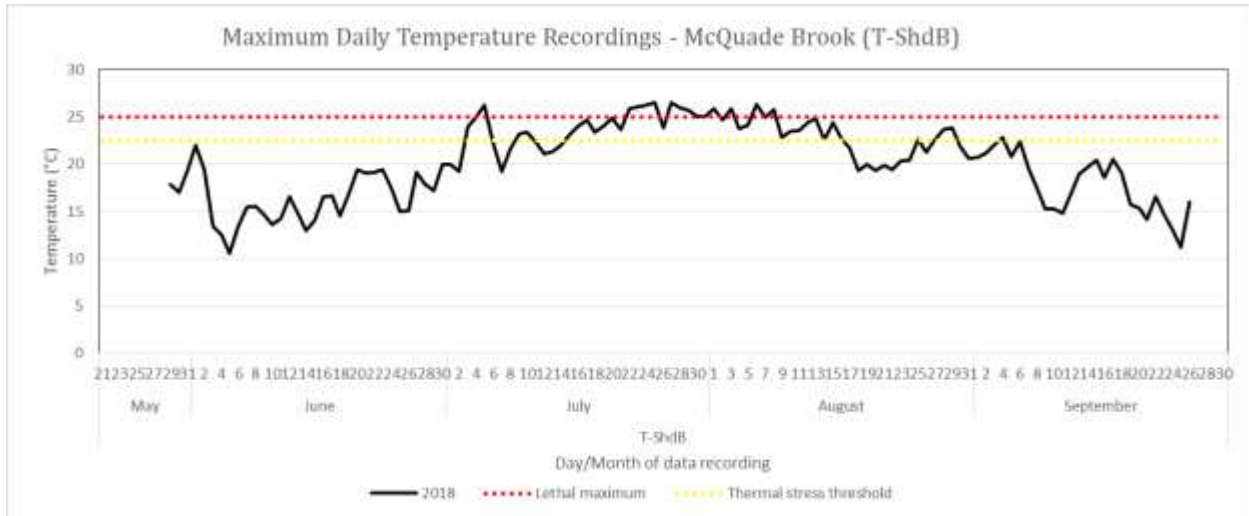
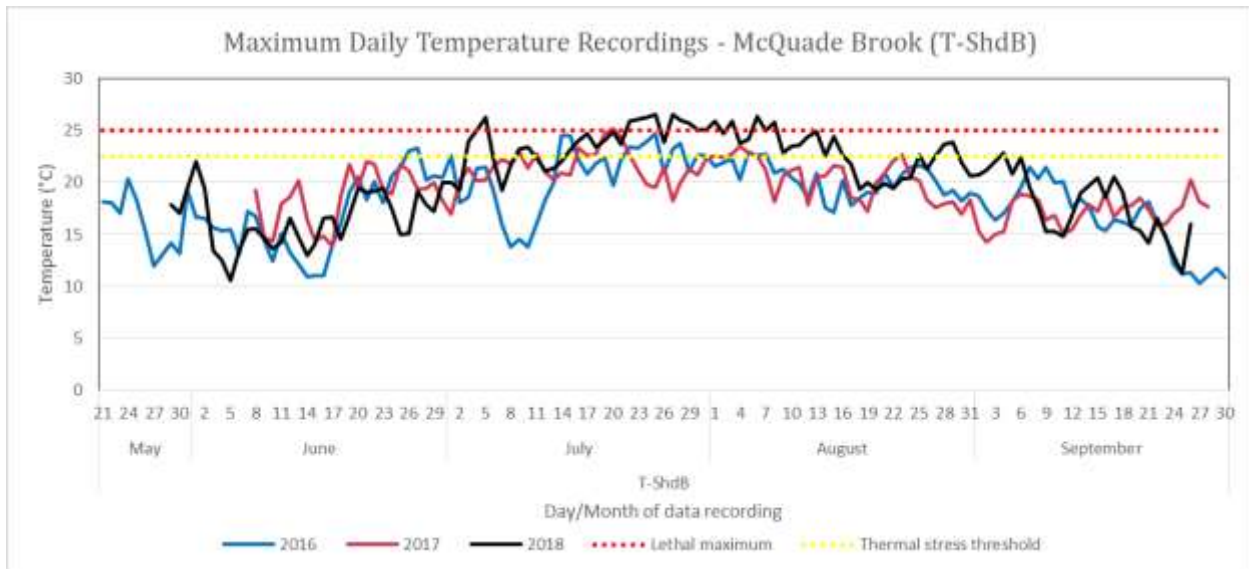
In 2017, maximum temperatures exceeded the threshold on 39 days, in which on three occasions exceed the thermal stress threshold on 14 occasions during the peak of the summer months; 4 independent days, 6 consecutive days in July and 4 in August. The maximum daily temperatures exceeded the lethal maximum limit only once.

**Figure 30: Thermograph data chart for monitoring station ID T-ShdB, Shediac River 2018**

**Figure 31: Thermograph data chart for monitoring station ID T-ShdB, Shediac River 2016-2018**

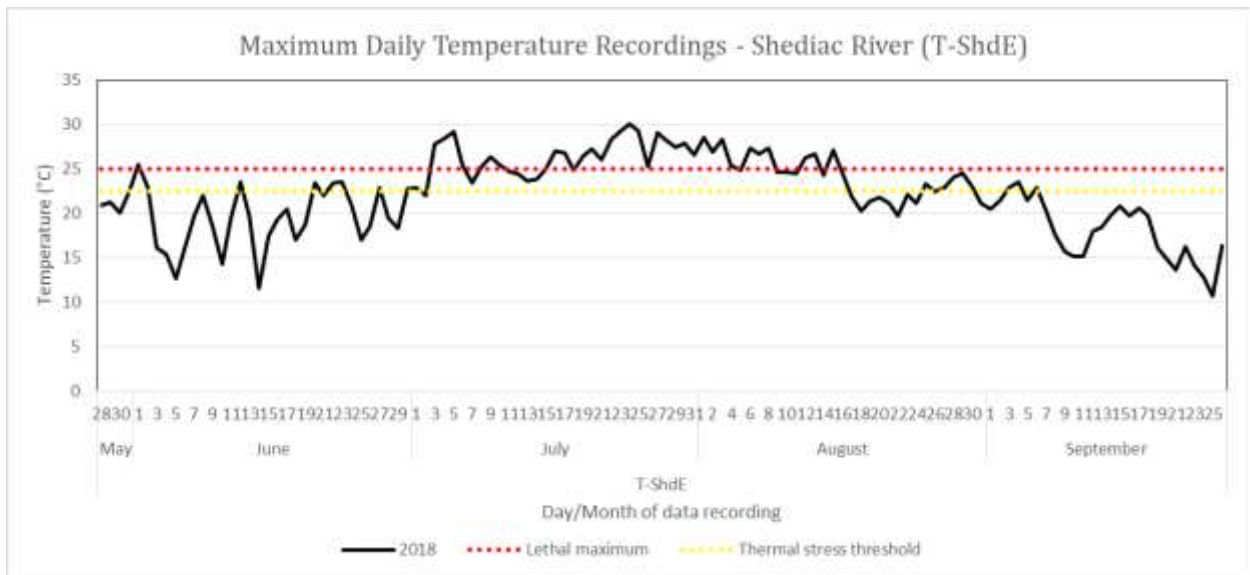
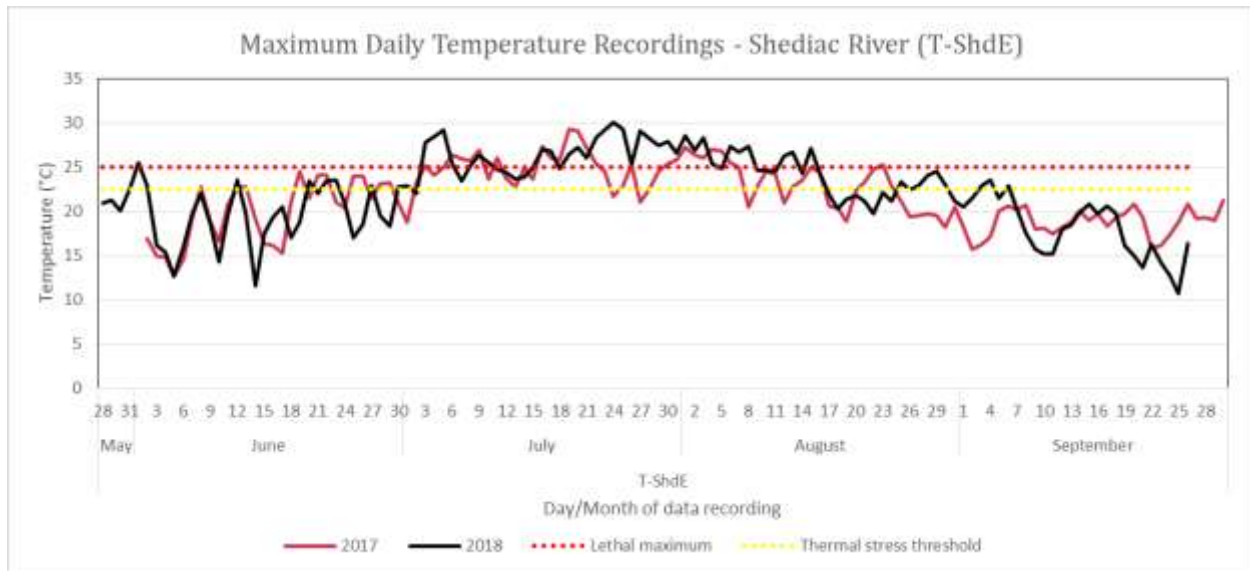
In 2017, maximum temperatures exceeded the threshold on 56 occasions during the peak of the summer months, on 22 consecutive days in July. The thermograph also shows that the maximum temperatures exceeded the lethal maximum on 23 occasions.

**Figure 32: Thermograph data chart for monitoring station ID T-ShdE, Shediac River 2018**

**Figure 33: Thermograph data chart for monitoring station ID T-ShdE, Shediac River 2017-2018**

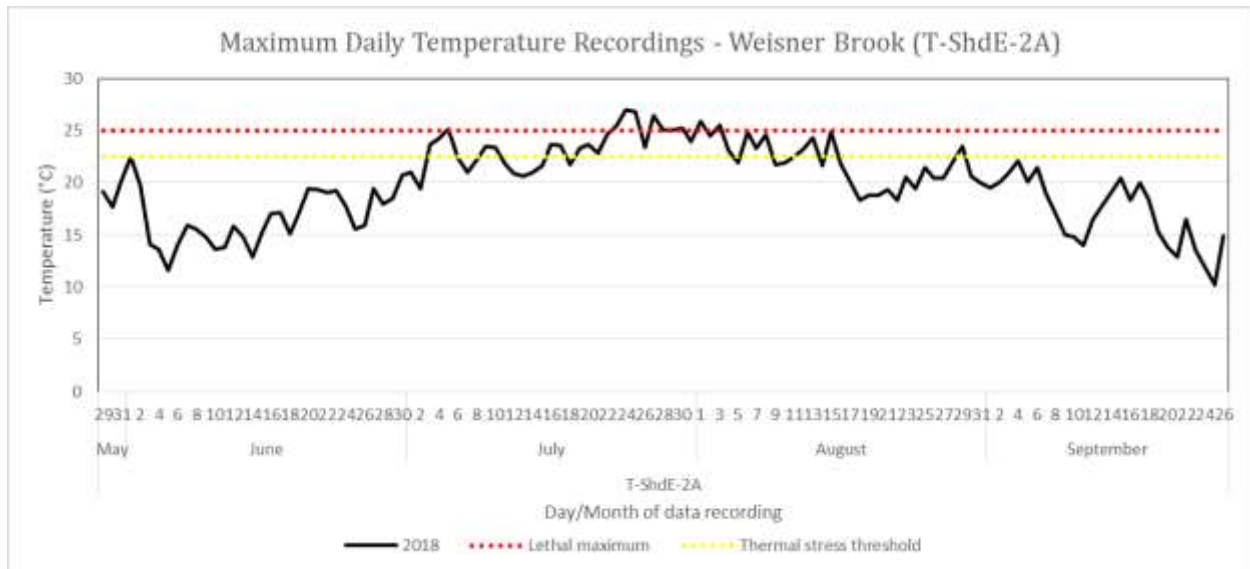
Only one year of data is available for this site, due to the accidental loss of the data on the logger in 2017.

**Figure 34: Thermograph data chart for monitoring station ID T-ShdE-2A, Weisner Brook 2018**

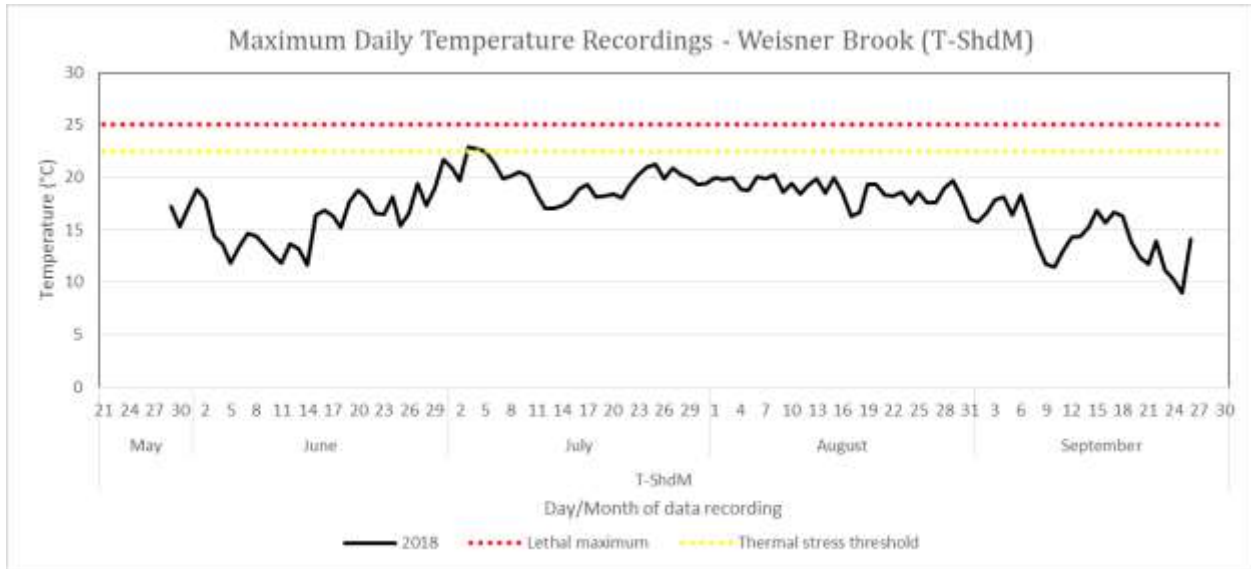
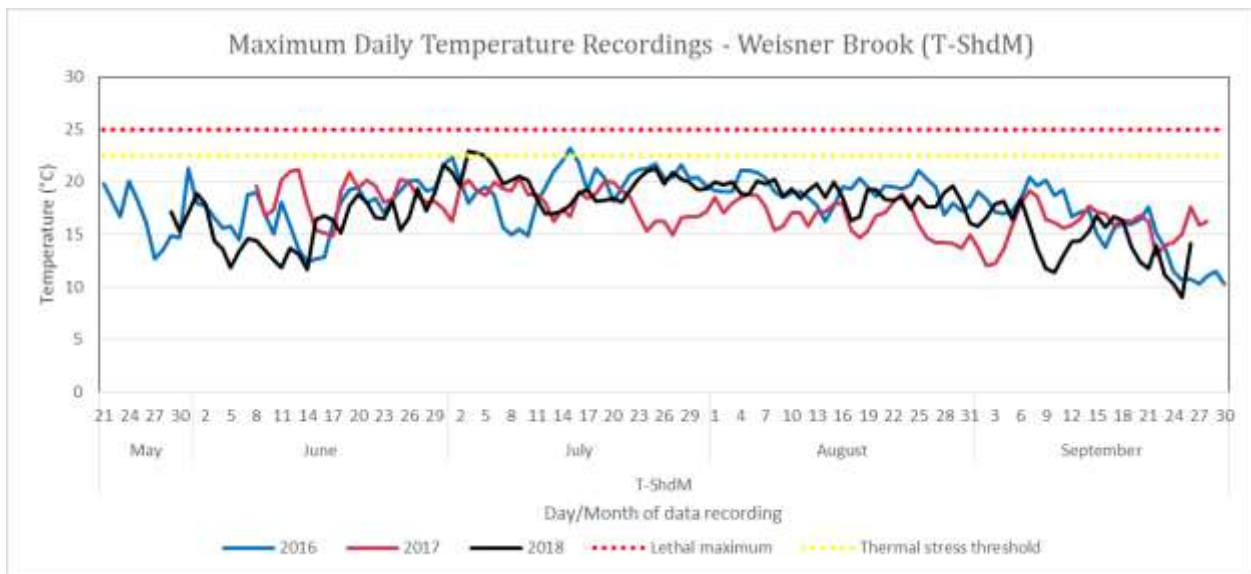
The temperature readings for this site are slightly higher than 2017, where temperatures never exceeded the threshold value (highest temperature recorded was 21.19 °C). Regardless, the temperatures in 2018 are still very good. This stream has an excellent tree cover on both sides that creates adequate shade to keep water temperatures down.

**Figure 35: Thermograph data chart for monitoring station ID T-ShdM, Shediac River 2018**

**Figure 36: Thermograph data chart for monitoring station ID T-ShdM, Shediac River 2016-2018**

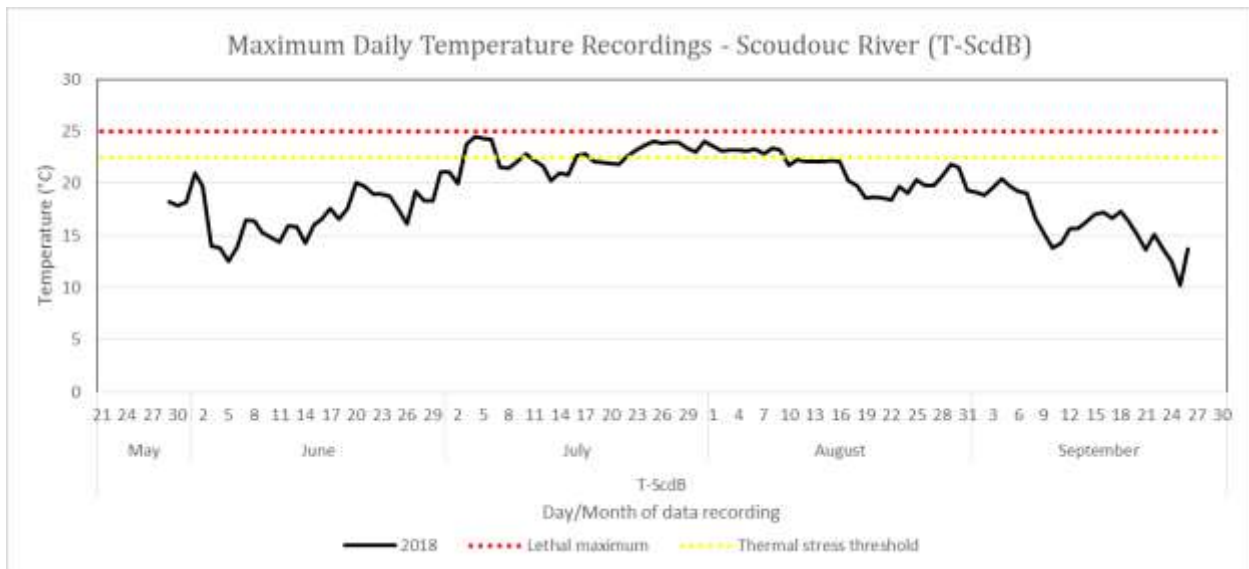
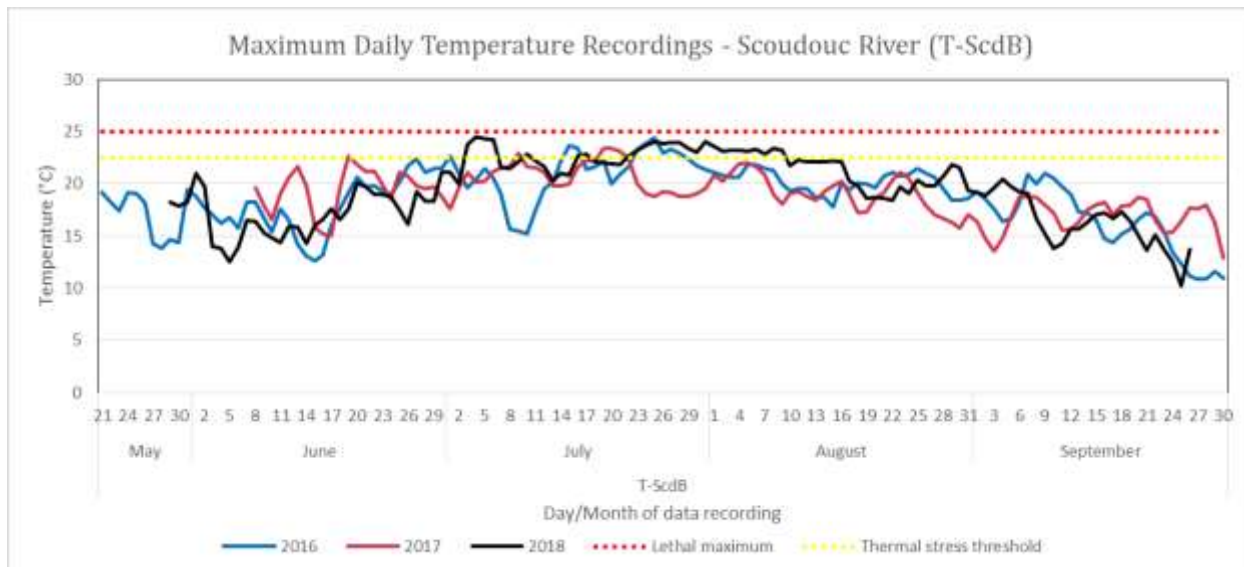
When comparing the three years of data for this site, temperatures in June of 2017 were higher than the other two years. However, overall temperature recordings for 2018 are warmer than 2016 and 2017.

Figure 37: Thermograph data chart for monitoring station ID T-ScdB, Scoudouc River 2018

**Figure 38: Thermograph data chart for monitoring station ID T-ScdB, Scoudouc River 2016-2018**

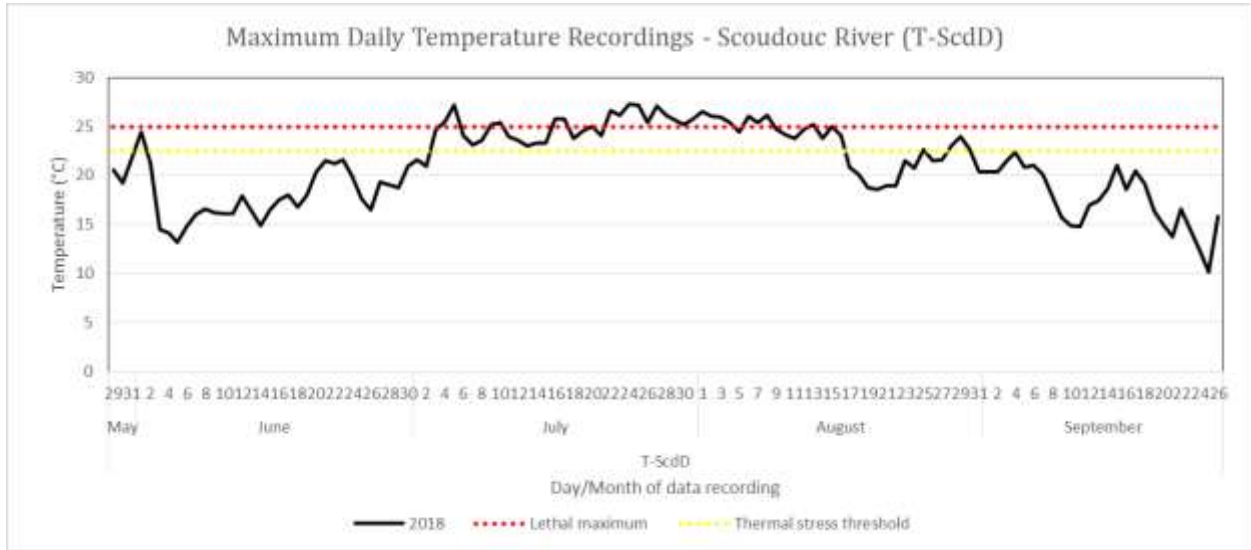
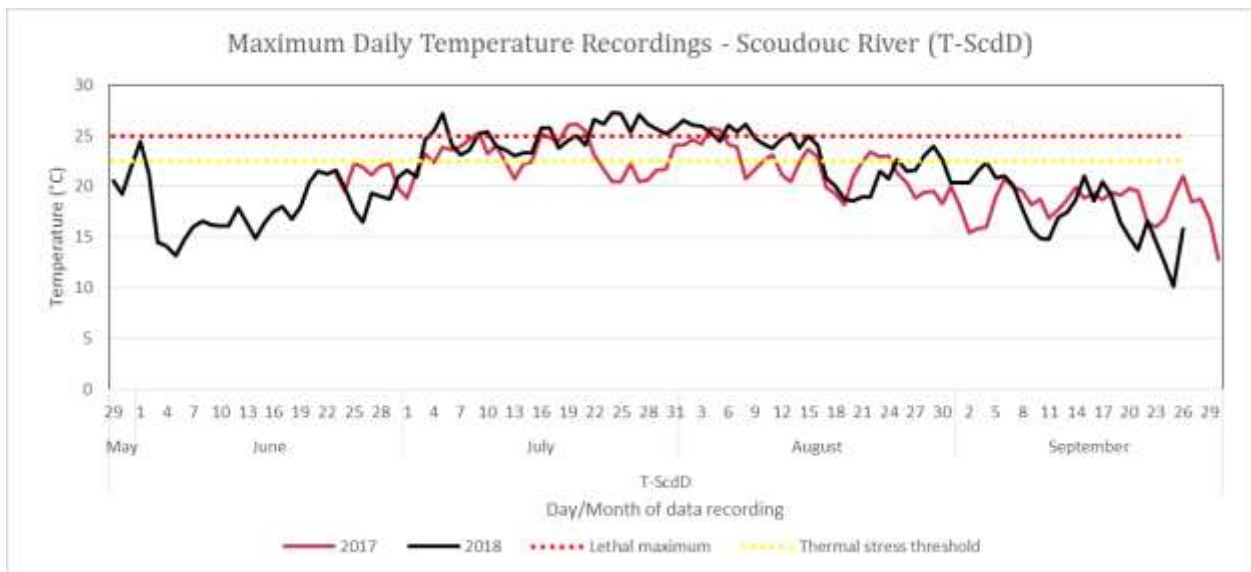
The summer of 2018 was very hot and dry, more so than last year. In 2017, maximum temperatures exceeded the threshold on 39 days, in which on three occasions exceed the threshold for at least 7 consecutive days (July 5 to 11, July 16 to 22 and July 31 to August 7, 2017). Temperatures exceeded the lethal limit on 9 occasions; twice in June, 5 times in July and twice in August.

**Figure 39: Thermograph data chart for monitoring station ID T-ScdD, Scoudouc River 2018**

**Figure 40: Thermograph data chart for monitoring station ID T-ScdD, Scoudouc River 2017-2018**

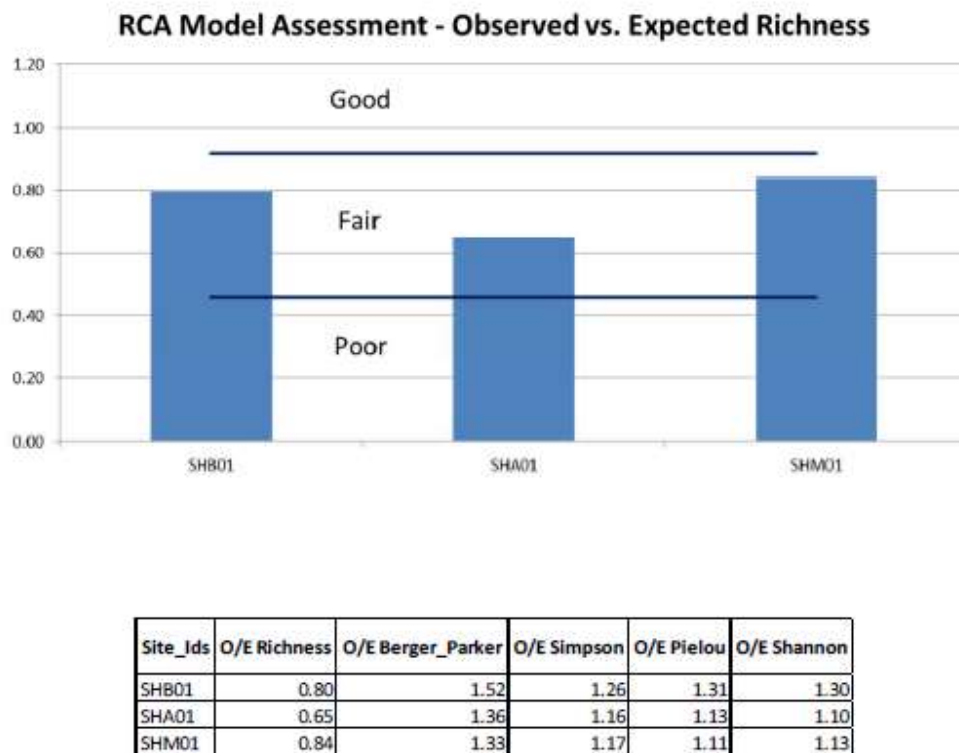
In the 2015, the sampling was done in partnership with the Miramichi River Environmental Assessment Committee (MREAC), as part of their project “The Atlantic Provinces Canadian Aquatic Biomonitoring Network Collaborative”, funded by AEI (Atlantic Ecosystem Initiative). The RCA model assessment was done for the SBWA’s site by MREAC staff (Figure 42).

**Figure 42: RCA Model Assessment – Observed vs. Expected Richness, CABIN 2015**

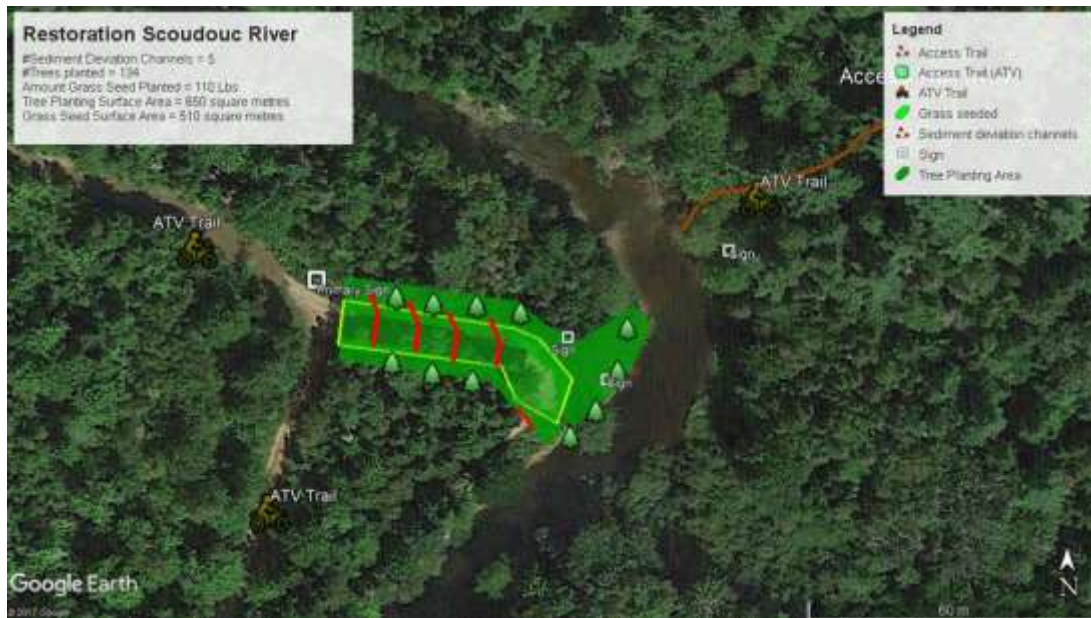
An area in the Scoudouc River was selected for remediation due to erosion and sedimentation problems surrounding sensitive salmon habitat in 2017. This year, the restoration of this site was continued. There was a bit of damage from the spring's canoe and ATV run. The fourth log, at the bottom of the hill, had been taken off and thrown to the side of the trail. This summer, the log was retrieved and reinstalled at the same location as well as a new piece of geotextile. The restoration also involved in the maintenance of the channel stabilizers, by digging trenches towards the woods, where fine sediments had accumulated on the logs over the winter and spring. Fall rye was planted all over the restoration site again this year due to the destruction made by this year's ATV run. It is important to establish a good amount of fall rye on the trail to further stabilize the soil that was disturbed by the creation of this project.

**Figure 45: Map showing where restoration work was done at the Scoudouc River in 2017-2018**

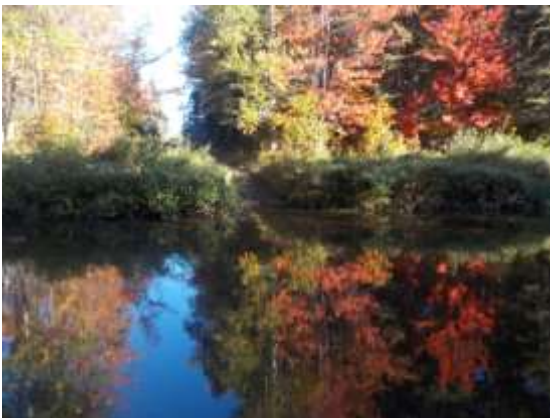
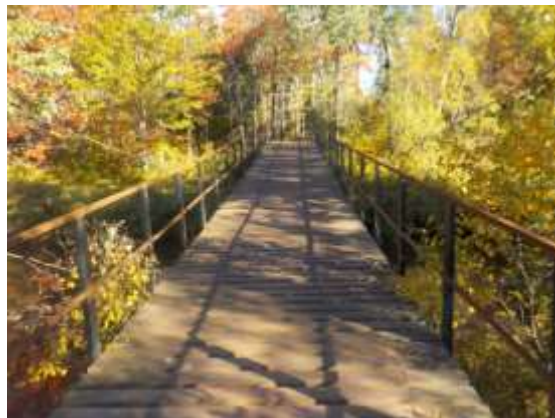
Figure 51: Images of the old crossing and new bridge
