# Improving Water Quality in the Shediac and Scoudouc Rivers

## Final Report

**The Shediac Bay Watershed Association Inc.**

**March 1, 2019**

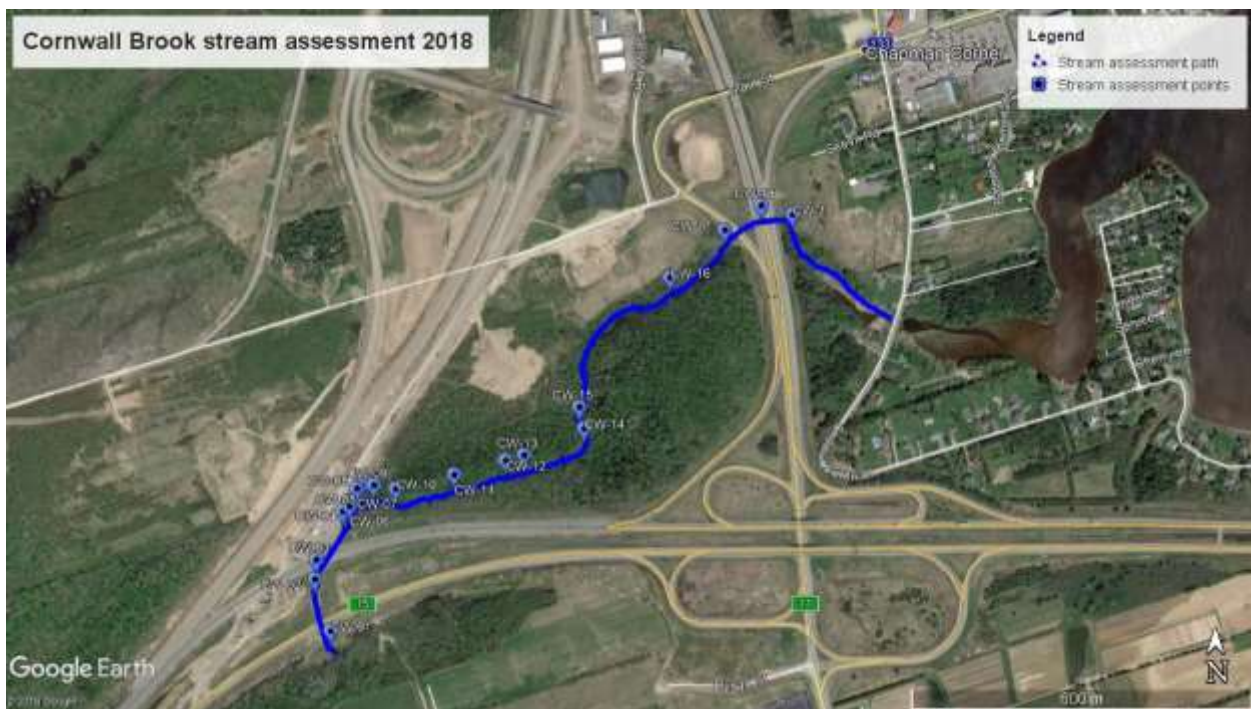
**Figure 54: Cornwall Brook stream assessment 2018**

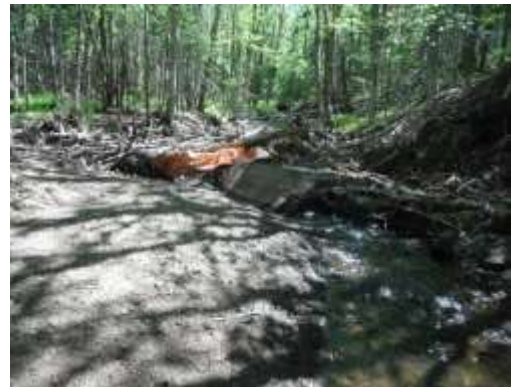
**Figure 55: Image of trash in stream**

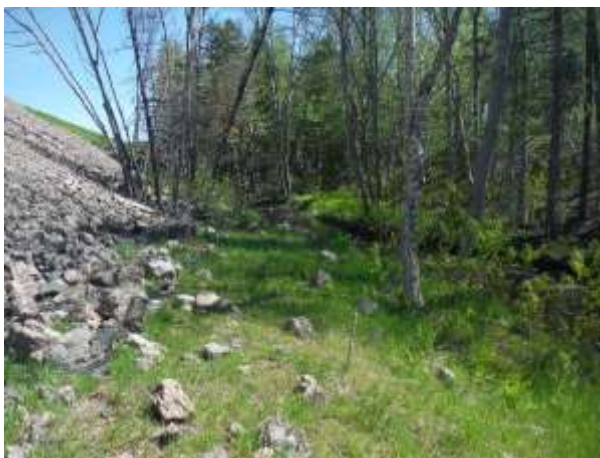
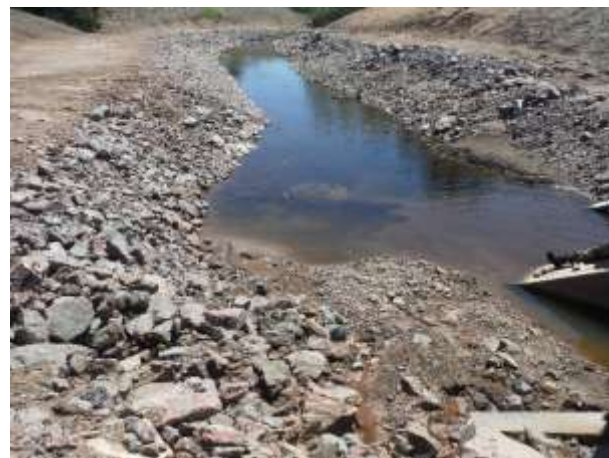
**Figure 56: Examples of degraded buffer zones along the Cornwall Brook**
