# **Environmental Evaluation of the Health of the Shediac Bay**

## **Final Report**

**The Shediac Bay Watershed Association Inc.**

**March 1, 2019**

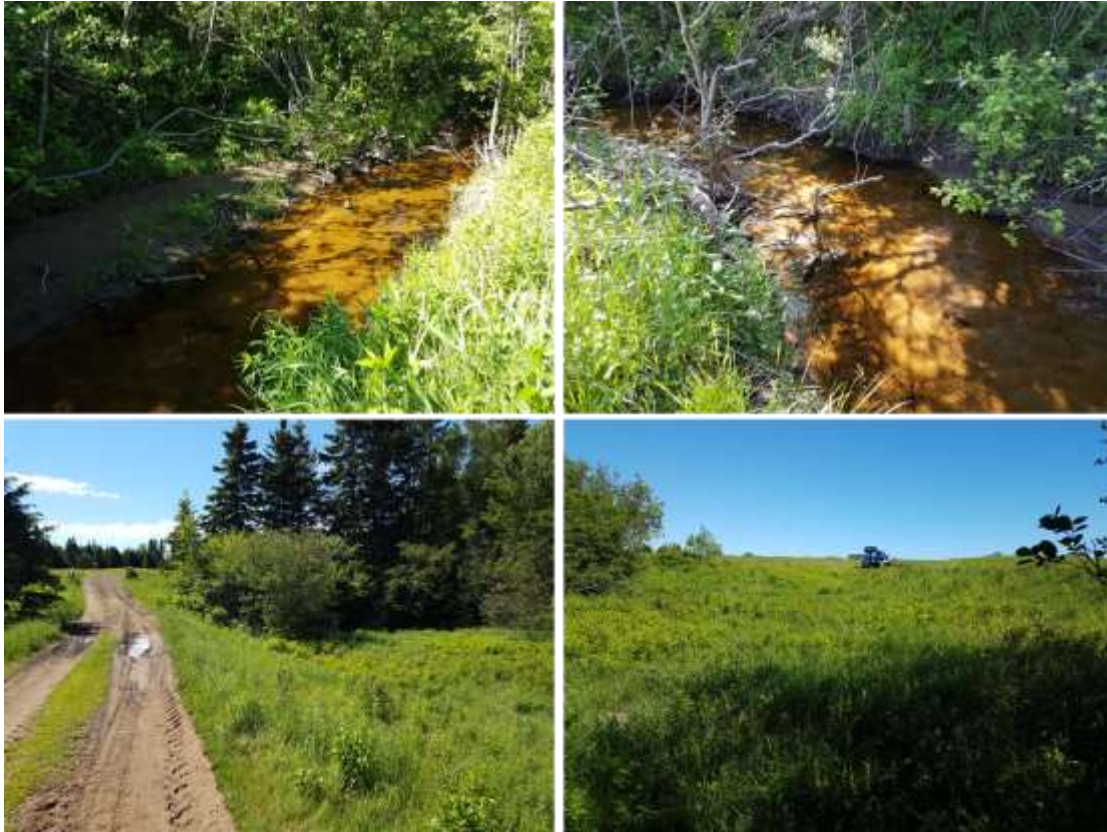
**Figure 4: Site photos for the water quality monitoring station WQ-1**

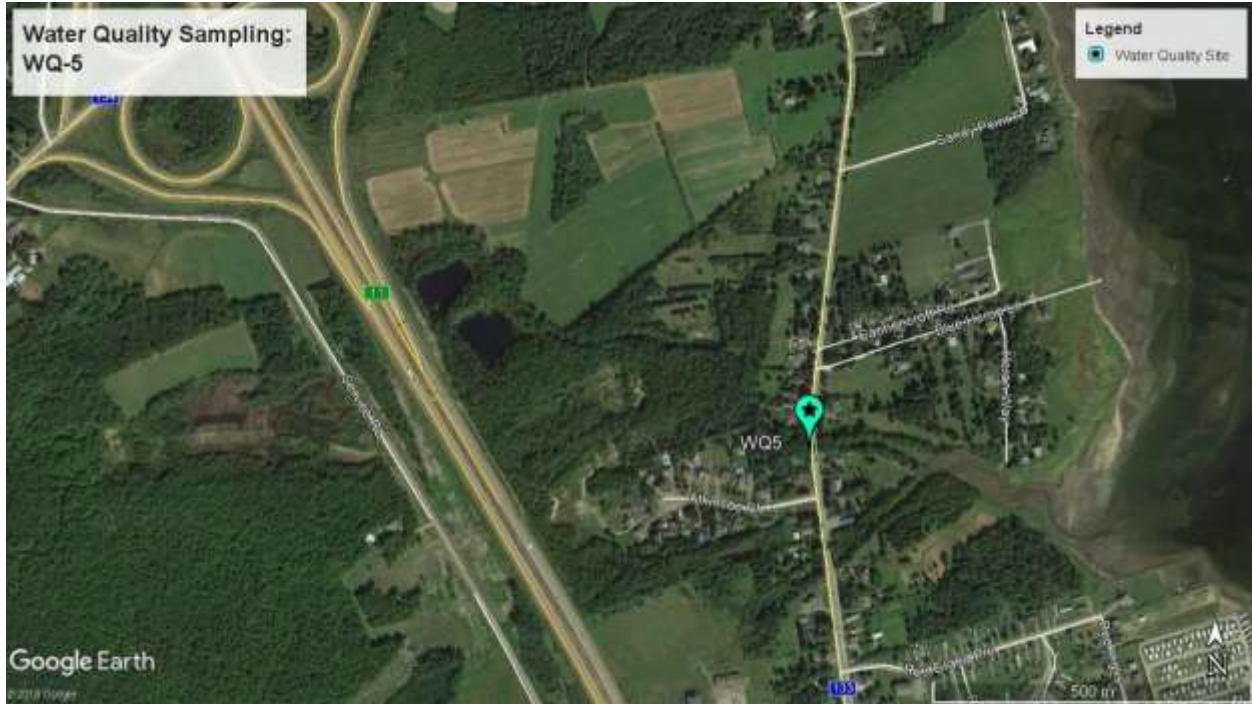
**Figure 11: WQ-5 site location and surrounding land uses**

The water sampling results for the site WQ-5, for 2018, meets or exceeds all the recommendations for the survival of freshwater aquatic life based on pH and dissolved oxygen. Total phosphorus levels for long-term eutrophic conditions according to the “CCME Guidance Framework for Phosphorus” were in the meso-eutrophic range (20 - 35 µg/L) in June and September, and in the eutrophic range (4 - 10 µg/L) in May, July and August.

Results did exceed the recommended CCME water quality guidelines for chloride in freshwater, from June to September, exceeding the long-term limit (120 mg/L) but the short-term limit was not exceeded (640 mg/L). Concentrations of aluminum exceeded the CCME water quality guideline (100 µg/L when the pH is ≥6.5) in the sample taken in May (126 µg/L). Concentrations of iron also exceeded the guidelines in May, June, and July (420 µg/L, 360 µg/L and 370 µg/L respectively), when the recommendation is 300 µg/L. Bacterial levels did not exceed the maximum concentration of *E. coli* from Health Canada recreational guideline (≥ 400 MPN/100 mL).

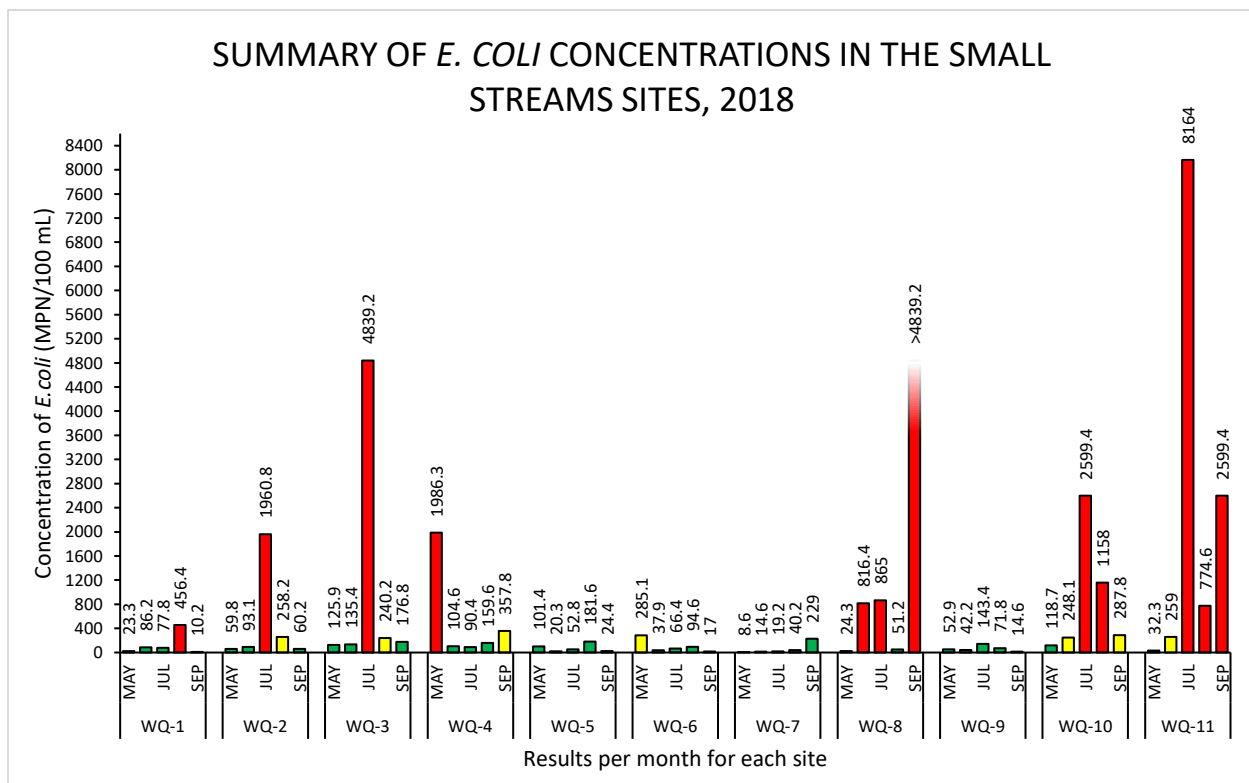
Most sampling stations had at least one instance of a bacterial spike over the recommended 400 MPN/100 mL limit in 2018. The sites that did not have an instance of bacterial spike are; WQ-5, WQ-6, WQ-7, and WQ-9. Based on the bacterial levels alone, the stations that merit further investigations for sources of fecal coliforms are; WQ-2, WQ-3, WQ-4, WQ-8, WQ-10 and WQ-11.

**Figure 25: Summary of water quality results for *E. coli*, small streams sampling 2018**

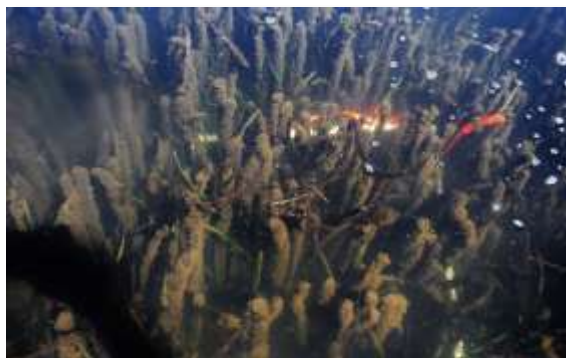
**Figure 29: Epiphytes present on eelgrass in the Scoudouc River site in 2016.**

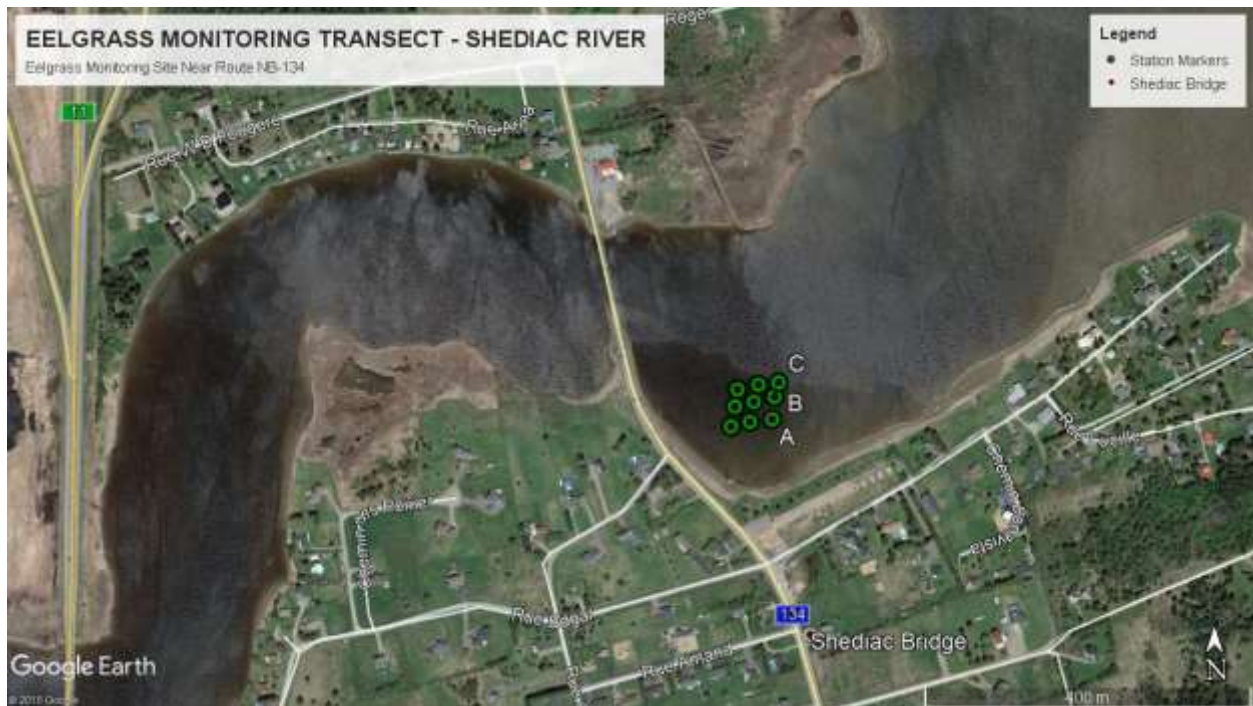
The Shediac River site is located east of the bridge on Route NB-134 (N46°16'16.54" W64°34'23.30"). This site was established and surveyed in August of 2017, and a second survey was performed in August 2018. Four station markers (screw anchors) had been torn out of the substrate over the winter 2017-2018, and were replaced using a GPS, compass bearings and measuring tape triangulation. Survey photos and field sheets can be found in Appendix B and C.

**Figure 30: Google Earth satellite image of the Shediac River estuary and the location of the eelgrass monitoring transects**

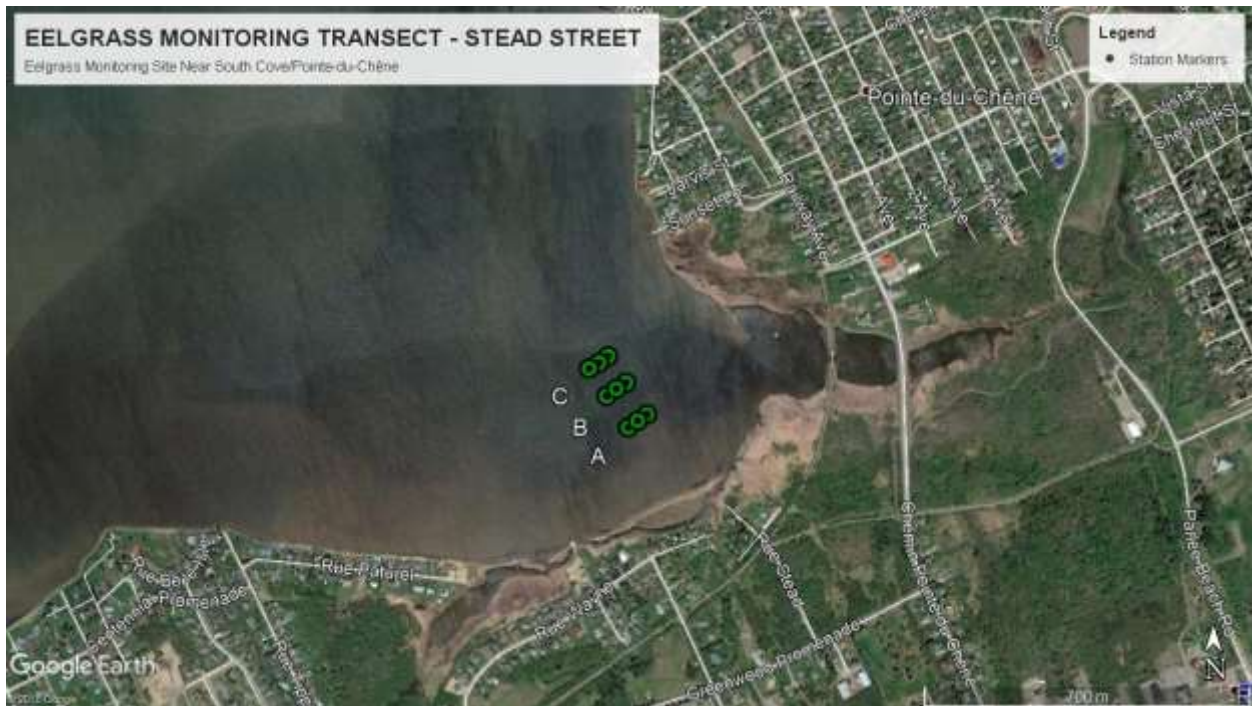
This eelgrass monitoring site is located in the Shediac Bay, near the mouth of the estuary of South Cove, near Pointe-du-Chêne (N46°13'53.7" W64°31'27.34"). This site was newly established in 2018, and its first survey was performed on August 7 & 8th. Survey photos and field sheets can be found in Appendix B and C.

**Figure 32: Google Earth satellite image of the Shediac Bay near Pointe-du-Chêne/South Cove estuary, and the location of the Stead Street eelgrass monitoring transect**

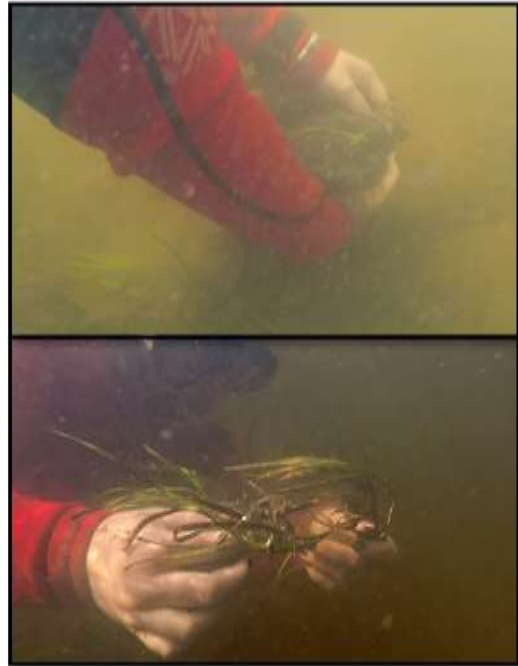
Using simple snorkelling equipment, SBWA staff dove to collect thousands of eelgrass plants in the shallow waters of the bridge construction zone. Floating crates were built by drilling holes into storage containers and fitting pool floaters for easy collection and transportation of the eelgrass. The plants were gently excavated from the soft substrate (mixture of sand and fine sediments) by digging with both hands and lifting from under the rhizome system, maintaining as much connected rhizomes as possible. Any eelgrass shoots with visible fish eggs were left alone.

Once collected, a portion of the plants were threaded through pre-drilled shells. The shells used were oyster and quahog shells, collected in other areas of the Shediac Bay and cleaned properly before use.

**Figure 34: Eelgrass collection and photo of rhizomes**

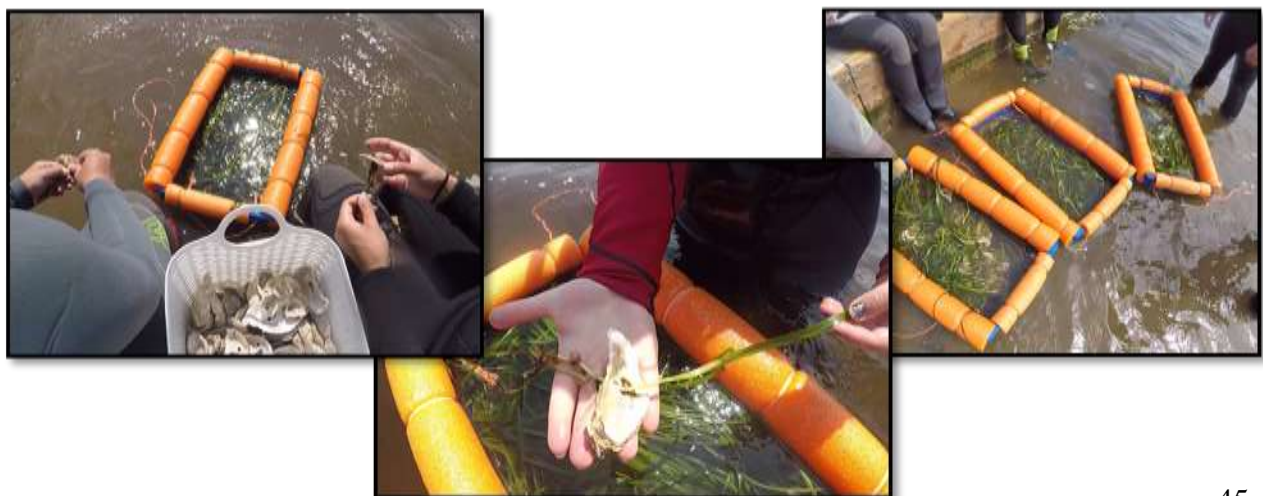
**Figure 35: Threading eelgrass plants through pre-drilled shells**

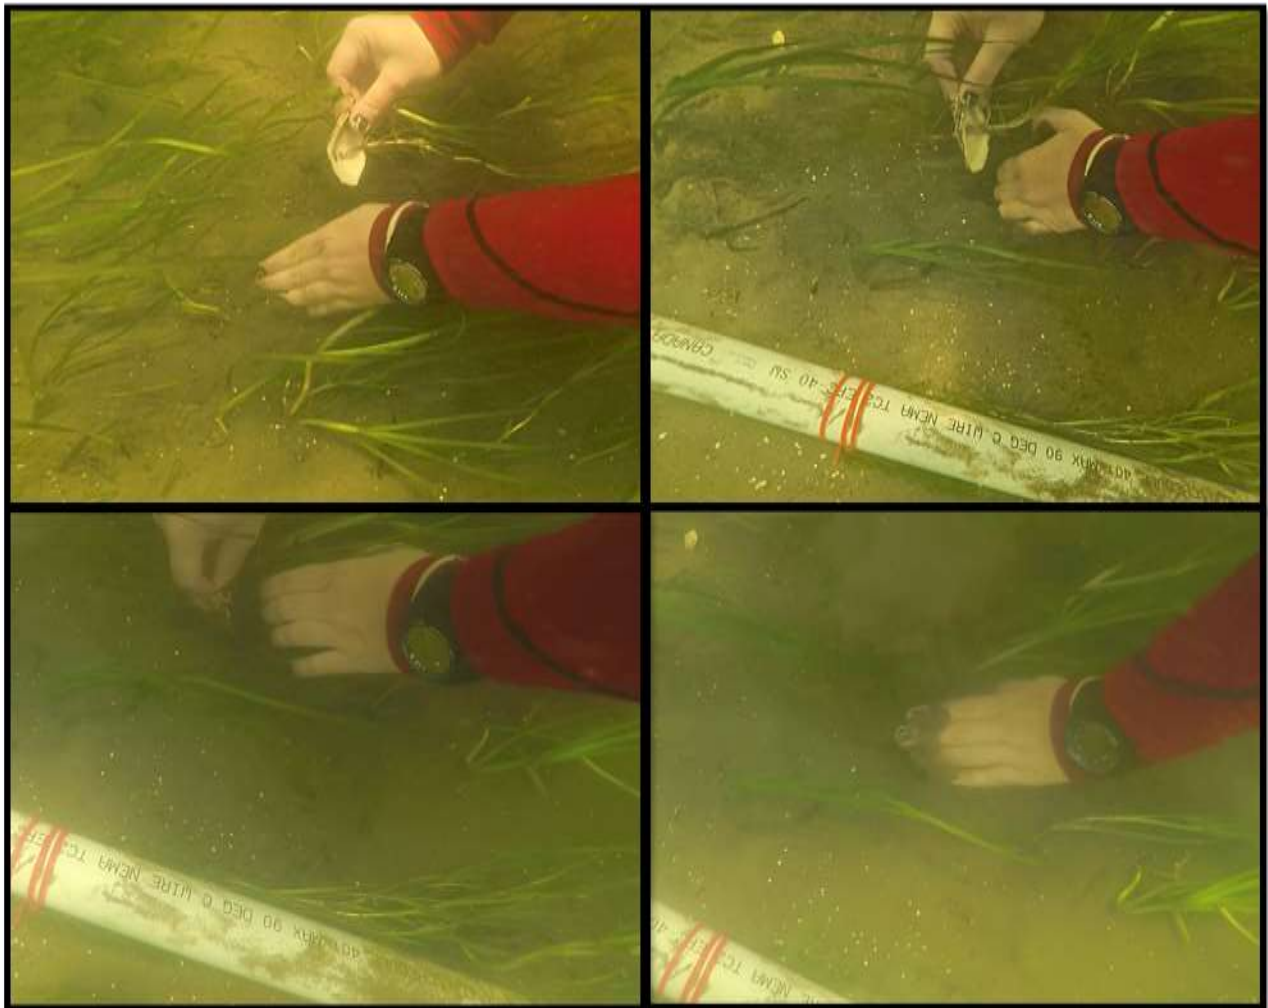
In addition to shells, rocks with reasonable weight were collected along the shore to be used as anchors for some of the eelgrass that was absent a shell. It is important to note that shell collection, cleaning and drilling can be a time-consuming process. In order to maximize the number of transplanted eelgrass from the construction impact zone to the new bed, on-site materials were used to increase the chances of survival of the plants.

**Figure 36: Transplanting eelgrass using oyster shells**

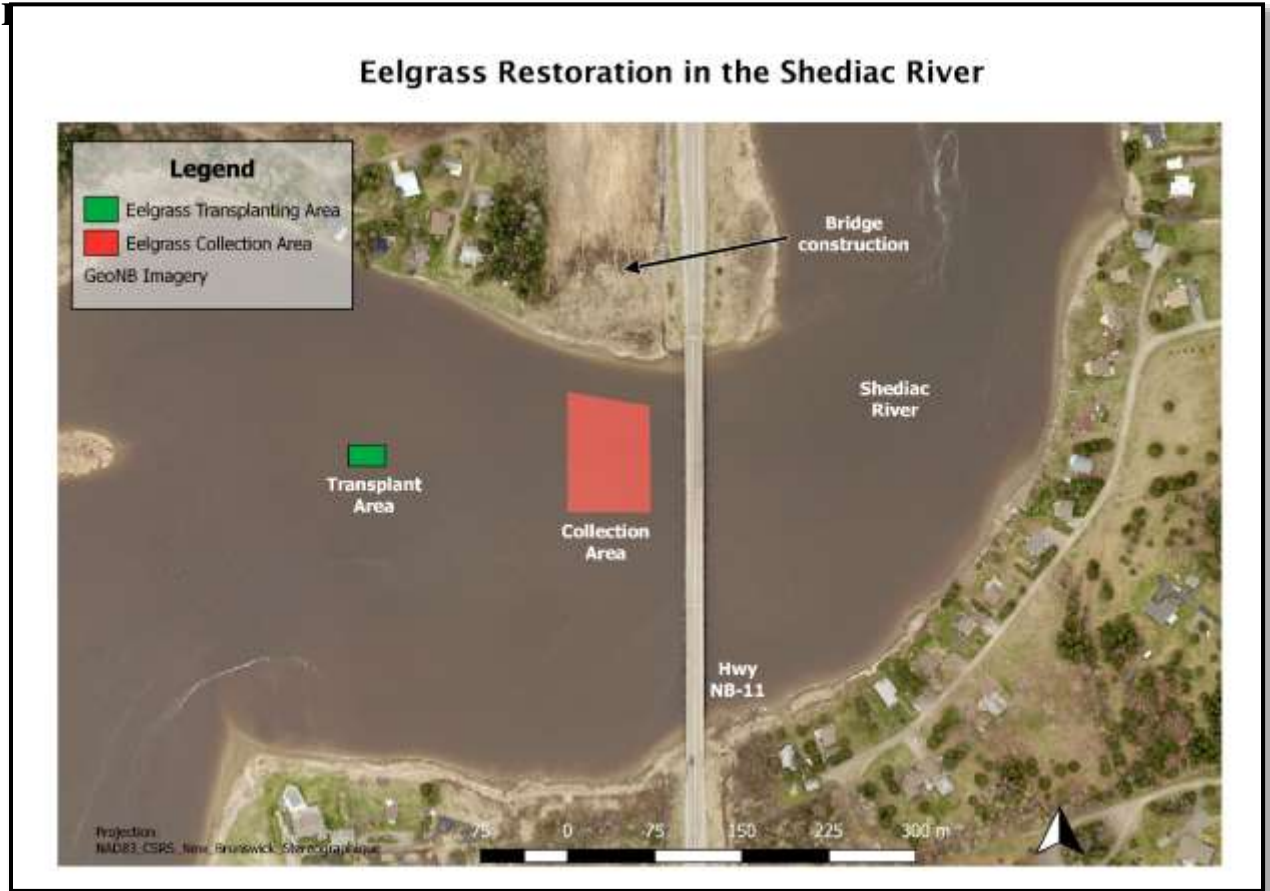
The study was continued by Homarus that revisited the transplant area in August and determined that the transplants had survived except for one quadrant containing eelgrass anchored with oysters that had been destroyed. The site will be re-evaluated in 2019 to determine long-term survival rate.

**Figure 37: Eelgrass Restoration Map; Collection and Transplant Areas, 2018**

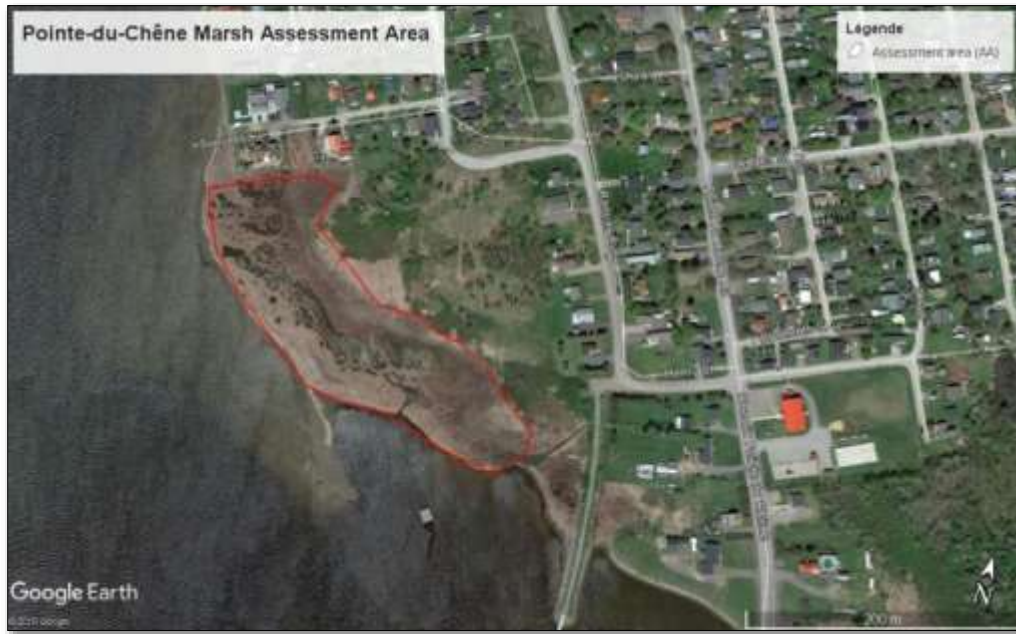
A portion of the marsh in South Cove Pointe-du-Chêne was evaluated. The section that was evaluated was chosen as it will be the first phase in a future marsh education park. The site was accessed from the walking trail at the end of Railway Avenue.

**Figure 39: Assessment area for Pointe-du-Chêne Marsh**

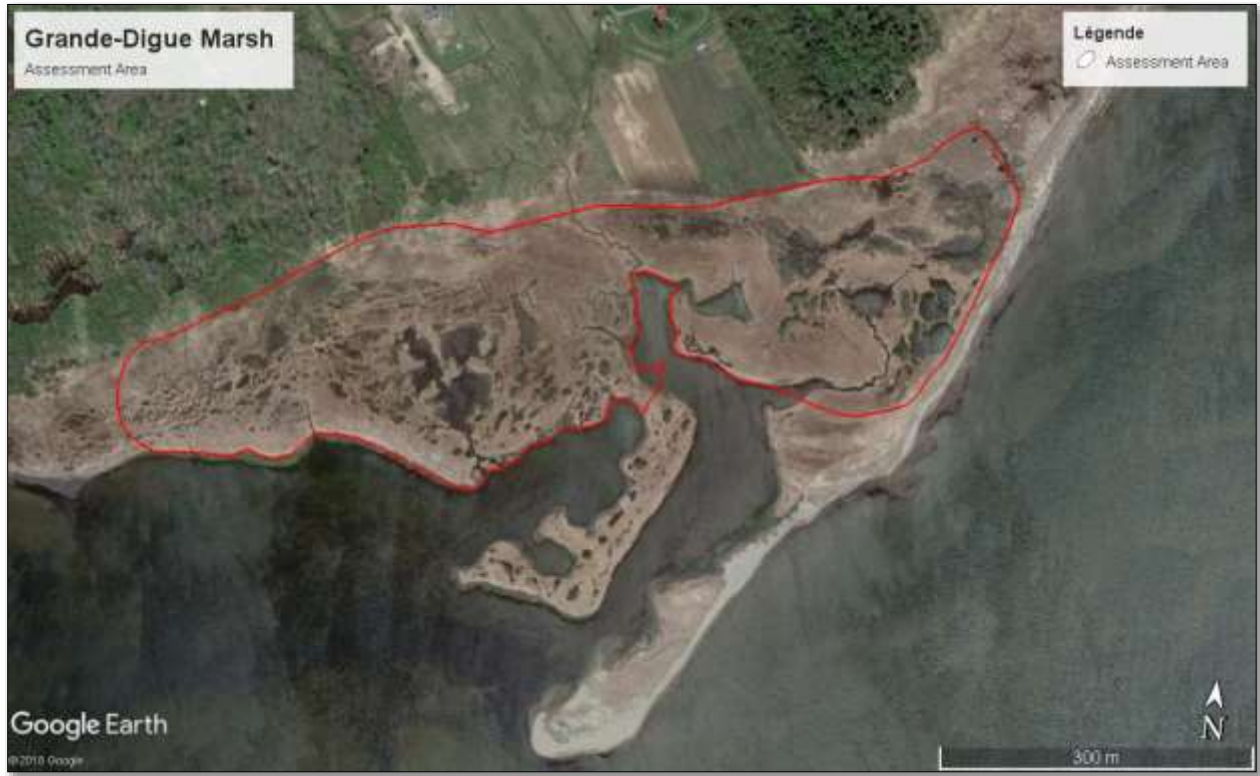
The Grande-Digue marsh is situated south of route 530 and can be accessed by following the shoreline from the fishing wharf in Caissie Cape or by contacting a local landowner.

**Figure 40: Assessment area for Grande-Digue Marsh**

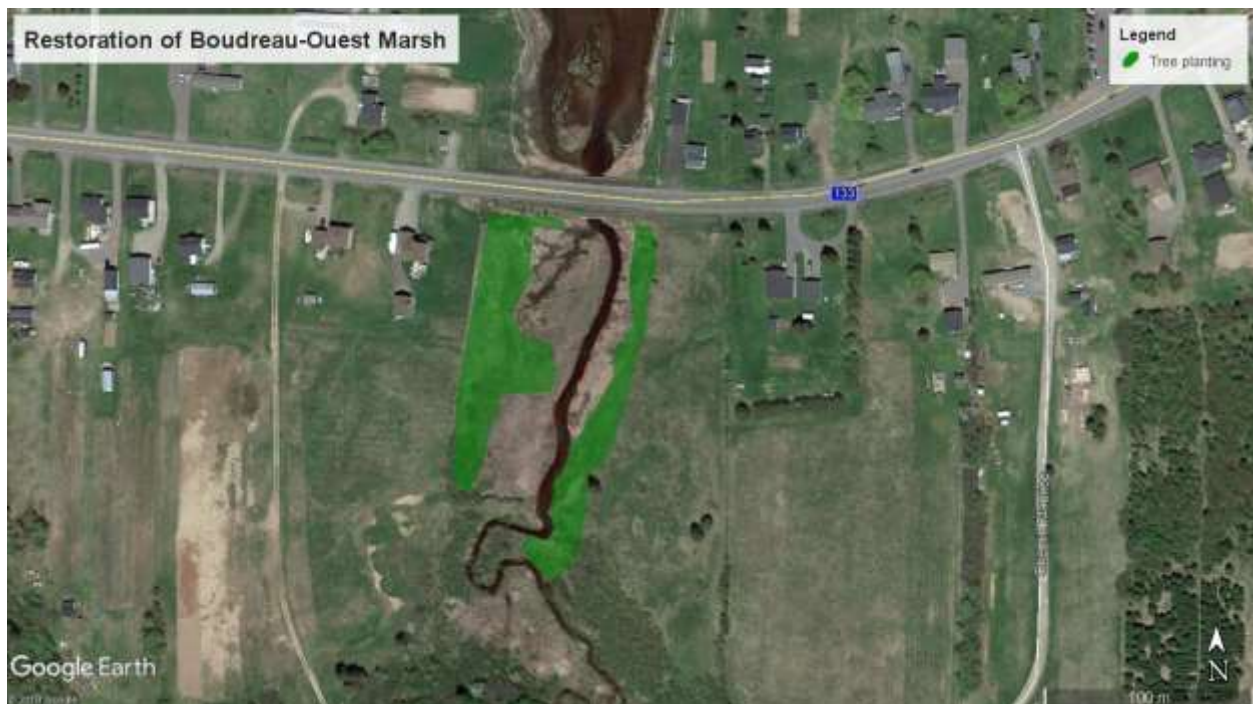
Unfortunately, there was a miscommunication between one of the landowners and the person that mows the field every summer. During the summer, the field in which trees were planted on one side of the stream, was mowed. It is unknown how many trees died during this process. However it was observed that some survived. A thorough survival count will be conducted in 2019. Following this tragic event, the SBWA is to place signs on all of their newly planted area. The signs simply indicates that there are young trees planted in the area in order to increase the buffer zone and stabilize the stream banks.

**Figure 42: Map of the tree planting site at the Boudreau-Ouest saltmarsh**
