**Identifying Habitat of the Brook Floater (*Alasmidonta varicosa*) in the  
Shediac Bay Watershed**

Prepared for:  
**NB Wildlife Trust Fund**  
**Habitat Stewardship Program for Species At Risk**

**March 2020**

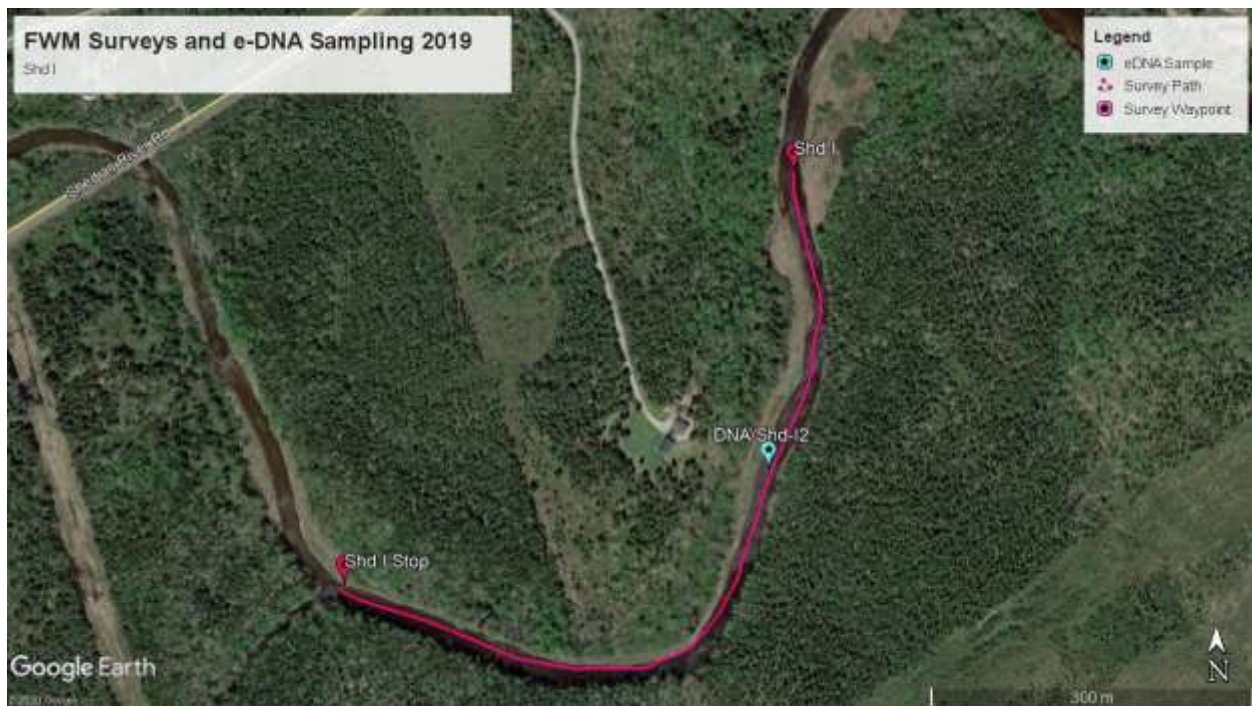
**Figure 2: Map of site of the total search area for Shd I, 2019**

In 2019, the entire section of the site Shd I (A, B and C) was swept again. A total of 830 m was searched and one e-DNA sample was collected (see Section 4.2, Table 3). The total surface area searched for Shd I; 830 m with an average stream width of 15 metres, is 12,450 m<sup>2</sup>. For more detailed information on the freshwater mussel surveys, refer to Appendix A. For the site photos, see Appendix B.

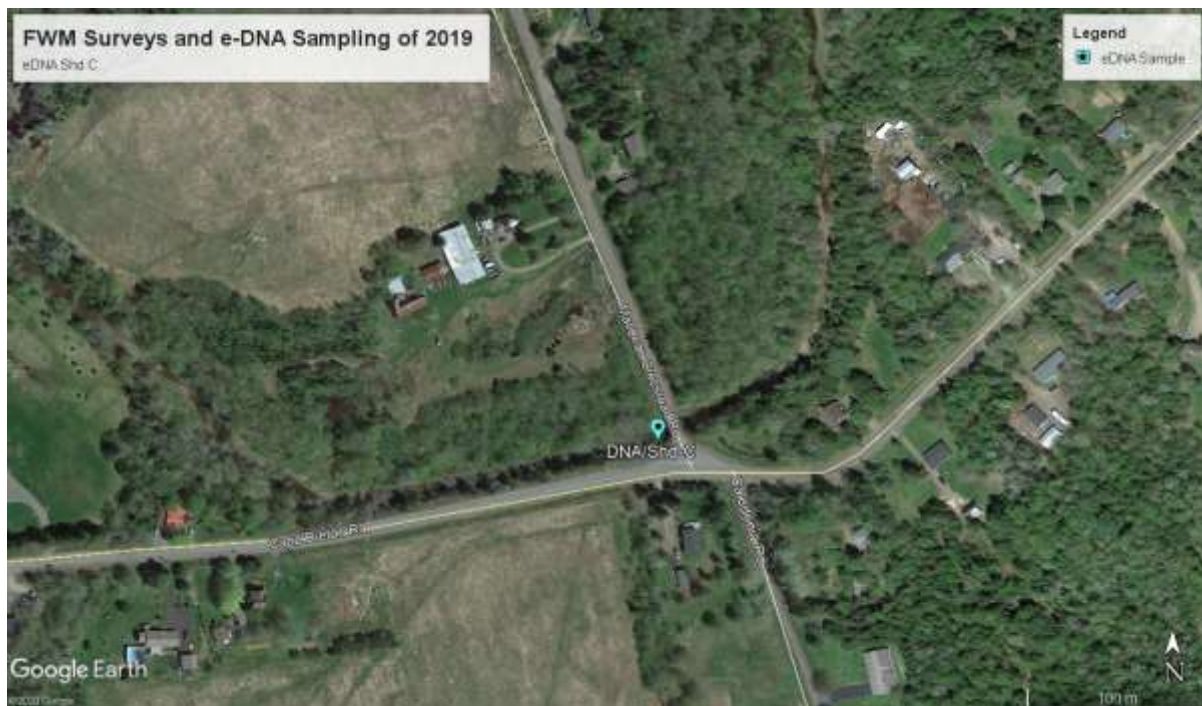
**Figure 8: Map of site of the e-DNA sample for Shd C, 2019**

This site does not contain any freshwater mussel habitat upstream or downstream; the substrate is comprised primarily of bare bedrock. Surveys have been conducted in both directions in the past (2014 and 2016) to assess the habitat, presence of freshwater mussels, and to collect data of the conditions of the river's habitat. There were no reported Brook Floater mussels in this area in the 2006<sup>1</sup> report.

However, this access point was used in 2019 to collect an e-DNA sample at the bridge crossing. The results were negative (see Section 4.2, Table 3).

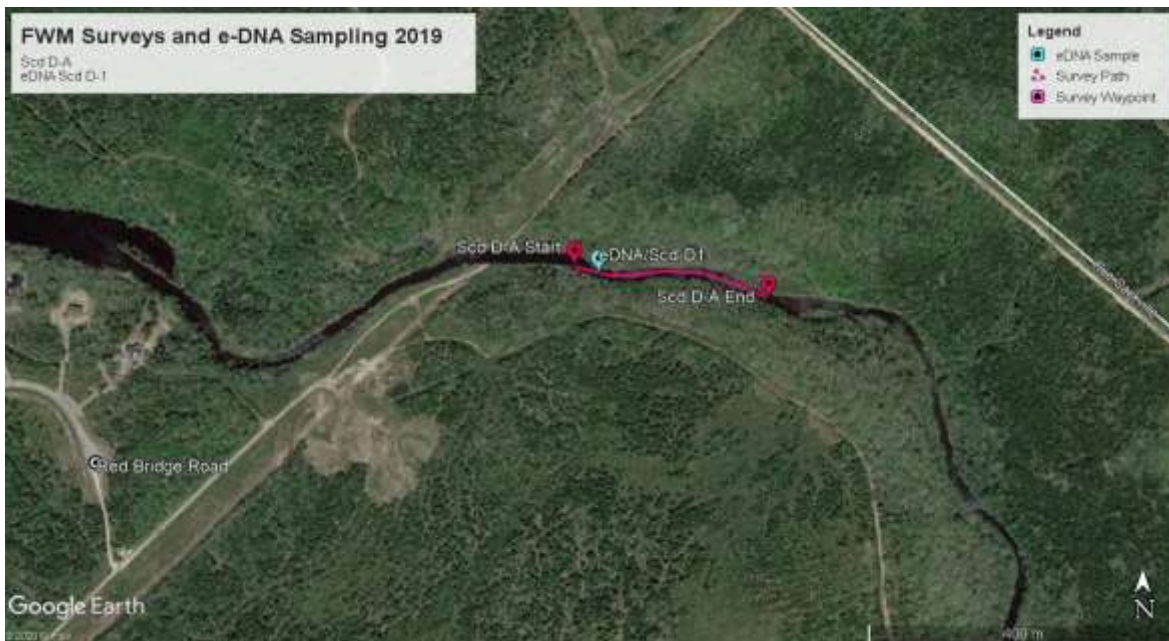
**Figure 13: Map of site of the total search area and e-DNA sampling for Scd D, 2019**

The habitat suitable for freshwater mussels begins a short distance away from the access point. The substrate is comprised of a mix of rocks, rubble, and sand, with some sections of bedrock. The riparian zone is healthy without any sign of severe erosion (mild natural erosion), and has good mixed forest vegetation on both sides. In addition to the common Eastern Pearlshell mussel (*Maragaritifera margaritifera*), there is a second species commonly found in the Scoudouc River; the Eastern Elliptio mussel (*Elliptio complanata*).

In 2019, the total surface area searched for Scd D; 265 m with an average stream width of 16 metres, is 4,240m<sup>2</sup>. One e-DNA sample was collected (see Section 4.2, Table 3). For more detailed information on the freshwater mussel surveys, refer to Appendix A. For the site photos, see Appendix B.

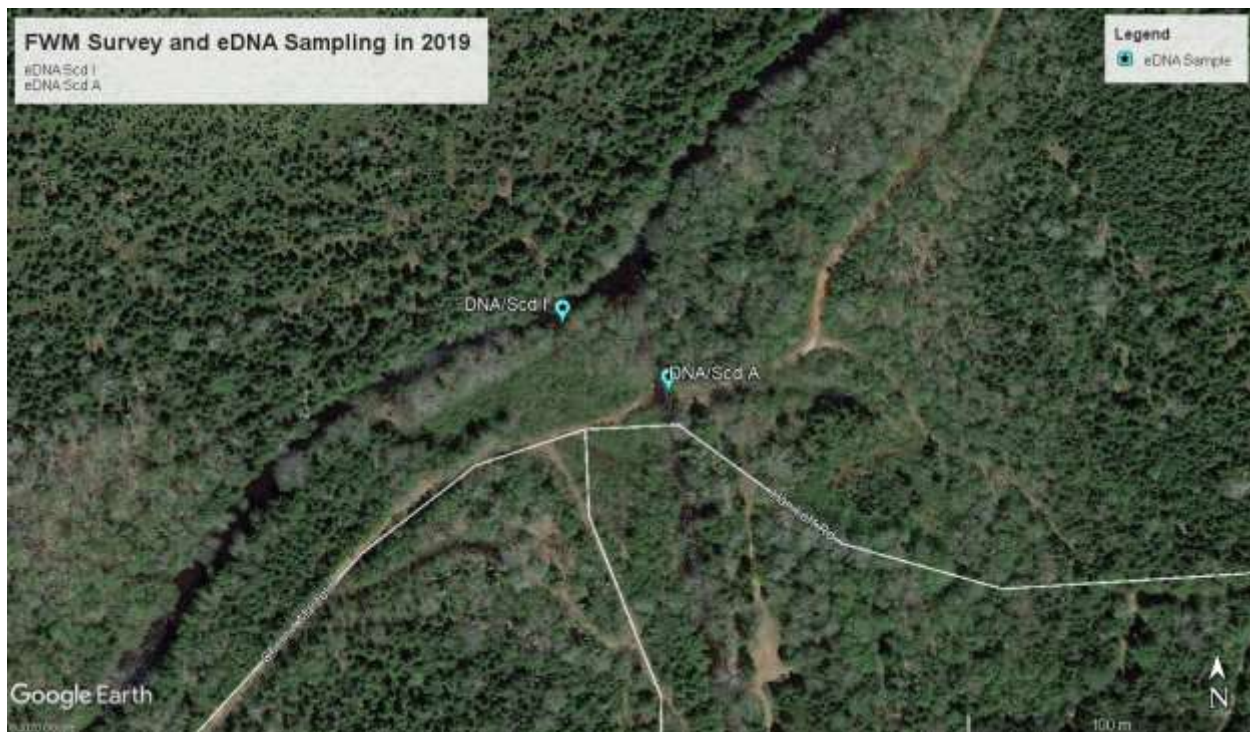
**Figure 16: Map of site of the e-DNA sampling for Scd A, 2019**

This site is located in an unnamed tributary of the Scoudouc River. This brook merges with the main branch where the site Scd I is located. As described in section 3.2, this site was said to have 18 Brook Floaters found in 2005.

This site was attempted to be surveyed in 2015, but it was discovered to be difficult to search for freshwater mussels. The site has been modified by beaver activity over the last 10 years. Beaver dams were observed and the site photos comparing the habitat to the one described and shown in the 2006 report<sup>1</sup> were much different. The conditions for conducting freshwater mussel surveys in this tributary are no longer favourable; low riverbed visibility due to concentration of tannins in the water; fine sediments covering the substrate, creating clouds of suspended particles; an abundance of large aquatic plants that effectively hides freshwater mussels. No Brook Floater mussels were found, but this doesn't mean they are actually absent.

Therefore, an e-DNA sample was collected here in 2019 in an attempt to detect the species. The results were negative (see Section 4.2, Table 3).

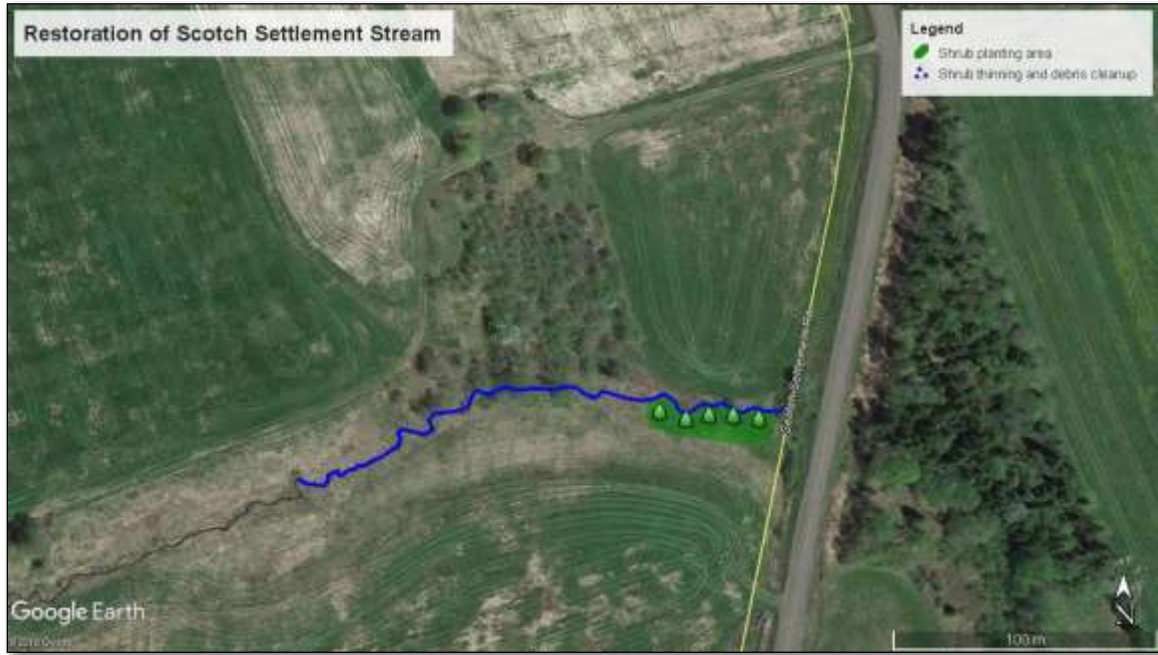
**Figure 25: Map of the Scotch Settlement stream restoration, 2019**

The issue was caused by shrub overgrowth directly upstream of the culvert, which causes debris to build up every spring. These blockages caused impediments to water flow, leading to flooding and fish passage issues. The area surrounding the culvert showed evidence of streambank erosion and sedimentation, due to a lack of a vegetative buffer zone, flooding and agriculture activities in the surrounding farmland.

The landowner was then contacted, and permission was granted to the SBWA to clear the obstructions at the mouth of the culvert, clean the excess of woody debris up the stream and plant native shrubs along the buffer zone to enhance fish habitat.
