# Improving Water Quality in the Shediac and Scoudouc Rivers

## Final Report

**The Shediac Bay Watershed Association Inc.**

**March 2020**

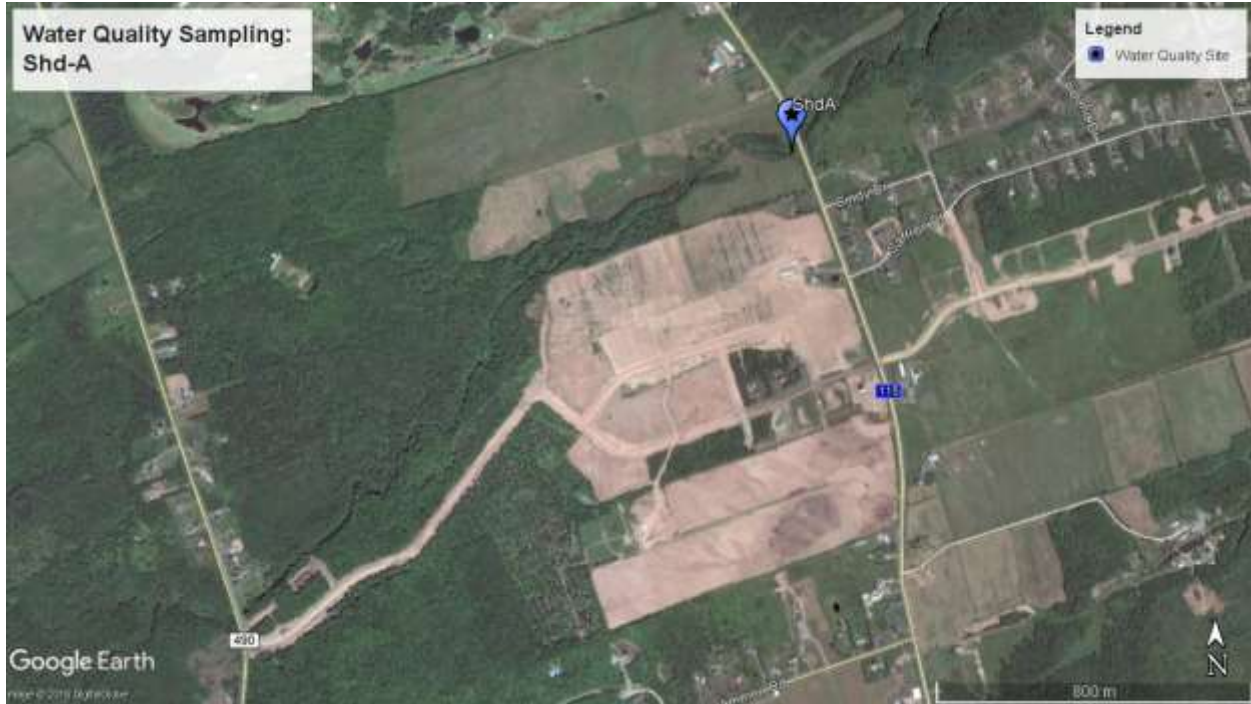
**Figure 4: ShdA site location and surrounding land uses (imagery view of 2017)**

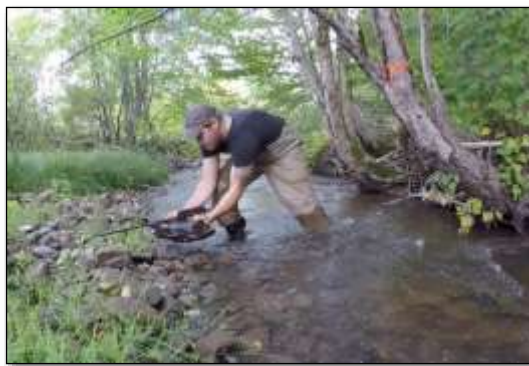
**Figure 26: Installation of a water temperature logger in-stream**

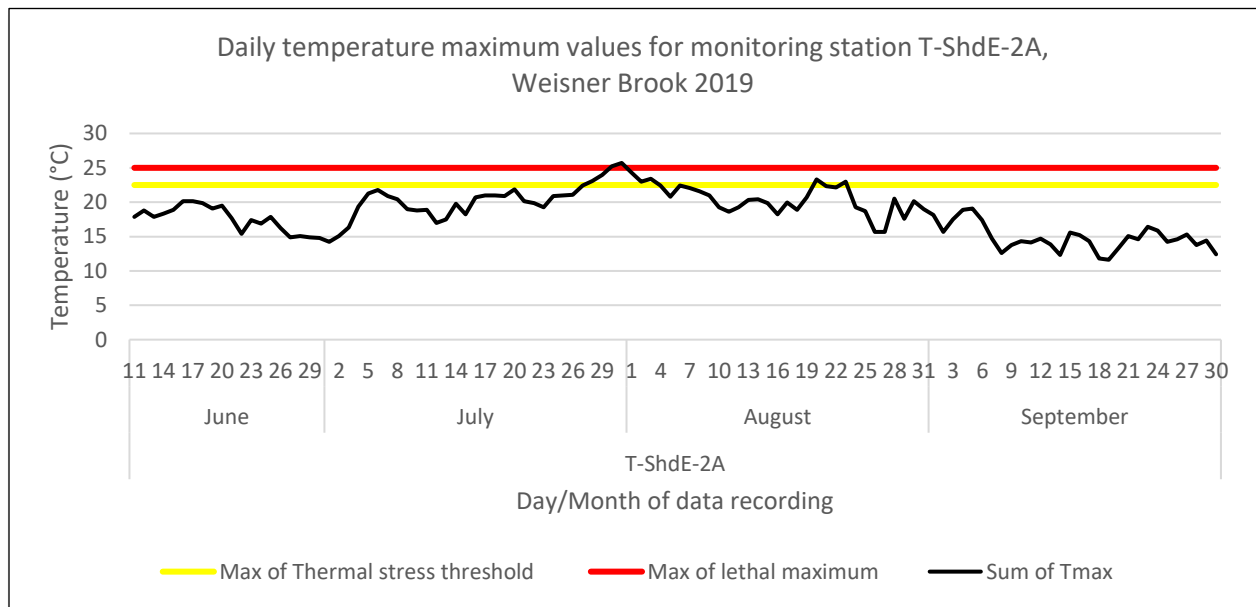
This temperature logger was installed in the Weisner Brook, approximately 300 metres upstream from its convergence with the Shediac River. This site is used to compare with the station of the covered bridge (T-ShdE), as it is the closest source of cold water for migrating fish looking for thermal refuge during high temperatures. This site is located approximately 5 km downstream from the second logger in the Weisner Brook; T-ShdM. Just like the other site in this brook (T-ShdM), the surrounding canopy coverage of the forested land and the input of cold water from natural springs contributes to the overall colder water temperatures.

Figure 31: Thermograph data chart for monitoring station ID T-ShdE-2A, Weisner Brook 2019

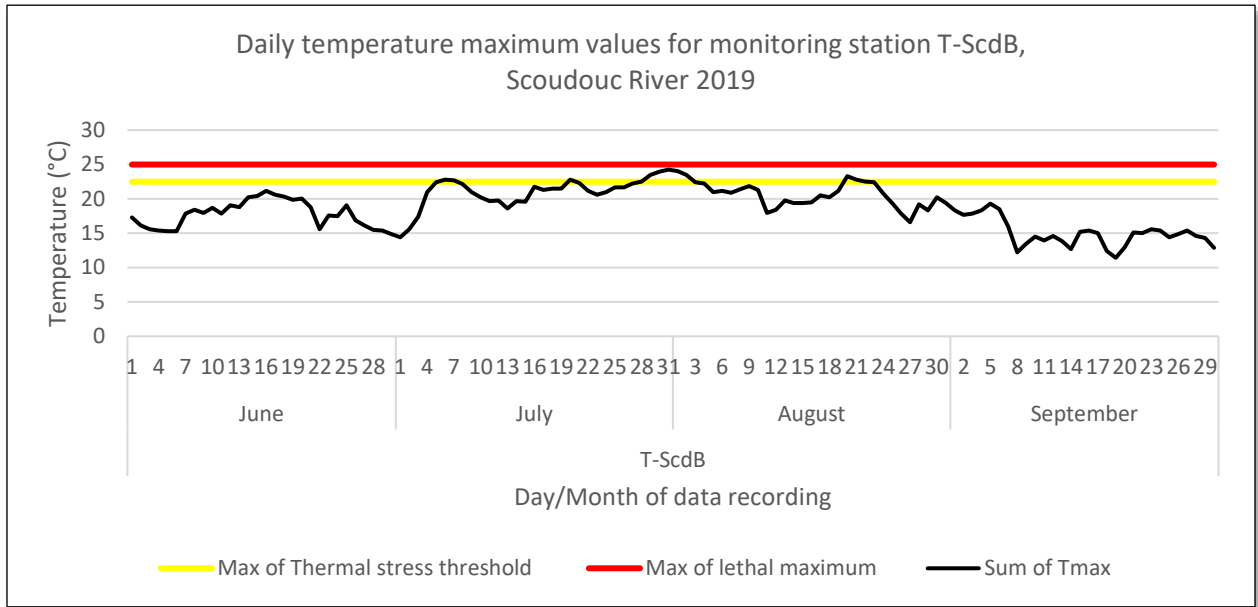
This temperature logger was installed in the main branch of the Scoudouc River, next to the *Greater Shediac Sewage Commission's* treatment lagoons in Scoudouc.

**Figure 33: Thermograph data chart for monitoring station ID T-ScdB, Scoudouc River 2019**

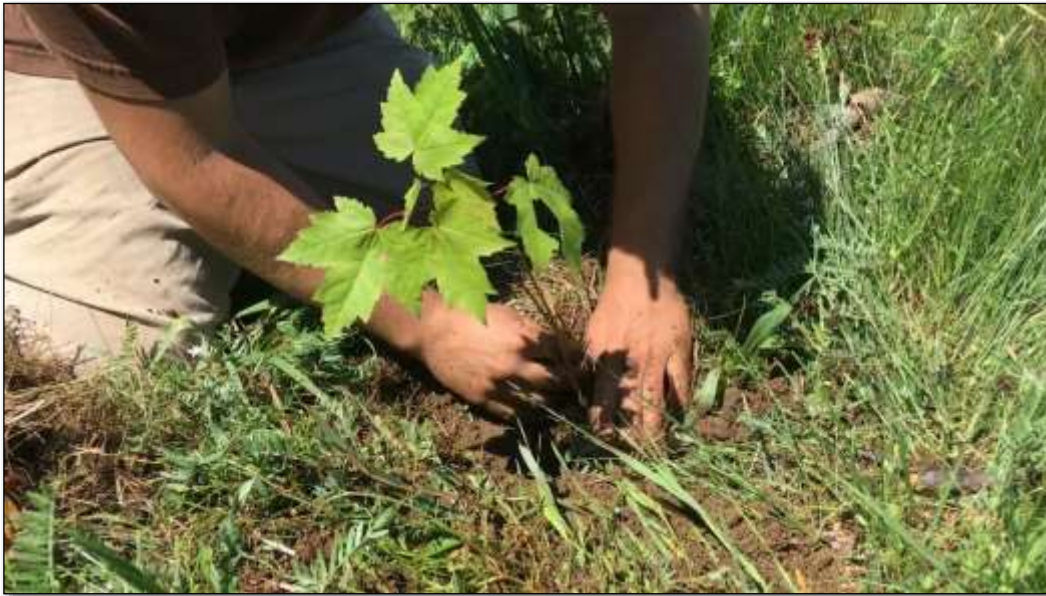
**Figure 34 : Native tree planting for riparian restoration is a technique used by the SBWA**

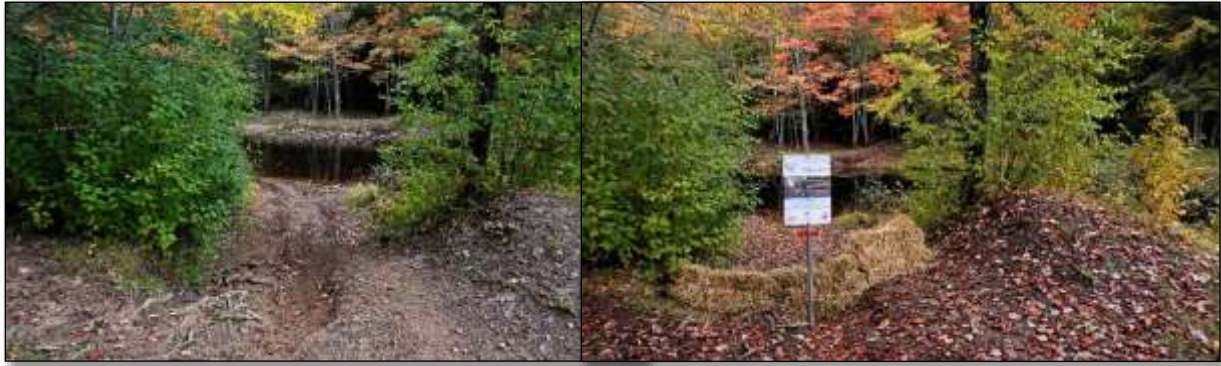
**Figure 36: Before and after photos of ATV access blockage and sediment control (hay-bale check dam)**

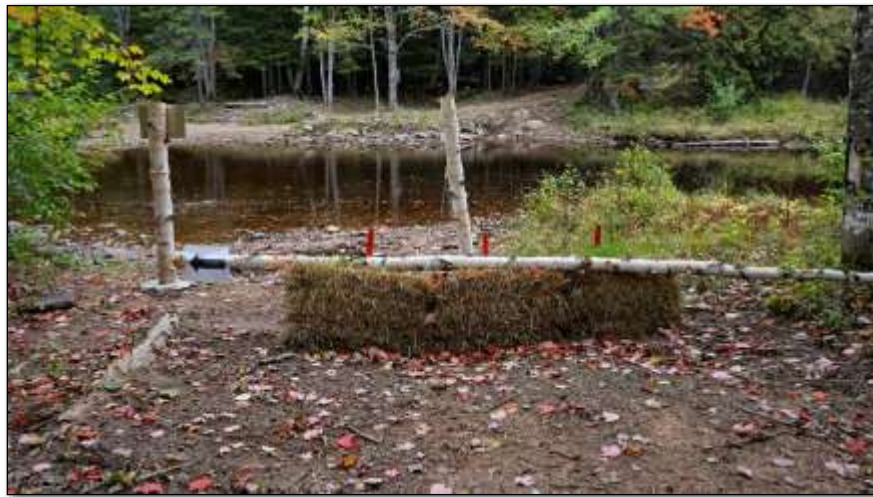
**Figure 37: ATV access blockage and sediment control (hay-bale check dam)**

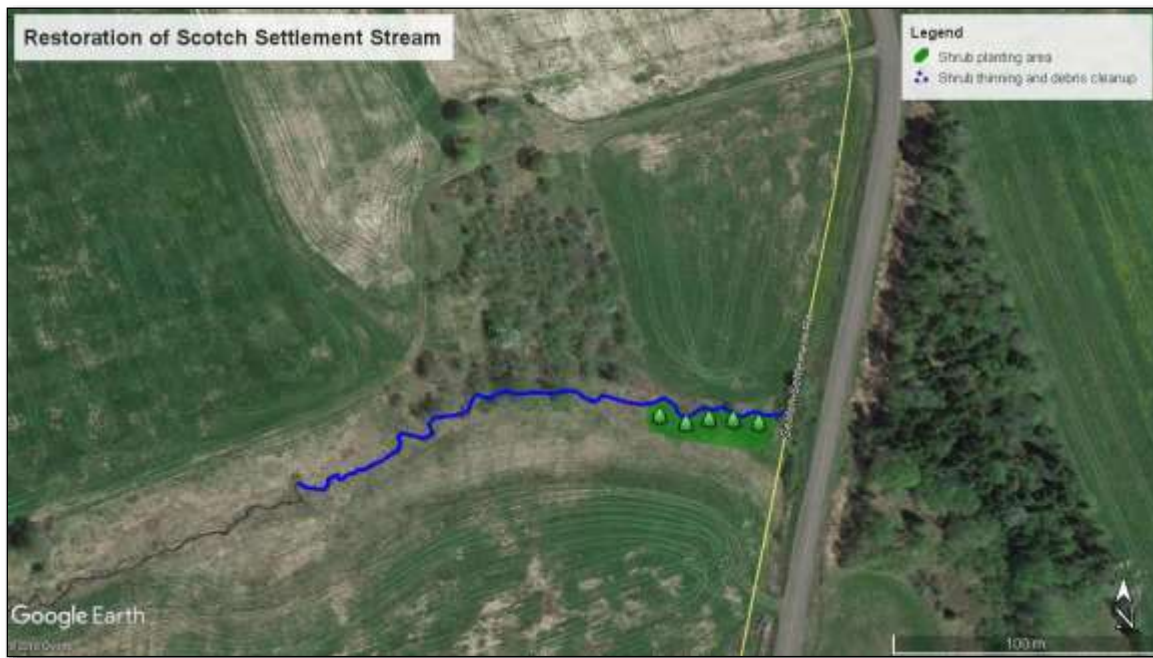
The landowner was then contacted, and permission was granted to the SBWA to clear the obstructions at the mouth of the culvert, clean the excess of woody debris up the stream and plant native shrubs along the buffer zone to enhance fish habitat.

**Figure 39: Map of the Scotch Settlement stream restoration, 2019**

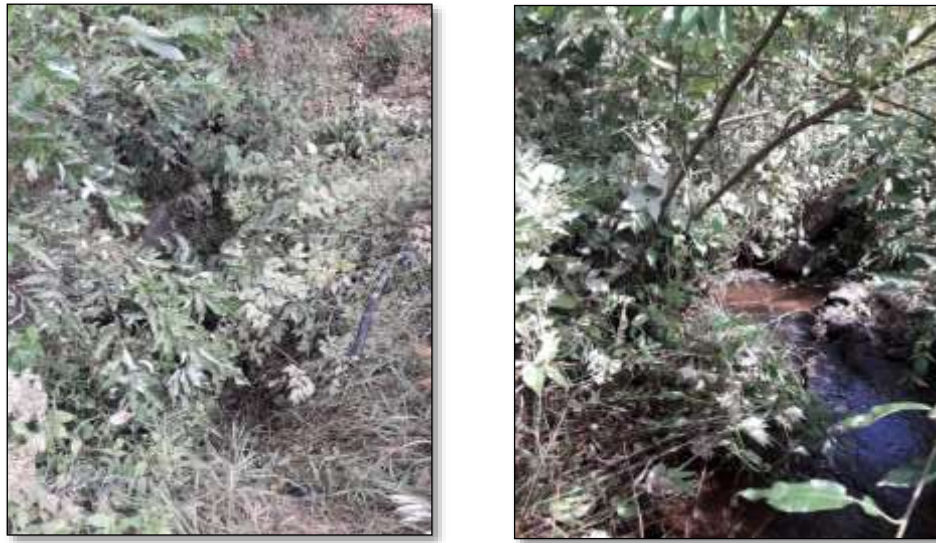
On September 12, the team trimmed the overgrowth at the culvert using manual tools. The stream was cleaned of excessive woody debris on a distance of approximately 235 meters upstream of the culvert. The native shrubs planted were Red Osier Dogwood, for its strong roots and its capacity to stabilize stream banks and prevent erosion. A total of 28 native shrubs were planted on a distance of approximately 60 meters. The farmer did not want reforestation beyond the planting of shrubs, but he may be willing to continue in future years if the project goes well.

**Figure 40: Before and after photos of the shrub thinning upstream of the culvert**

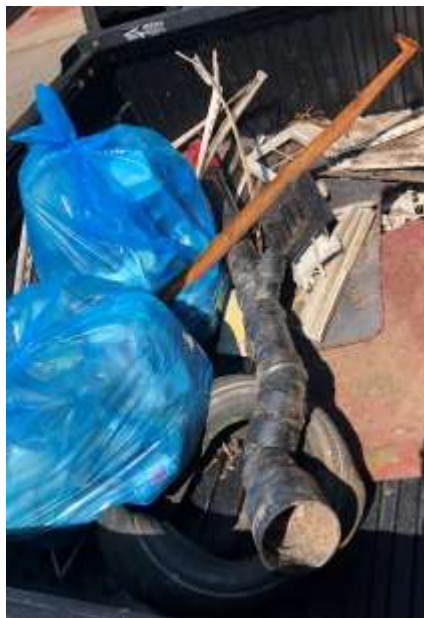
On June 19, 2019, the team picked up trash along a section of the Shediac River road and the covered bridge. A total of 2 full garbage bags, one tire, and a variety of bigger pieces like metal bars, pipes and plastic were collected.

+ **Figure 42 : Garbage from Shediac river road**
