Salmonid Habitat Evaluation, Restoration and Education for the Shediac Bay Watersheds

2019

Report produced for the Atlantic Salmon Conservation Foundation and the New Brunswick Wildlife Trust Fund

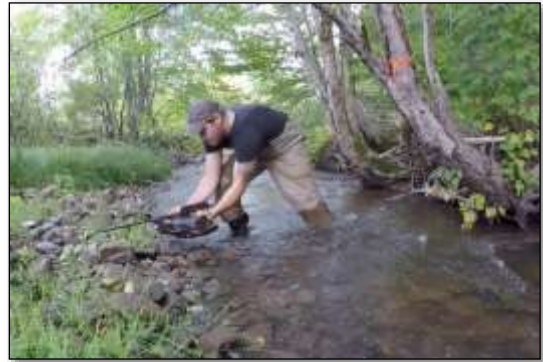
Figure 2: Installation of a water temperature logger in-stream

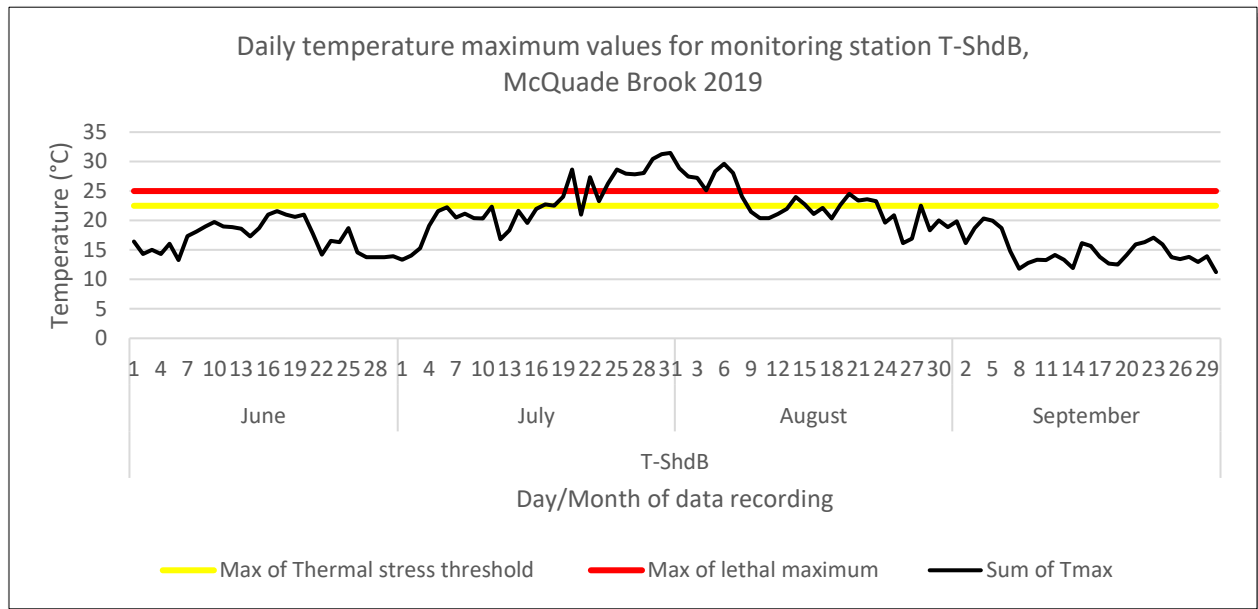
This temperature logger was installed in the McQuade Brook, approximately 35 metres downstream of the fish ladder and upstream of the electrofishing site EShdB-02.

Figure 4: Thermograph data chart for monitoring station ID T-ShdB, McQuade Brook 2019

The thermograph shows the maximum daily temperature between June 1st and September 30th (Fig.4). The maximum temperatures exceeded the thermal stress threshold on 30 occasions during the peak of the summer months. During these 30 days, the maximum temperatures exceeded the lethal limit on 17 occasions. The lethal maximum temperature was exceeded for 15 consecutive days (July 24 to August 7). The highest maximum temperature recorded at this station was 31°C, and lasted for 2 consecutive days (on July 30 and July 31). The highest average daily temperature was 23.35°C.

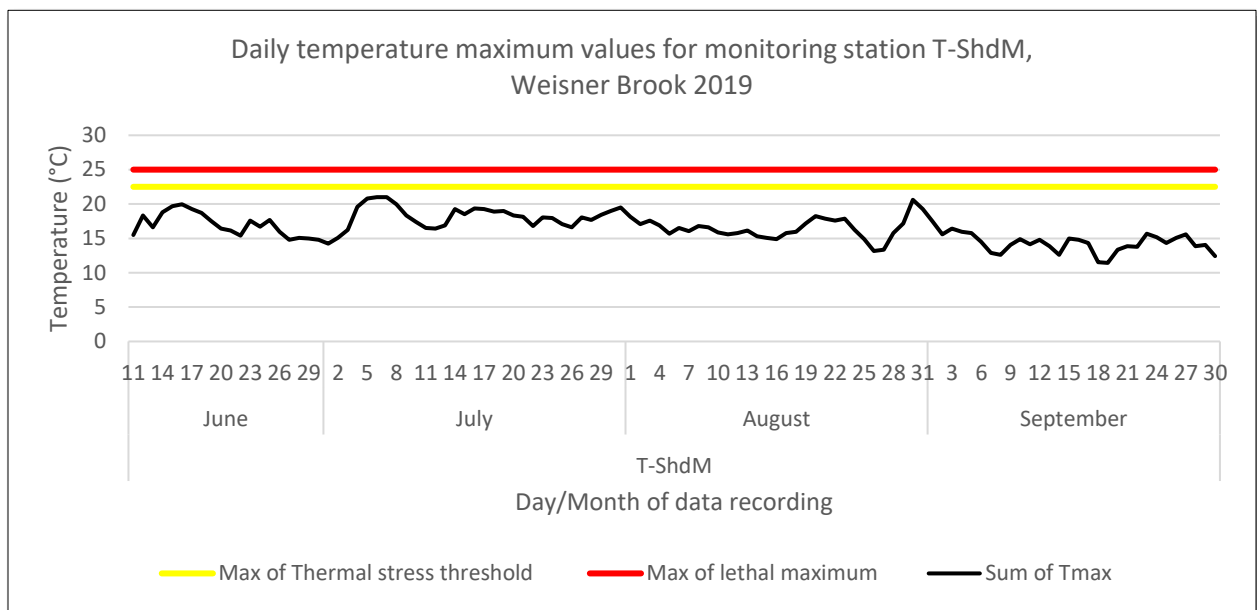
This temperature logger was installed in the Weisner Brook, a tributary of the Shediac River. This logger was predicted to show cooler temperatures, as the brook is recognized as a summer resting area for mature brook trout by the *Department of Natural Resources and Energy Development*, due to its colder characteristics. This stream has an excellent tree coverage; undeveloped forested lands along the majority of the brook. It also has a lot of input of cold water from natural underground springs. These conditions of shade from the forest and cold water springs are great to keep the water temperatures cool.

Figure 5: Thermograph data chart for monitoring station ID T-ShdM, Weisner Brook 2019

The thermograph shows the maximum daily temperatures between June 11th and September 30th (Fig.5). The logger was installed on June 1st but it did not start recording until the 11th, the cause of the glitch is unknown. The maximum temperatures did not exceed the lethal limit or the thermal stress threshold. The highest temperature recorded was 21°C on July 6 and July 7. The highest daily average temperature for this site was 19.22 °C.

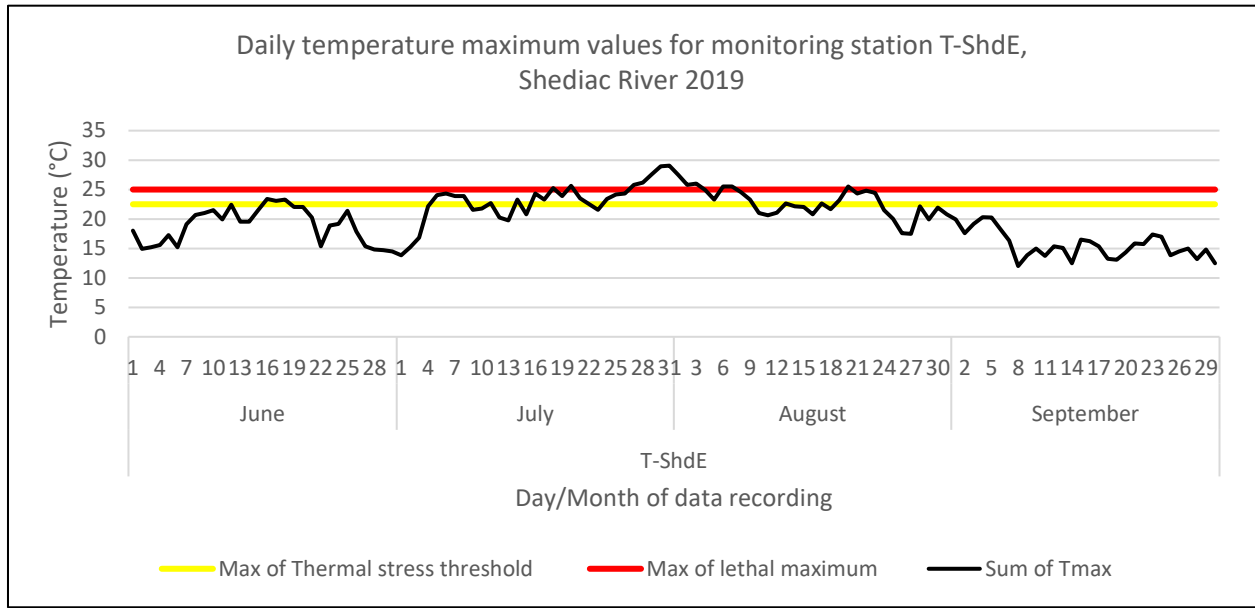
This temperature logger is located in the mid to lower reaches of the main branch of the Shediac River, near the covered bridge. This area was predicted to have warmer waters due to the lack of canopy coverage, and its wide and shallow channel.

Figure 6: Thermograph data chart for monitoring station ID T-ShdE, Shediac River 2019

The thermograph shows the maximum daily temperature between June 1st and September 30th (Fig.6). The maximum temperatures exceeded the thermal stress threshold on 40 occasions during the peak of the summer months. Of those 40 days, the maximum temperatures exceeded the lethal limit on 13 occasions. The lethal maximum temperature was exceeded for 8 consecutive days (July 27 to August 3). The highest maximum temperature recorded at this station was 29.05°C on August 31st and the highest average daily temperature was 25.27°C.

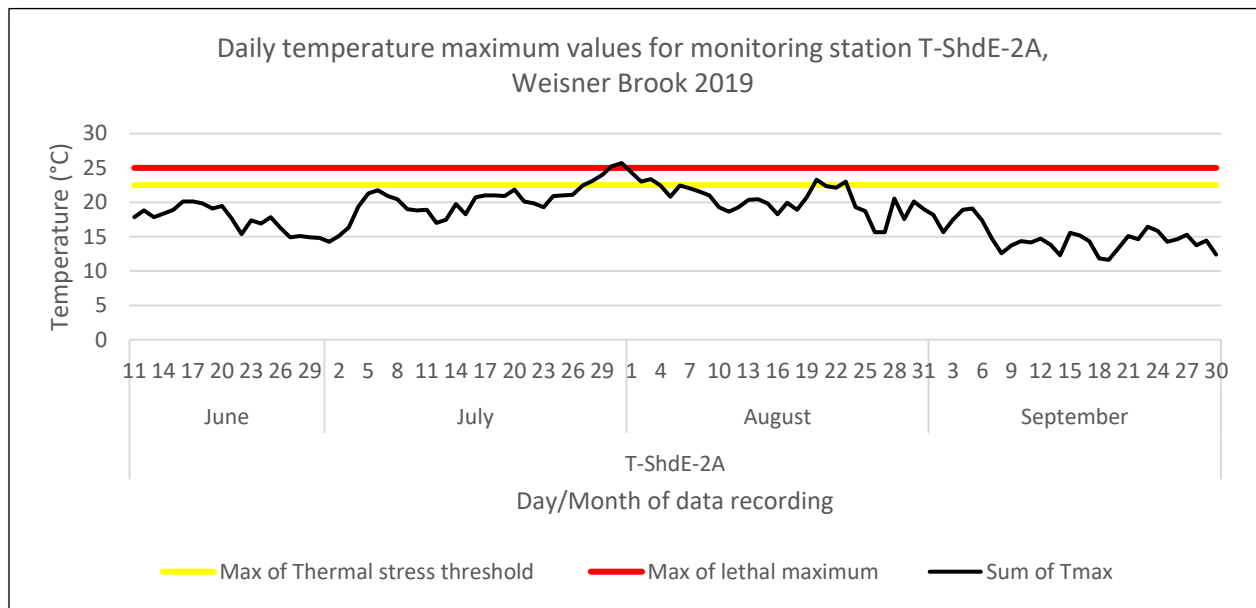
This temperature logger was installed in the Weisner Brook, approximately 300 metres upstream from its convergence with the Shediac River. This site is used to compare with the station of the covered bridge (T-ShdE), as it is the closest source of cold water for migrating fish looking for thermal refuge during high temperatures. This site is located approximately 5 km downstream from the second logger in the Weisner Brook; T-ShdM. Just like the other site in this brook (T-ShdM), the surrounding canopy coverage of the forested land and the input of cold water from natural springs contributes to the overall colder water temperatures.

Figure 7: Thermograph data chart for monitoring station ID T-ShdE-2A, Weisner Brook 2019

The thermograph shows the maximum daily temperatures between June 11th and September 30th (Fig.17). The temperature was installed on June 1st but it did not start recording until the 11th, the cause of the glitch is unknown. The maximum temperatures exceeded the thermal stress threshold on 9 occasions during the peak of the summer months. Of those 9 days, the maximum temperatures exceeded the lethal limit on only 2 occasions (July 30 and July 31). The highest maximum temperature recorded at this station was 25.71°C on July 31 and the highest average daily temperature was 21.91°C.

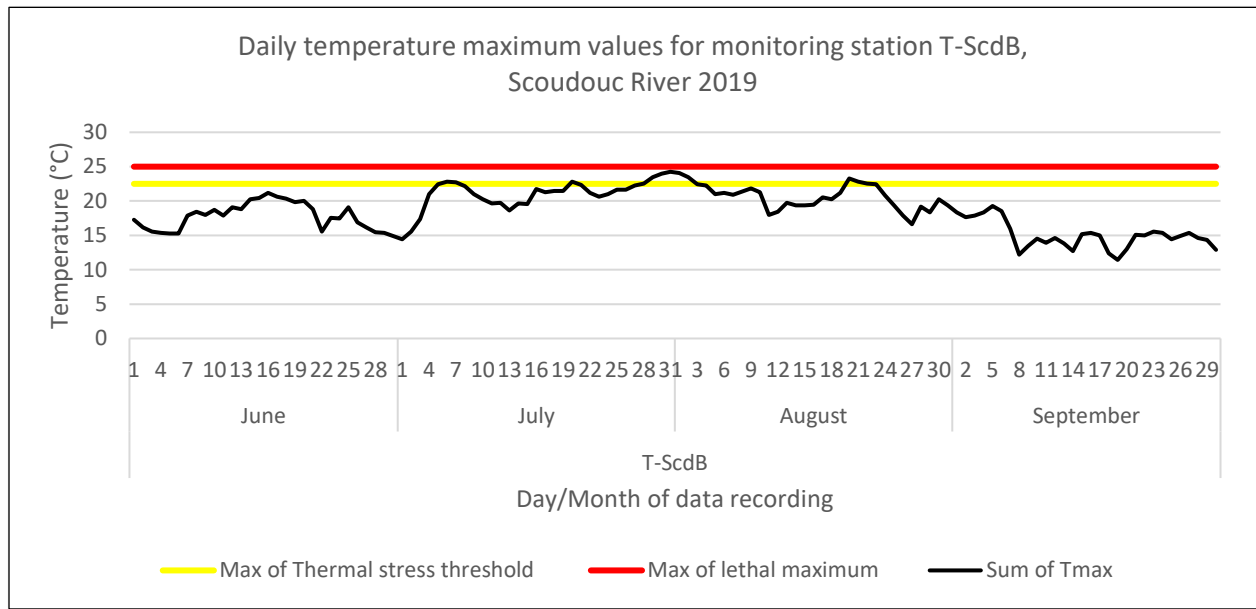
This temperature logger was installed in the main branch of the Scoudouc River, next to the *Greater Shediac Sewage Commission's* treatment lagoons in Scoudouc.

Figure 9: Thermograph data chart for monitoring station ID T-ScdB, Scoudouc River 2019

The thermograph shows the maximum daily temperatures between June 1st and September 30th (Fig.9). The maximum temperatures exceeded the thermal stress threshold on 12 occasions during the peak of the summer months. The maximum temperatures at this site did not exceed the lethal limit. The highest temperature recorded during this time period was 24.26°C on July 31. The highest average temperature daily temperature for this site was 23.05°C.

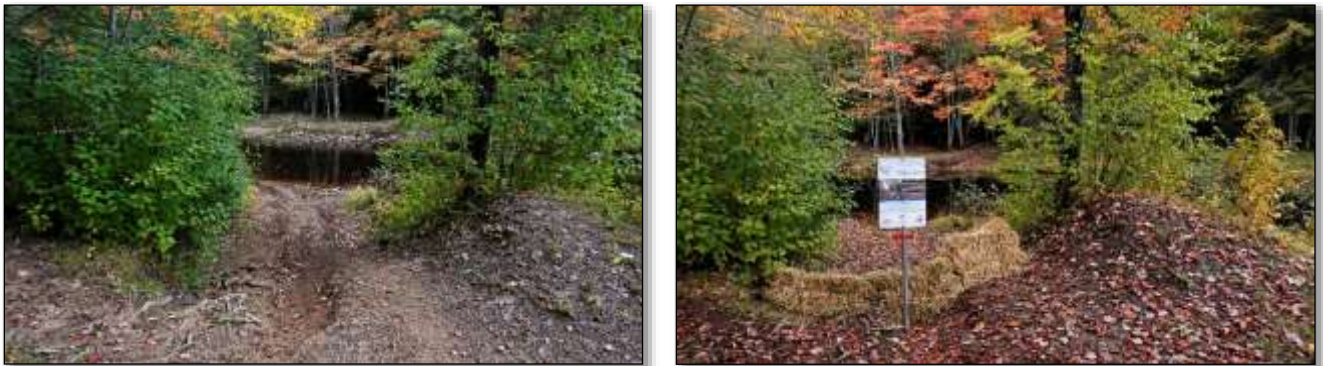
Figure 12: Before and after photos of ATV access blockage and sediment control (hay-bale check dam)

Actions have been taken this year to block two illegal river crossing access trails. Three large posts made out of a fallen birch tree was set deep in the middle of the two river

access trails and cement was poured in the holes to help secure them. Along with the posts, straw bales were set in the trails. This will hopefully discourage ATV from trying to use the river access trails and also will help capture sediment from runoff. These were installed with student volunteers from Shediac Cape School.

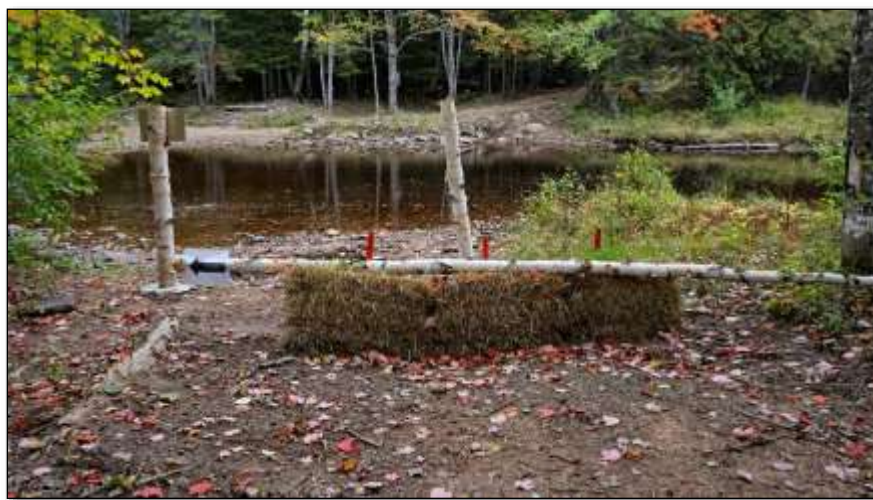
Figure 13: ATV access blockage and sediment control (hay-bale check dam)

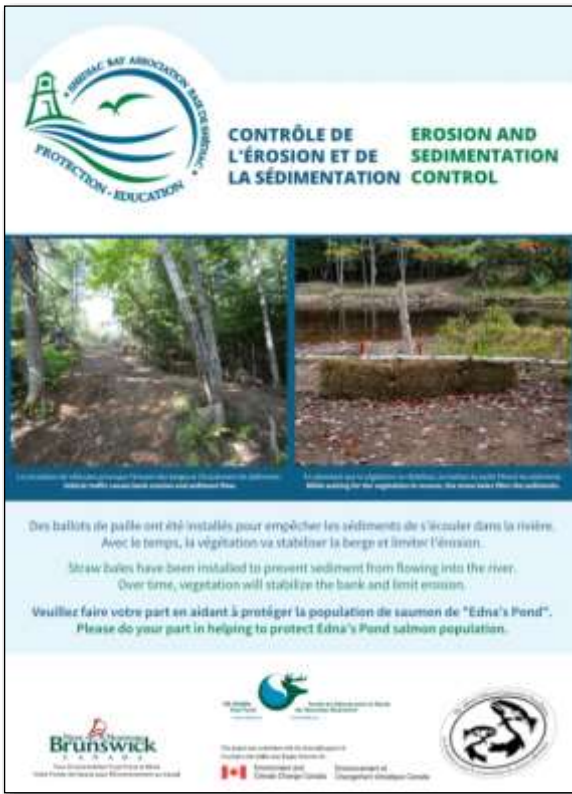
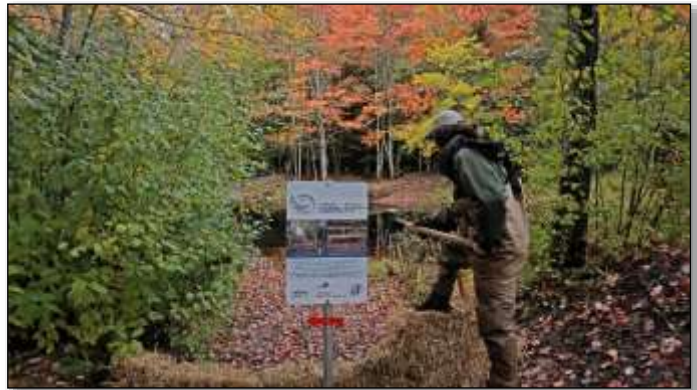
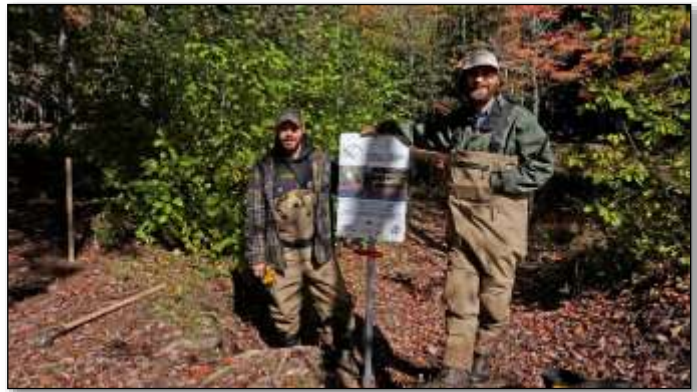
Figure 14: New signage designed for Edna's pond restoration site, 2019

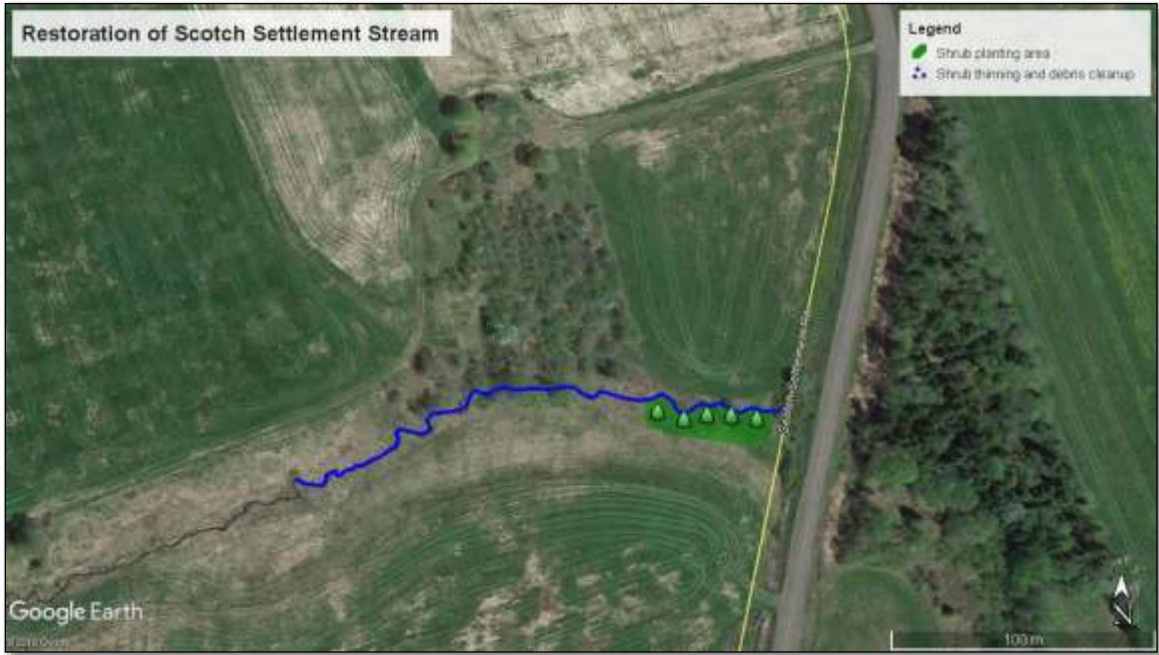
The issue was caused by shrub overgrowth directly upstream of the culvert, which causes debris to build up every spring. These blockages caused impediments to water flow, leading to flooding and fish passage issues. The area surrounding the culvert showed evidence of streambank erosion and sedimentation, due to a lack of a vegetative buffer zone, flooding and agriculture activities in the surrounding farmland.

Figure 15: Map of the Scotch Settlement stream restoration, 2019

The landowner was then contacted, and permission was granted to the SBWA to clear the obstructions at the mouth of the culvert, clean the excess of woody debris up the stream and plant native shrubs along the buffer zone to enhance fish habitat.

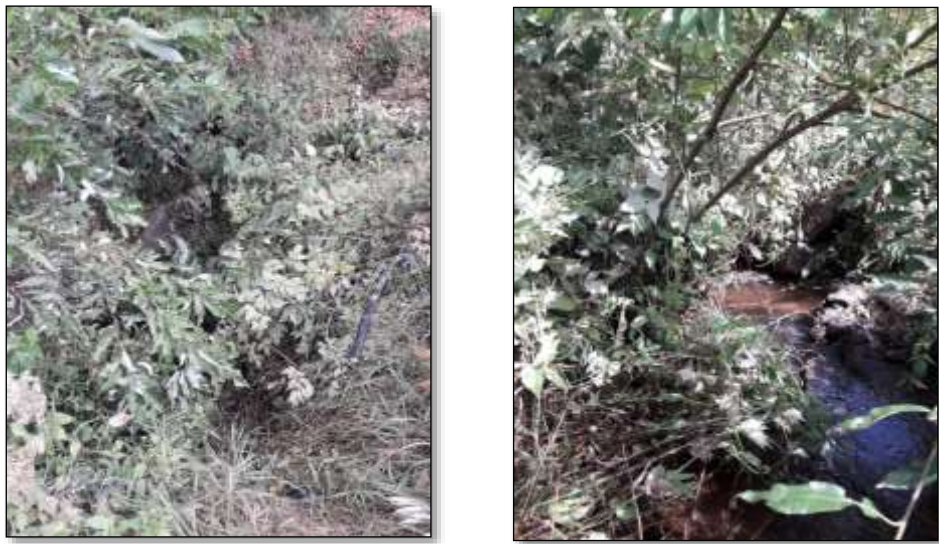
Figure 16: Before and after photos of the shrub thinning upstream of the culvert

On September 12, the team trimmed the overgrowth at the culvert using manual tools. The stream was cleaned of excessive woody debris on a distance of approximately 235 meters upstream of the culvert. The native shrubs planted were Red Osier Dogwood, for its strong roots and its capacity to stabilize stream banks and prevent erosion. A total of 28 native shrubs were planted on a distance of approximately 60 meters. The farmer did not want reforestation beyond the planting of shrubs, but he may be willing to continue in future years if the project goes well.

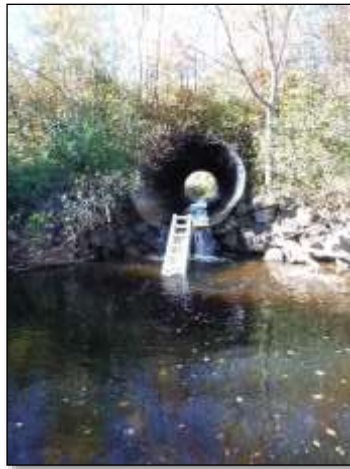
Figure 17: Fish ladder on the McQuade Brook

In 2015, funding was received to mitigate a suspended culvert in a critical area of the McQuade Brook. A 10-foot heavy-duty aluminum fish ladder was installed on the elevated culvert, to bridge the gaps of this broken brook. The following year, water deflectors were added to increase efficiency of the structure. Ongoing maintenance of the structure is required, such as clearing of the occasional woody debris, removing and reinstalling the water deflectors in late fall and early spring, and repairing minor winter damages. The SBWA is committed to the ongoing maintenance of the fish passage structure.

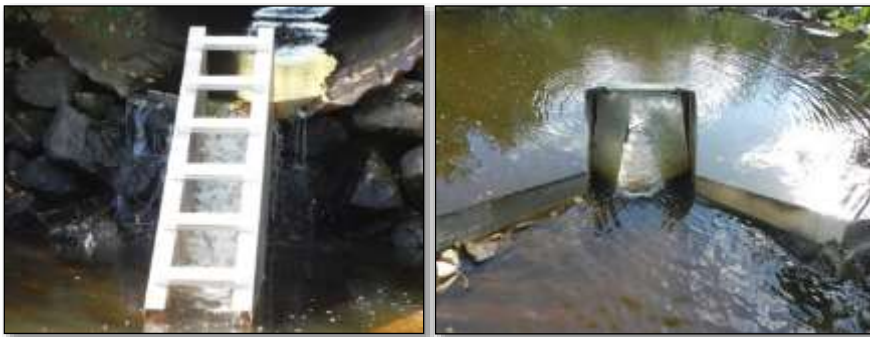
Figure 18: Up-close view and overhead view of the fish ladder with water deflectors

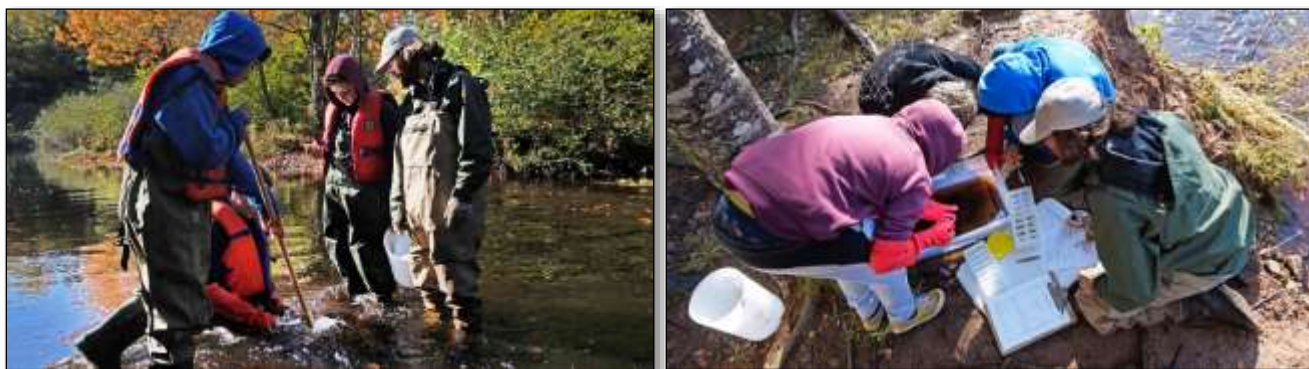
Figure 20: In-stream collection of benthic macroinvertebrates and sorting for sample

The groups were divided into teams, each with a specific task. There were multiple tasks designed to complete the macroinvertebrate sampling, sorting the invertebrates using a sampling protocol, taking site measurements, filling out data sheets, drawing a sketch of the site, and taking habitat observations. The science teachers are always amazed with the various components of the activity, stating that a great portion of the curriculum's objectives and outcomes are being attained in one day.

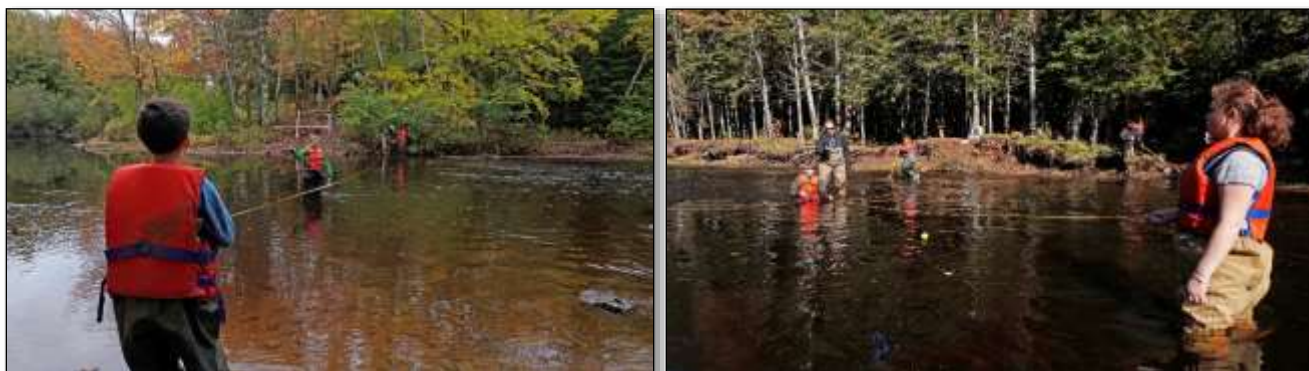
Figure 21: Data collection (site measurements and flow speed)

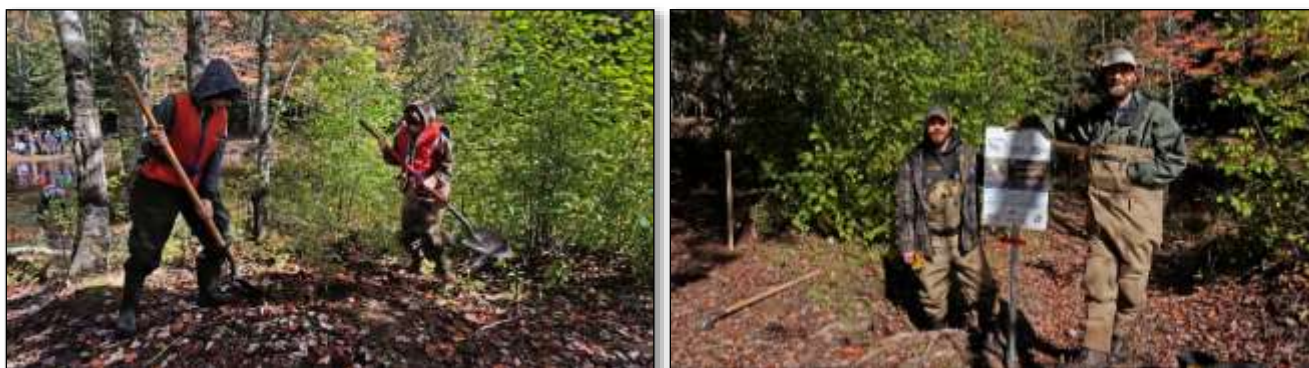
Figure 22: Tree planting and installation of sign at Edna's Pond

After the lunch on the first day, several students volunteered to plant a few native trees (7 trees) at the active restoration site across the river. On the second day, the students observed the installation of a restoration sign and installation of hay bales for sediment control. Both groups received a presentation on the impacts of sediment runoff on fish habitat, a description of the ongoing restoration work, and the importance of responsible use of recreational vehicles.

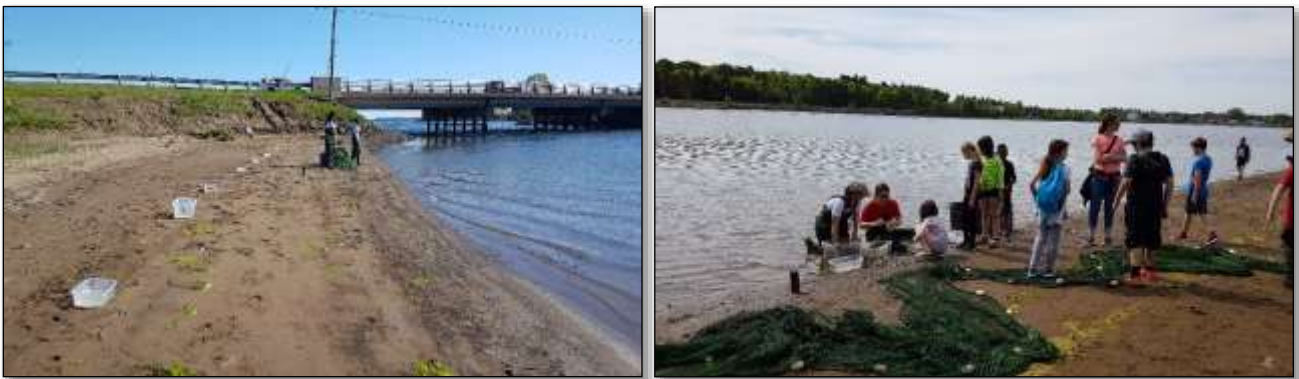
Figure 23: Preparation of the activity and beach seine fish sampling

The 3rd graders of MFB School (57 students) went to the Big Lobster for the activity on June 12th and the 3rd and 4th graders of the Shediac Cape School (41 students) went on June 13th. During the field trip, the kids observed SBWA staff perform a 30-meter beach seine sampling to catch small fish, shrimps and crabs. The catch was divided and transferred to clear containers, where the kids got to observe the specimens. The fish, shrimps and crabs were then transferred to mason jars, and the students got to release them back into the water.
