# Improving Water Quality in the Shediac and Scoudouc Rivers

## Final Report

**The Shediac Bay Watershed Association Inc.**

**March 2021**

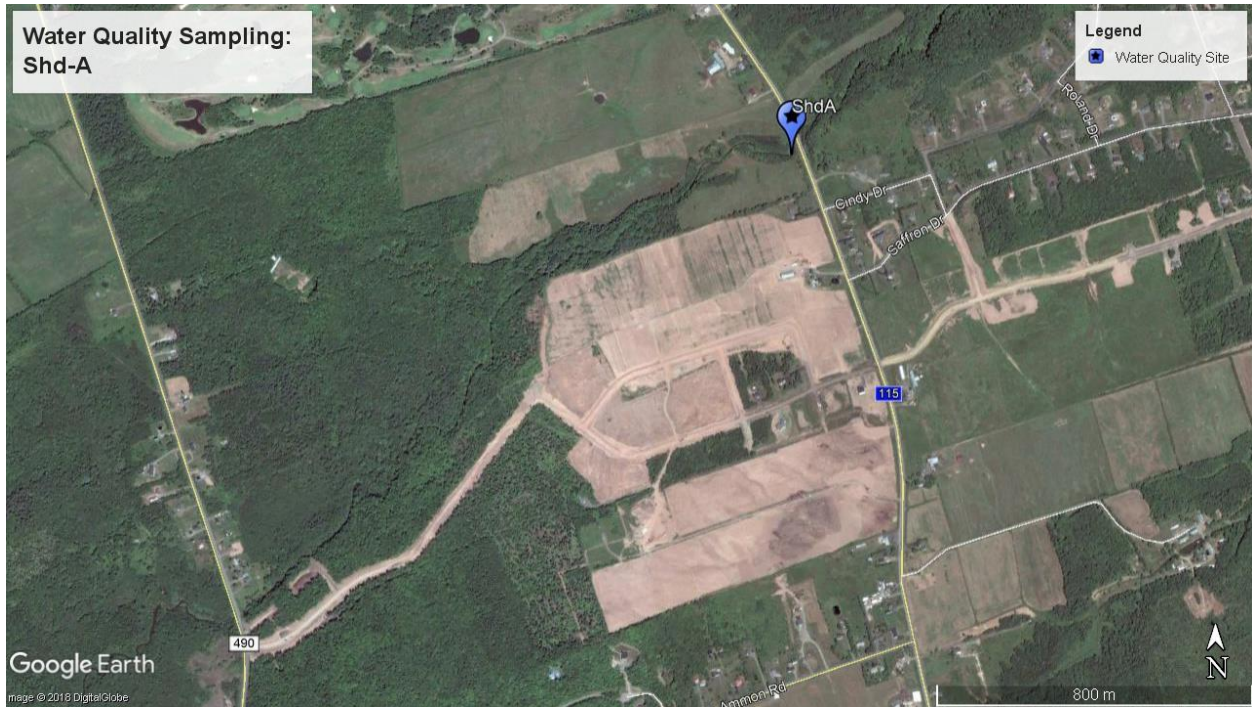
The water sampling results for the site ShdA, for 2020, meets or exceeds all the recommendations for the survival of freshwater aquatic life based on pH and dissolved oxygen.

Concentrations of aluminum reached or exceeded the guidelines in July (0.100 mg/L), September (0.233 mg/L), and October (0.155 mg/L) when the recommendation is 0.100 mg/L when the pH value is  $\geq 6.5$ . Iron exceeded the guideline (0.3 mg/L) in one sample in September (0.42 mg/L).

**Figure 3: ShdA site location and surrounding land uses (imagery view of 2015)**

**Figure 4: ShdA site location and surrounding land uses (imagery view of 2017)**

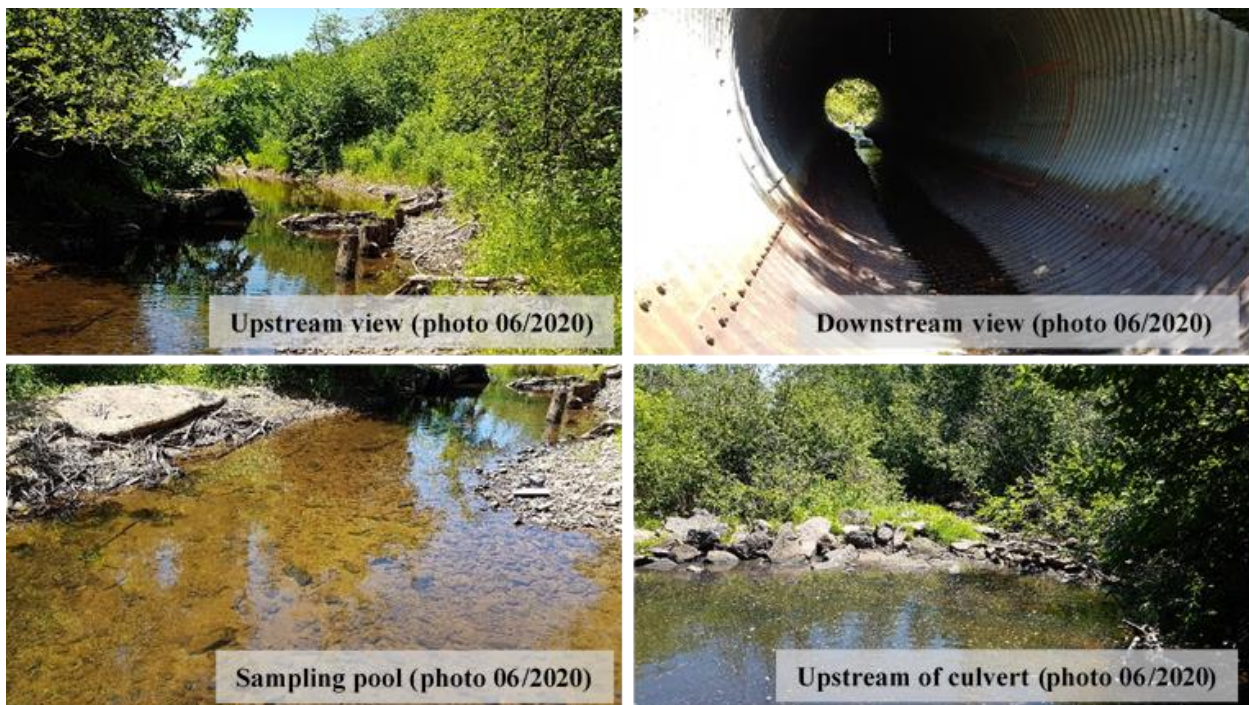
The water sampling results for the site ShdB, for 2020, meet the recommendations for the survival of freshwater aquatic life based on pH. However, one level of dissolved oxygen was slightly below the recommendation (6.5 mg/L) for general cold-water organisms in July (6.40 mg/L). The water temperature exceeded the limit for thermal stress in salmonids (22.5°C) in June (25.8°C) and July (24.6°C).

Concentrations of aluminum exceeded the CCME water quality guideline (0.100 mg/L when the pH is  $\geq 6.5$ ) in the sample taken in August (0.124 mg/L). Iron levels exceeded the guideline (0.3 mg/L) in the samples taken in June (0.47 mg/L), July (0.79 mg/L), August (1.10 mg/L), and September (0.34 mg/L), when the recommendation is 0.3 mg/L.

**Figure 6: ShdB site location and surrounding land uses**

**Figure 7: Site photos for water quality sampling site ShdB**

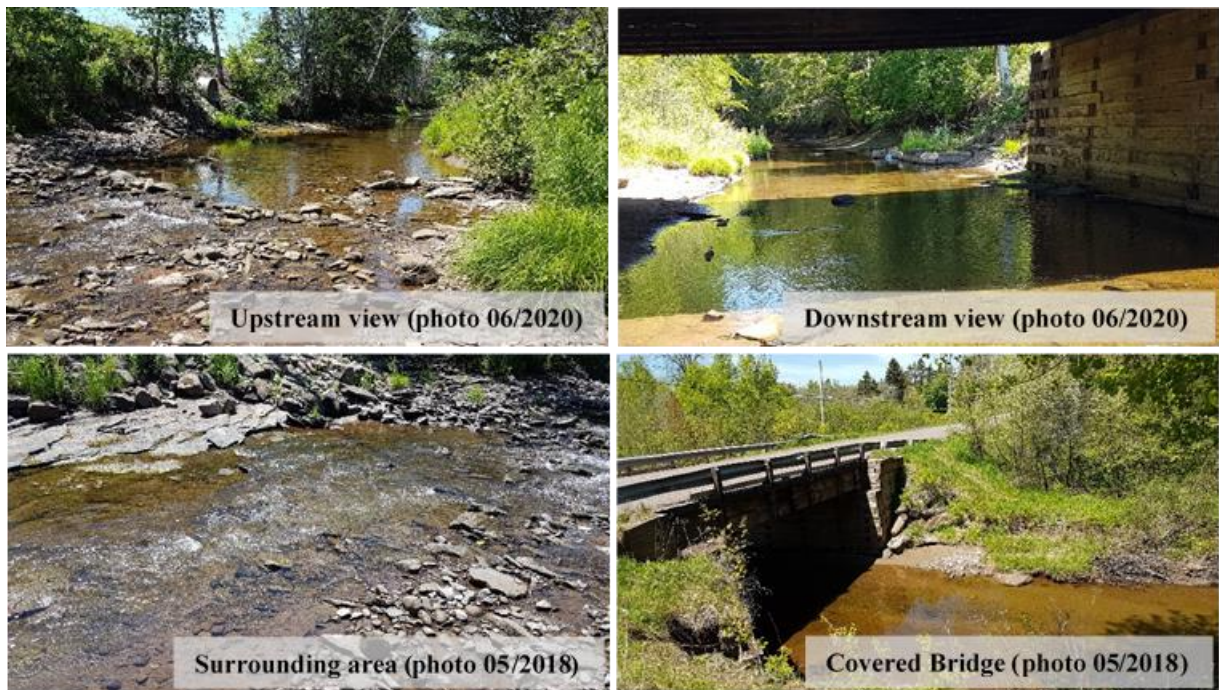
The water sampling results for the site ShdC, for 2020, meets or exceeds all the recommendations for the survival of freshwater aquatic life based on pH and dissolved oxygen.

Total phosphorus levels for long-term eutrophic conditions, according to the CCME Guidance framework for Phosphorus, were: in the ultra-oligotrophic range (<0.004 mg/L) in June; in the oligotrophic range (0.004 – 0.010 mg/L) in July; in the mesotrophic range (0.010 – 0.020 mg/L) in August and September, and in the meso-eutrophic range (0.020 – 0.035 mg/L) in October.

**Figure 8: ShdC site location and surrounding land uses**

**Figure 9: Site photos for water quality sampling site ShdC**

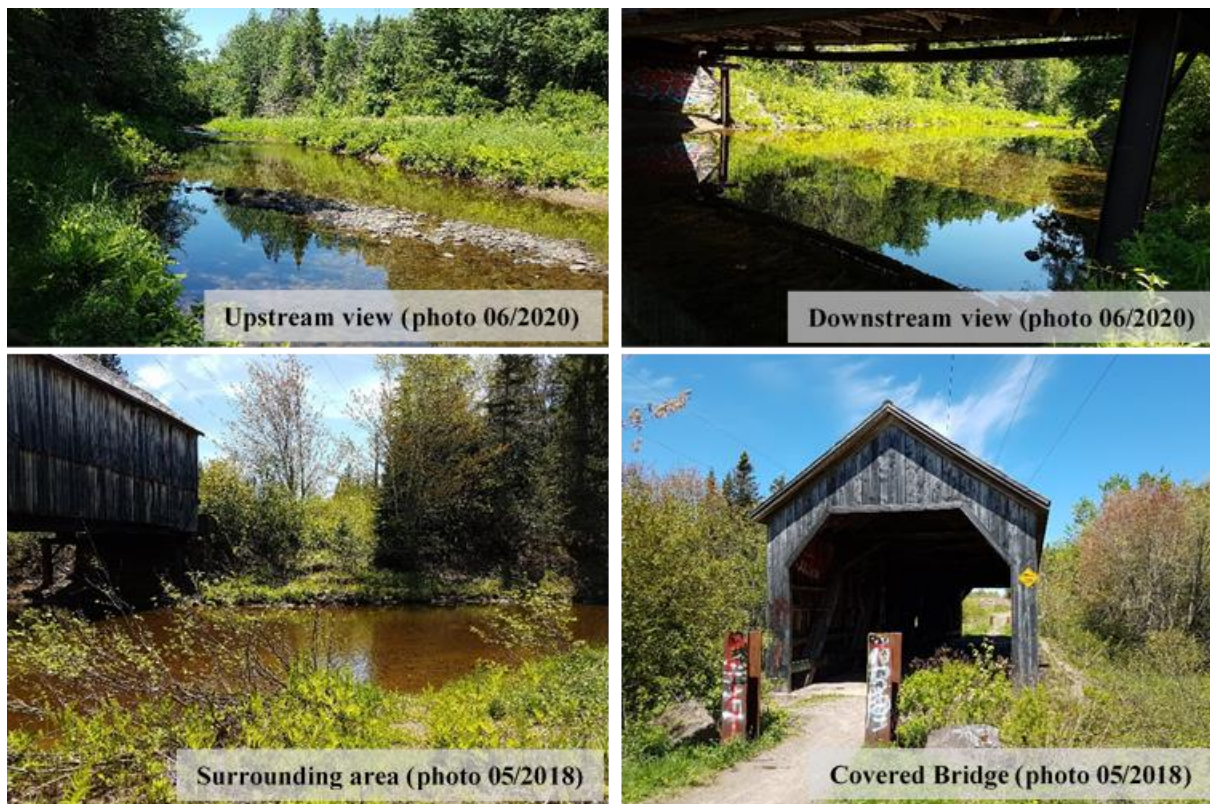
The water sampling results for the site ShdE, for 2020, meets or exceeds all the recommendations for the survival of freshwater aquatic life based on pH and dissolved oxygen. The water temperature slightly exceeded the limit for thermal stress in salmonids (22.5°C) in June (23.9°C) and July (23.5°C).

Total phosphorus levels for long-term eutrophic conditions, according to the *CCME Guidance framework for Phosphorus*, were: in the oligotrophic range (0.004 – 0.010 mg/L) in June and July; and in the mesotrophic range (0.010 – 0.020 mg/L) from August to October.

**Figure 10: ShdE site location and surrounding land uses**

**Figure 11: Site photos for water quality sampling site ShdE**

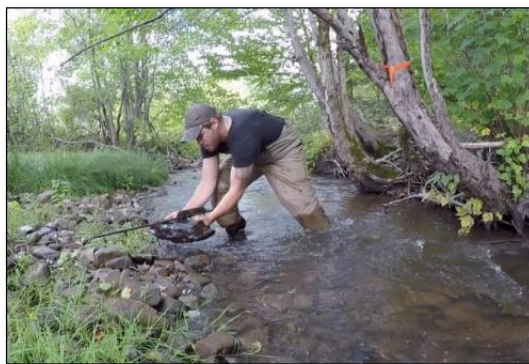
**Figure 26: Installation of a water temperature logger in-stream**

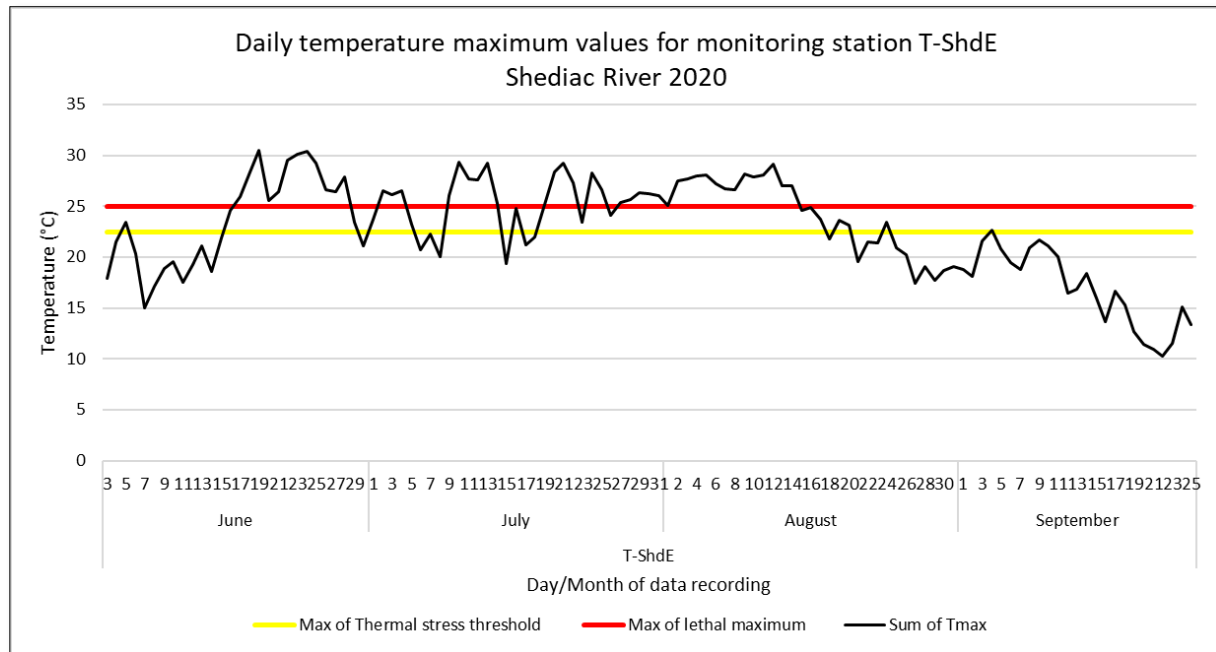
This temperature logger is located in the mid to lower reaches of the main branch of the Shediac River, near the covered bridge. This area was predicted to have warmer waters due to the lack of canopy coverage, and its wide and shallow channel.

**Figure 31: Thermograph data chart for monitoring station ID T-ShdE, Shediac River 2020**

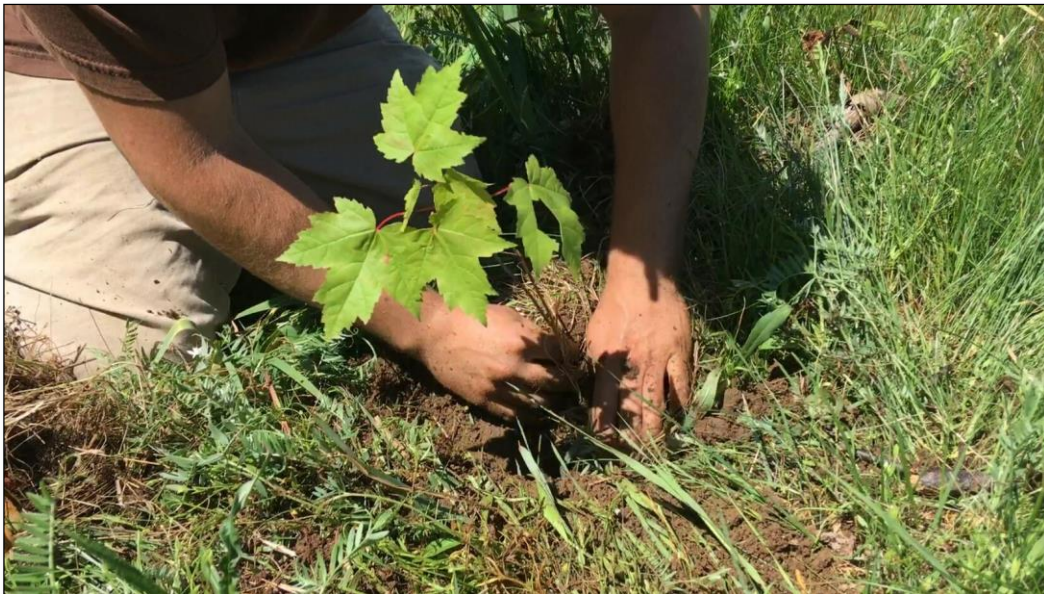
**Figure 35 : Native tree planting for riparian restoration is a technique used by the SBWA**

Another area of focus for reforestation is where bank erosion occurs. This causes an excess of sediment in the watercourse. Sedimentation can cause various issues for aquatic ecosystems; it can suffocate fish and fish eggs, bury aquatic insects, can carry harmful pollutants such as heavy metals and excessive nutrients that can further worsen conditions of the ecosystem, etc. The SBWA mostly uses vegetation and bioengineering techniques to stabilize banks.

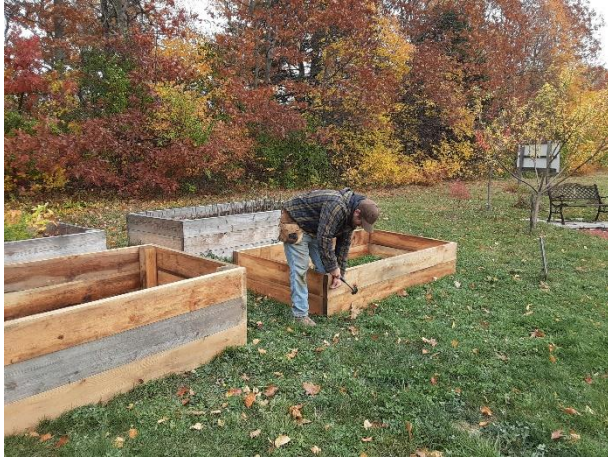
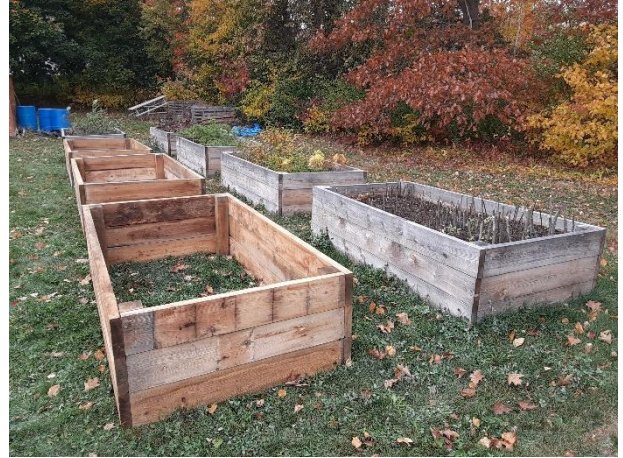
**Figure 37: Photos of the construction of the raised beds at the SBWA tree nursery**

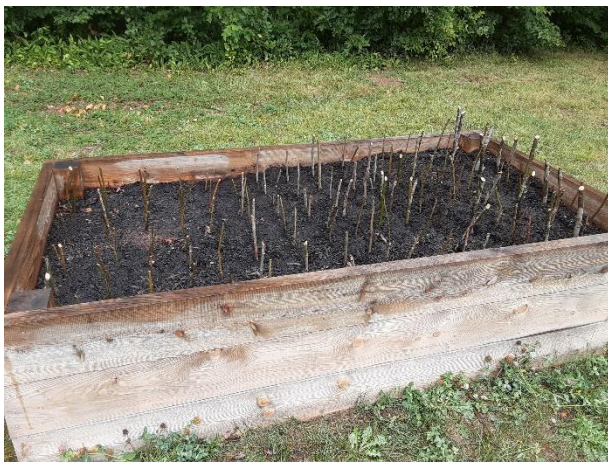
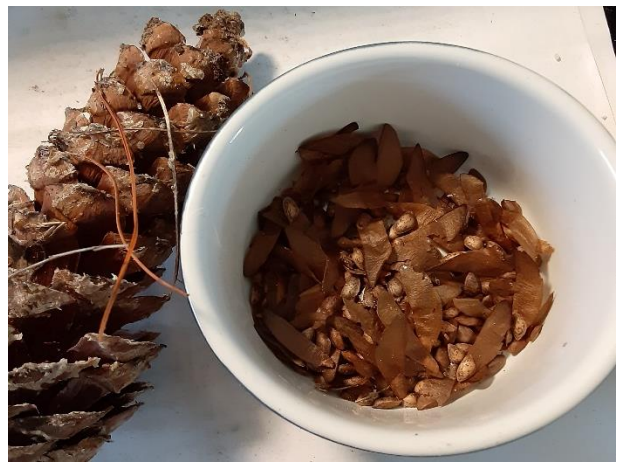
**Figure 38: Photos of the Willow cuttings in the raised bed and seed saving from the cone of a White pine**

This project is also self-sufficient by taking cuttings and starting trees by seeds to keep replacing the trees that get planted for restoration projects. In late summer 2020, 134 willow cuttings were taken from the farm “*Vert l’Avenir*” woodlot and were planted in one of the raised beds. A few weeks later most of the cuttings were growing leaves and already sprouted roots. These will be planted for SBWA restoration projects in 2021.

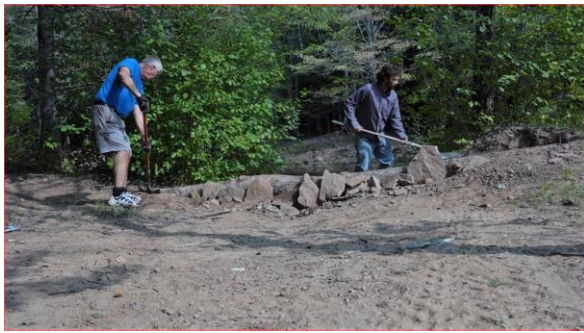
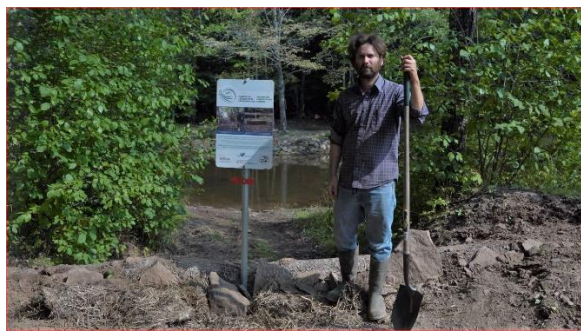
Actions have continued this year to block river crossing access trails. In the fall SBWA staff blocked access to the river using a log dug into the bank to prevent passage.

**Figure 39: Blocking ATV trail access to river**

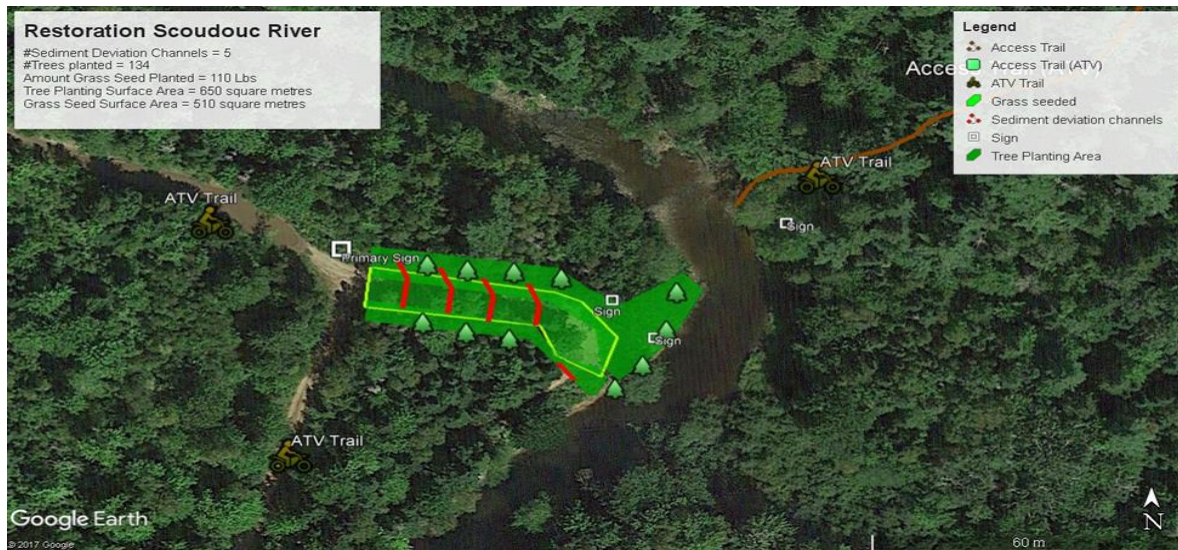
Tree planting also continued at the site. A total of 45 native trees were planted on October 22<sup>nd</sup>. These include 23 Red oaks, 6 Red maples, 5 Sugar maples, 3 Eastern hemlocks, 1 White pine, 1 Balsam fir, 2 Staghorn sumacs and 4 Yellow birches. Approximately 50 Red oak acorns were also planted along the river bank. All of the trees were provided by the SBWA tree nursery.

**Figure 40: Map of the tree planting area of Edna`s pond in the Scoudouc River**
