Restoration and Stewardship of Coastal Ecosystems in the Shediac Bay

The Shediac Bay Watershed Association Inc.

March 2022

Report produced for the New Brunswick Environmental Trust Fund

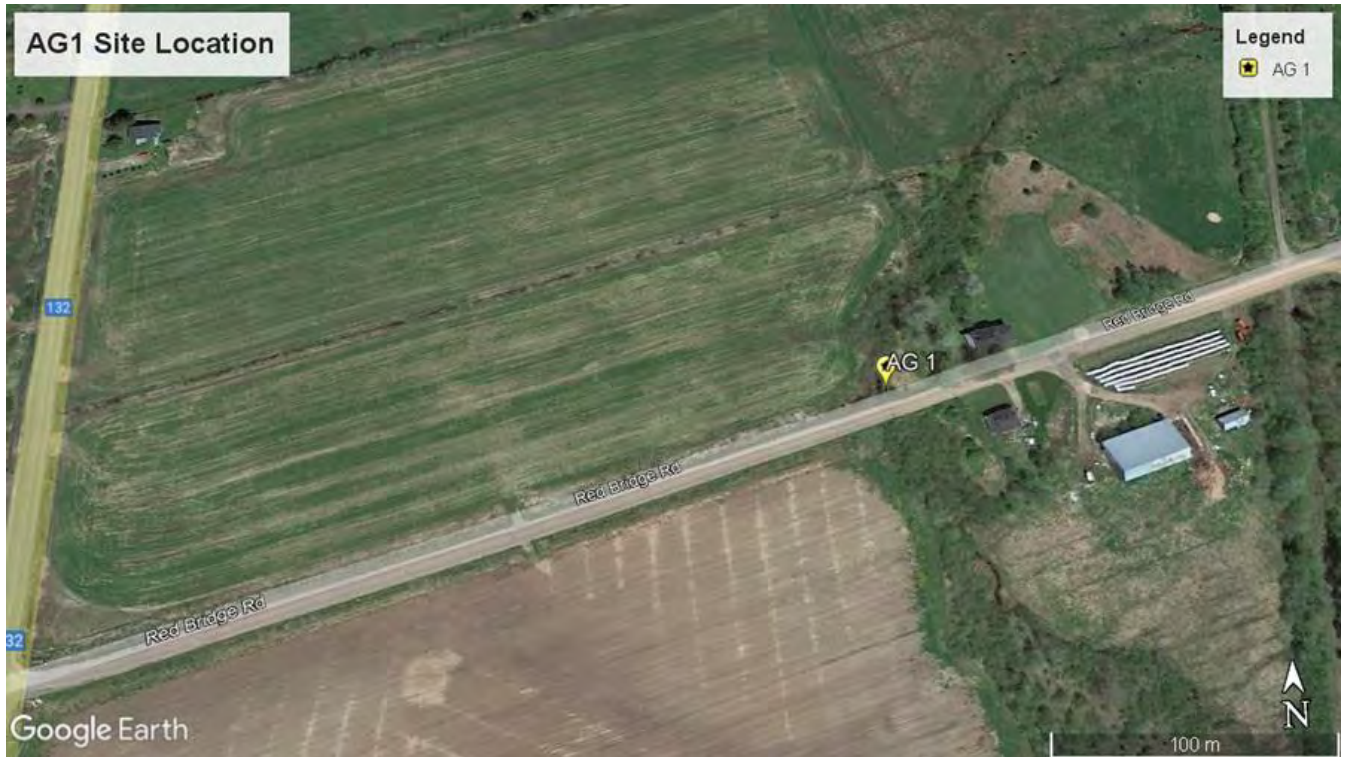
Figure 3: AG1 site location and surrounding land uses

The water sampling results for the site AG1, for 2021, meet the recommendations for the survival of freshwater aquatic life based on pH. However, levels of dissolved oxygen dropped below the recommendation (6.5 mg/L) for general cold-water organisms in September (6.22 mg/L) (Table 9).

Total phosphorus levels for long-term eutrophic conditions according to the CCME Guidance Framework for Phosphorus were: in the oligotrophic range (0.004 – 0.010 mg/L) July; in the meso-eutrophic (0.020-0.035 mg/L) in August; and in the eutrophic range (0.035-0.100 mg/L) in September and October (Table 10).

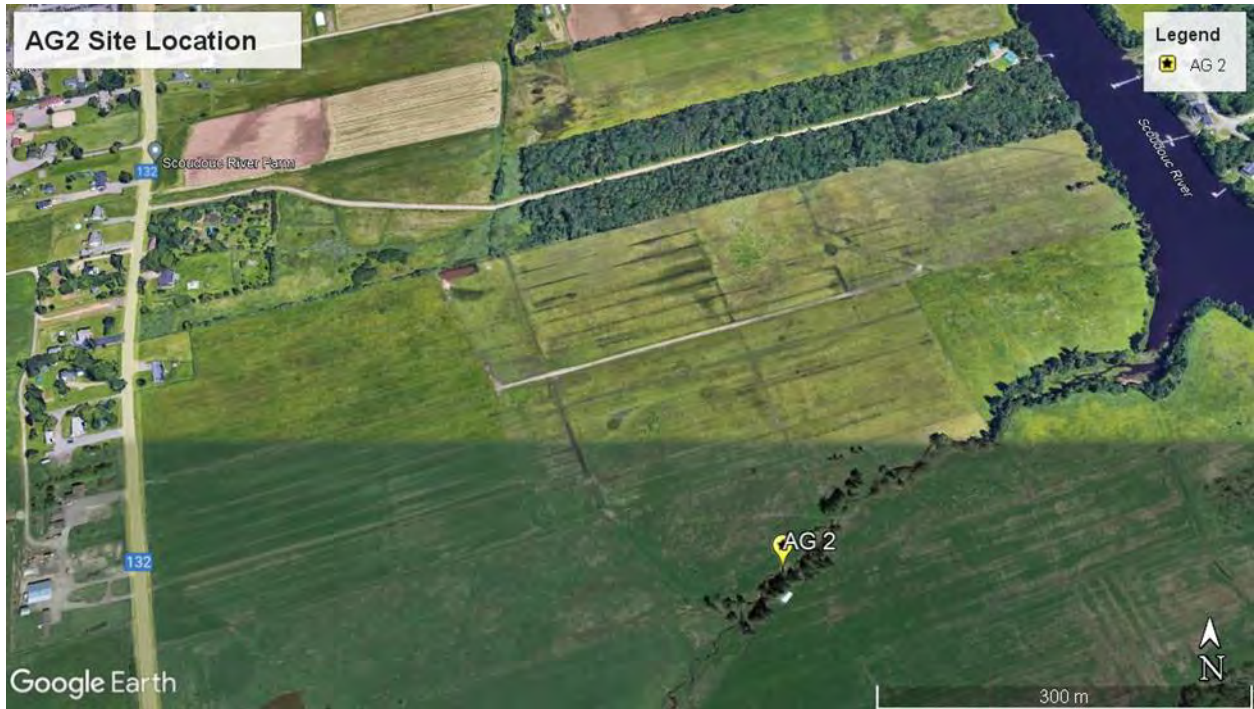
Figure 5: AG2 site location and surrounding land uses

The water sampling results for the site AG2, for 2021, meet the recommendations for the survival of freshwater aquatic life based on pH. However, levels of dissolved oxygen dropped below the recommendation (6.5 mg/L) for general cold-water organisms in August (5.89 mg/L) and September (6.23 mg/L) (Table 13).

Total phosphorus levels for long-term eutrophic conditions according to the CCME Guidance framework for Phosphorus were: in the eutrophic range (0.035 – 0.100 mg/L) in August, September, and October; and in the hyper-eutrophic range (>100 mg/L) in July (Table 14).

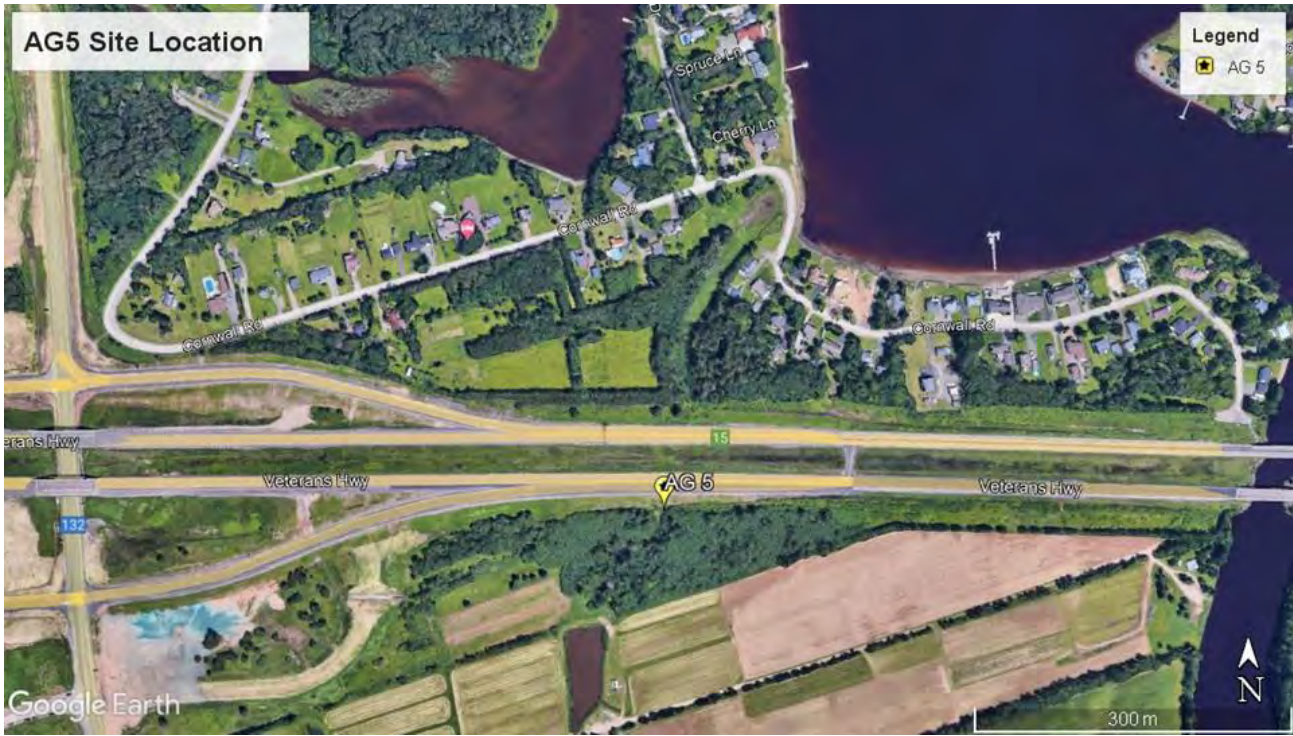
Figure 6: AG5 site location and surrounding land uses

The water sampling results for the site AG5, for 2021, meets or exceeds the recommendations for the survival of freshwater aquatic life based on pH and dissolved oxygen.

Total phosphorus levels for long-term eutrophic conditions according to the CCME Guidance Framework for Phosphorus were all eutrophic range (>100 mg/L) in October (Table 16).

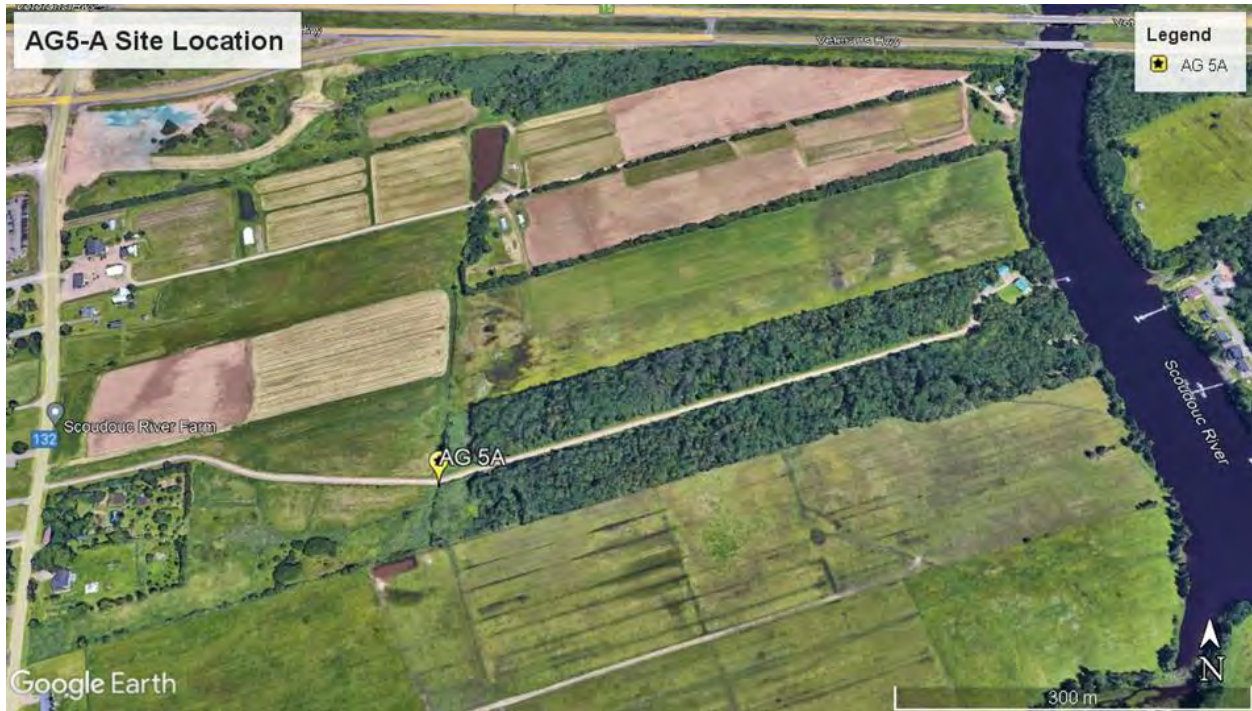
Figure 7: AG5-A site location and surrounding land uses

The water sampling results for the site AG5-A, for 2021, meet the recommendations for the survival of freshwater aquatic life based on pH. However, levels of dissolved oxygen dropped below the recommendation (6.5 mg/L) for general cold-water organisms in July (3.64 mg/L), August (4.91 mg/L), and September (5.63 mg/L) (Table 17).

Total phosphorus levels for long-term eutrophic conditions according to the CCME Guidance Framework for Phosphorus were all hyper-eutrophic range (>100 mg/L) in October (Table 18).

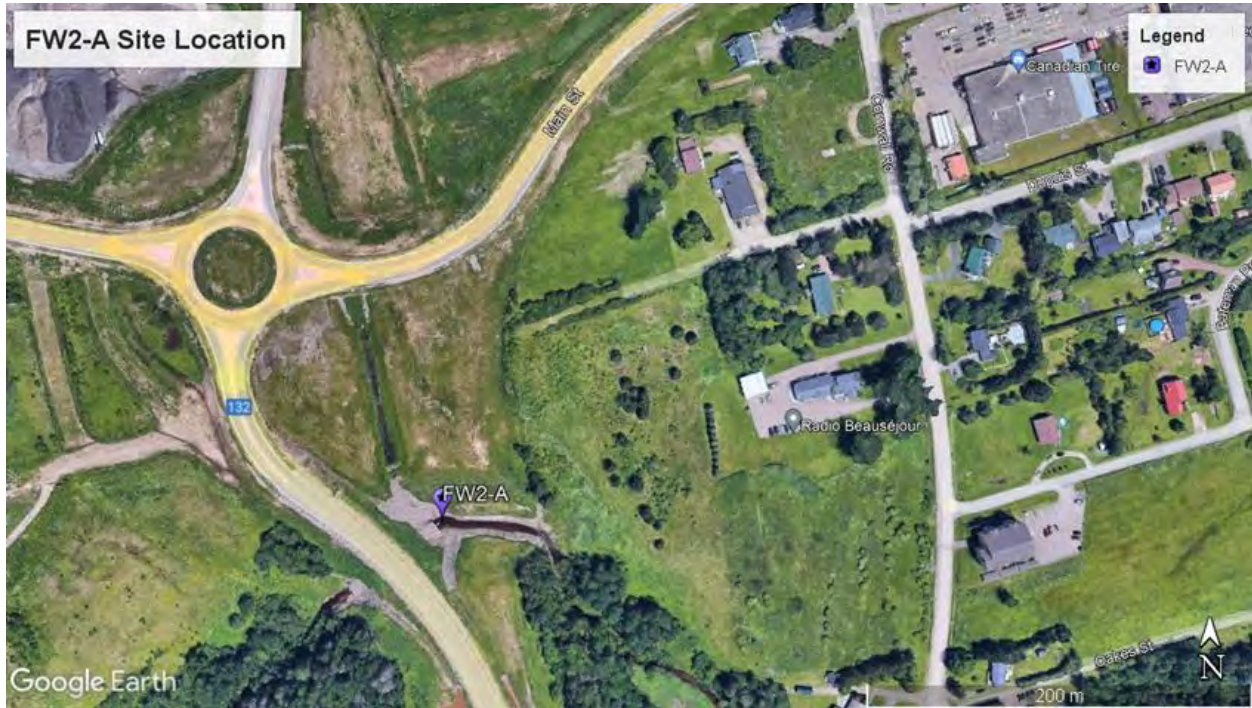
Figure 8: FW2-A site location and surrounding land uses

This water quality sampling site is located in the Cornwall Brook, at the crossing with Route NB-132 near the Shediac roundabout (Figure 8). This area is not affected by tide. Small trout and some larger fish have been seen near this site. The SBWA began replanting trees along the banks at this site in 2020, to help mitigate the damages caused by the construction of the new highway interchange between NB-15, NB-11 and NB-132.

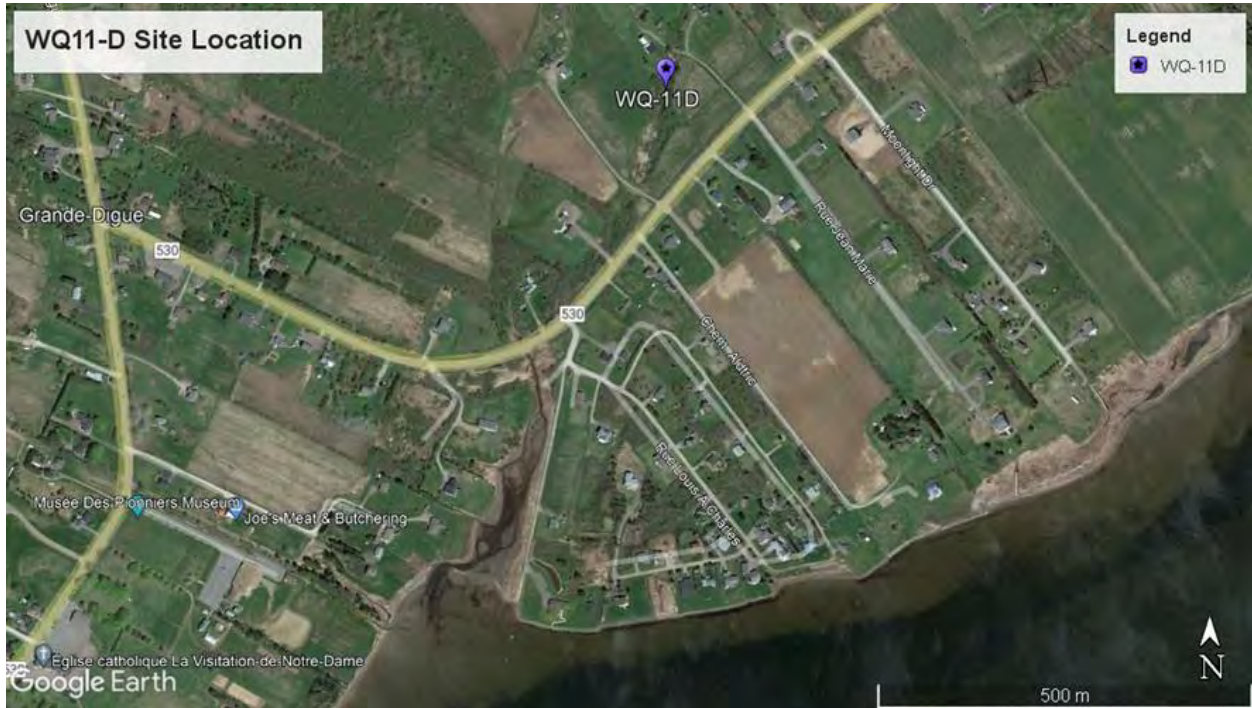
Figure 9: WQ-11D site location and surrounding land uses

This water quality sampling site is located on Route NB-530 in Grande-Digue, and is accessed through a private property with the landowner’s permission (Figure 9). This site has a thick riparian vegetation along most of its length. Hayfields dominate the levels on the edge and above the stream.

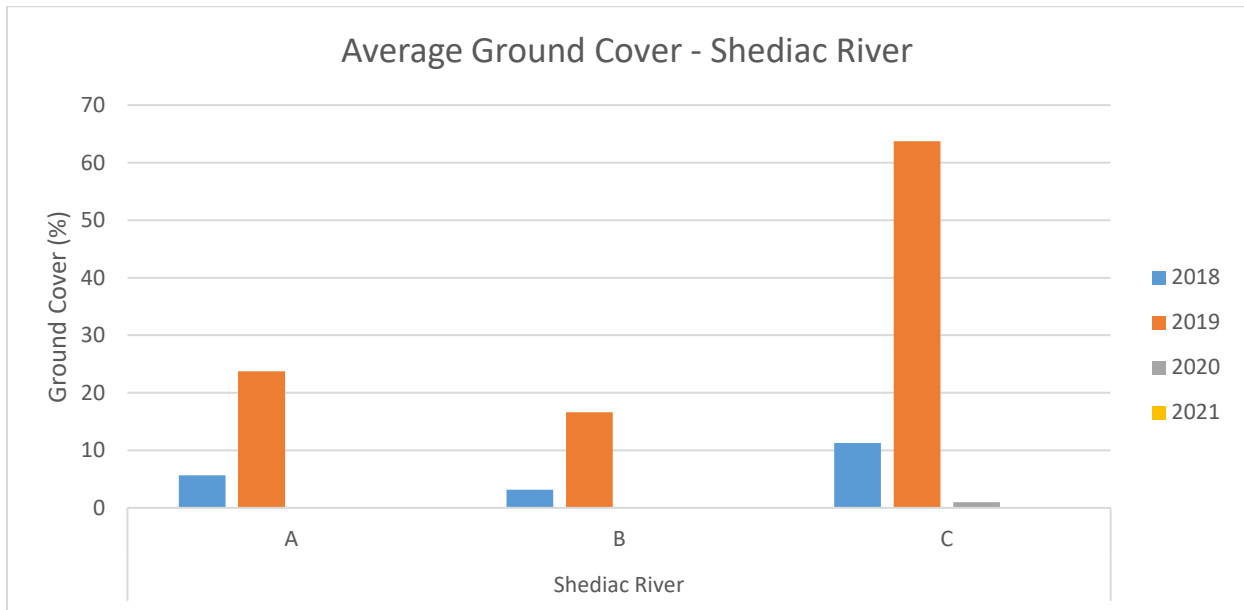
The average percent cover also has had no significant change since 2020. Similar to the average height, the average percent cover of eelgrass had been increasing yearly from 2017 to 2019. The Shediac River transects showed no eelgrass presence (*Appendix A – Shediac River Site*), therefore no average percent cover could be measured for 2021 (Figure 14).

Figure 14: Average Shediac River eelgrass ground cover in percentage per transect throughout 2018-2021

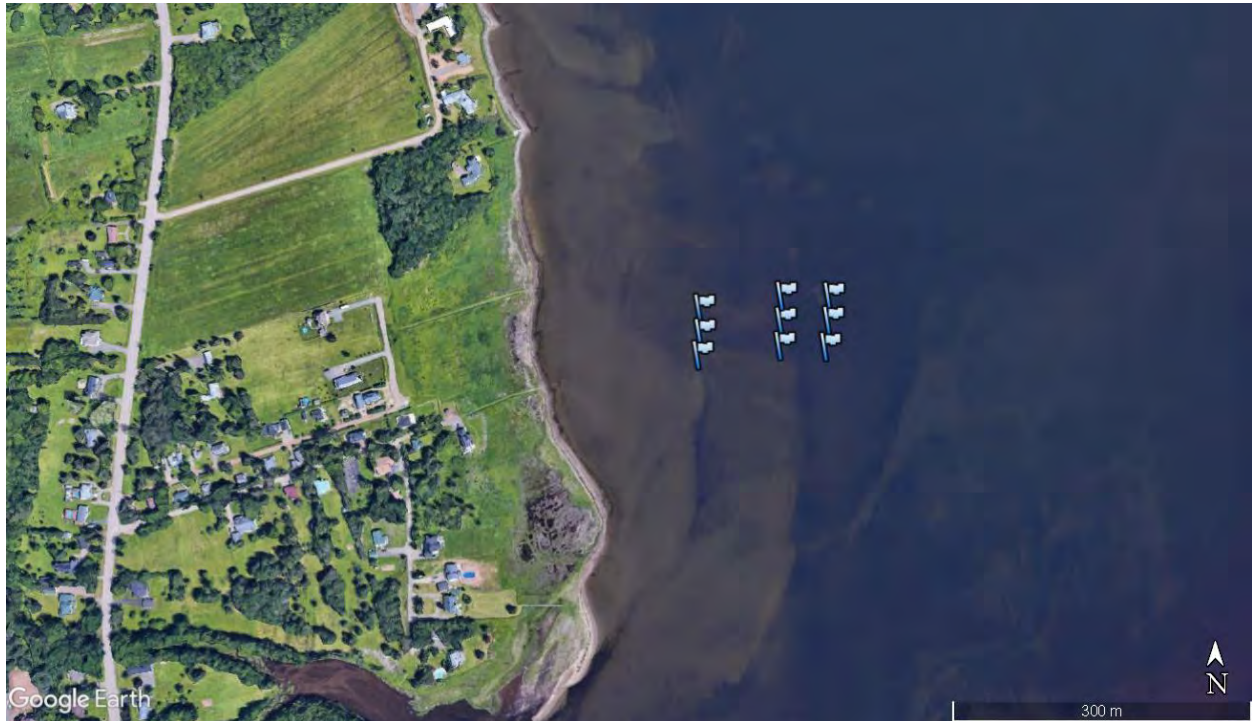
Figure 15. Scoudouc River eelgrass monitoring sites

Another eelgrass monitoring site is located in the Scoudouc River estuary. Access is from the private Heron Lane. The SBWA has received permission from the property owners to use the road and permission from the Greater Shediac Sewage Commission to park at their lift station for easy access to the beach (Figure 15). This site was established in 2016. However, in 2018, the site anchors could not be found. In 2019, the site was re-established in an area slightly further north (Table 27). The A-line of the original site being too shallow for a proper assessment.

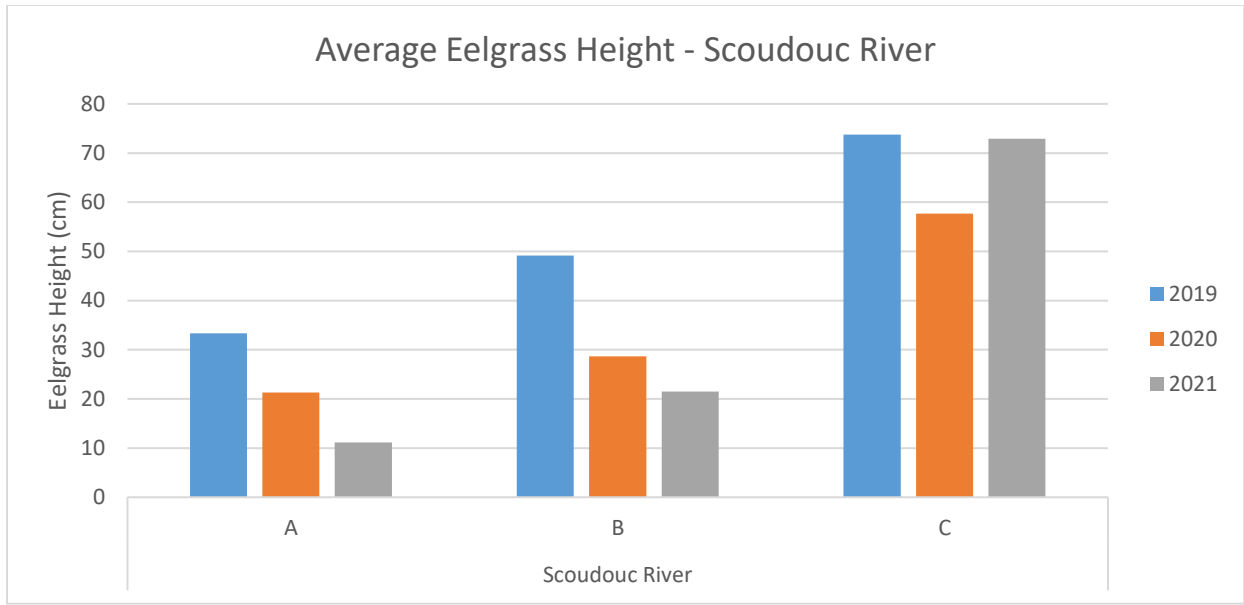
For both nearshore (A) and middle (B) sites, the average plant height has decreased in 2021 with a decrease of 10cm and 7cm respectively. Ever since Hurricane Dorian in 2019, the average plant height has been decreasing in all sites except the offshore site (C). The offshore site has showed signs of recovery from the hurricane with an increase of 15cm in average plant height (Figure 16).

Figure 16: Average Scoudouc River eelgrass height in centimeter per transect throughout 2019-2021

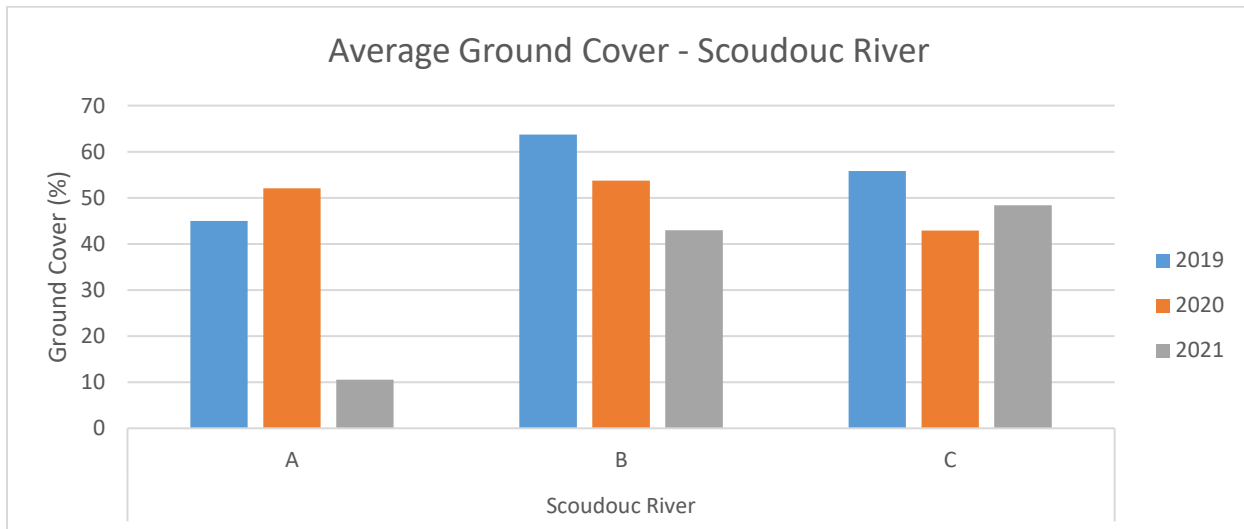
The average percent cover of eelgrass showed the same trends as the average height. In both nearshore and middle sites there has been a decrease of 41% and 11% respectively from 2020 to 2021. The offshore site, however, has had an increase of 5% (Figure 17).

Figure 17: Average Scoudouc River eelgrass ground cover in percentage per transect throughout 2019-2021

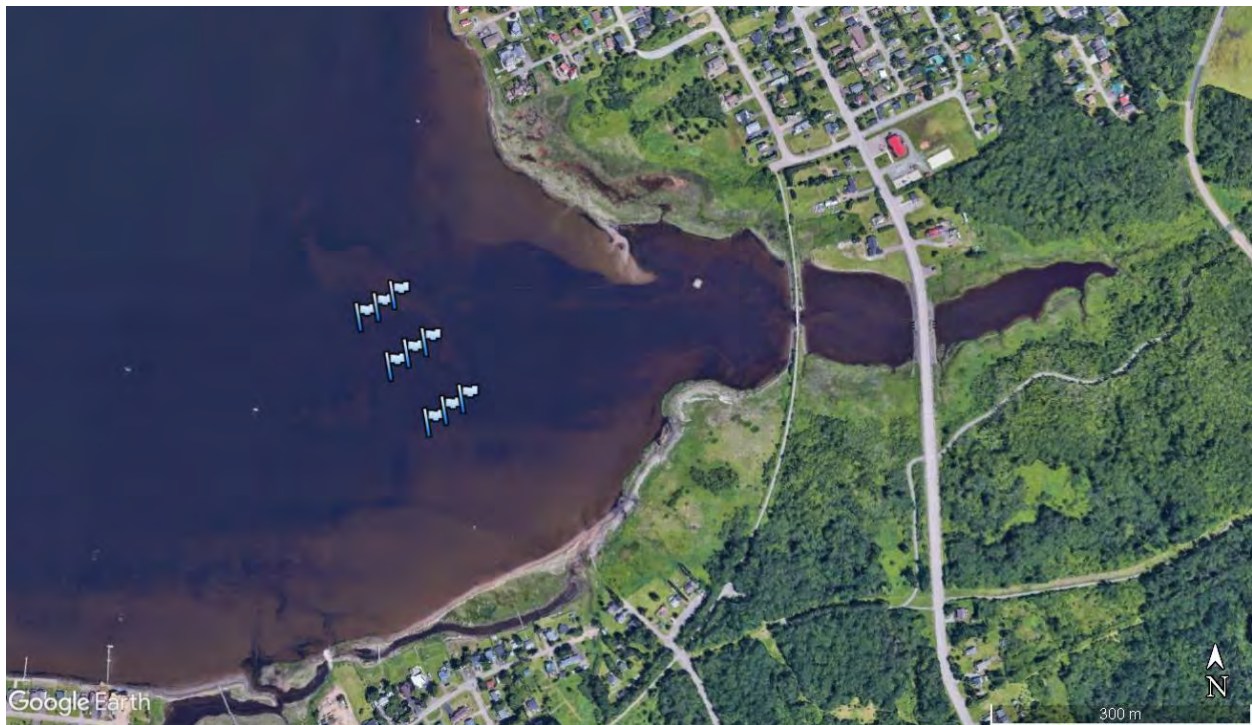
Figure 18: Point-du-Chêne eelgrass monitoring sites

The Pointe-du-Chêne assessment site is located at the end of Stead Road (Table 28 & Figure 18).

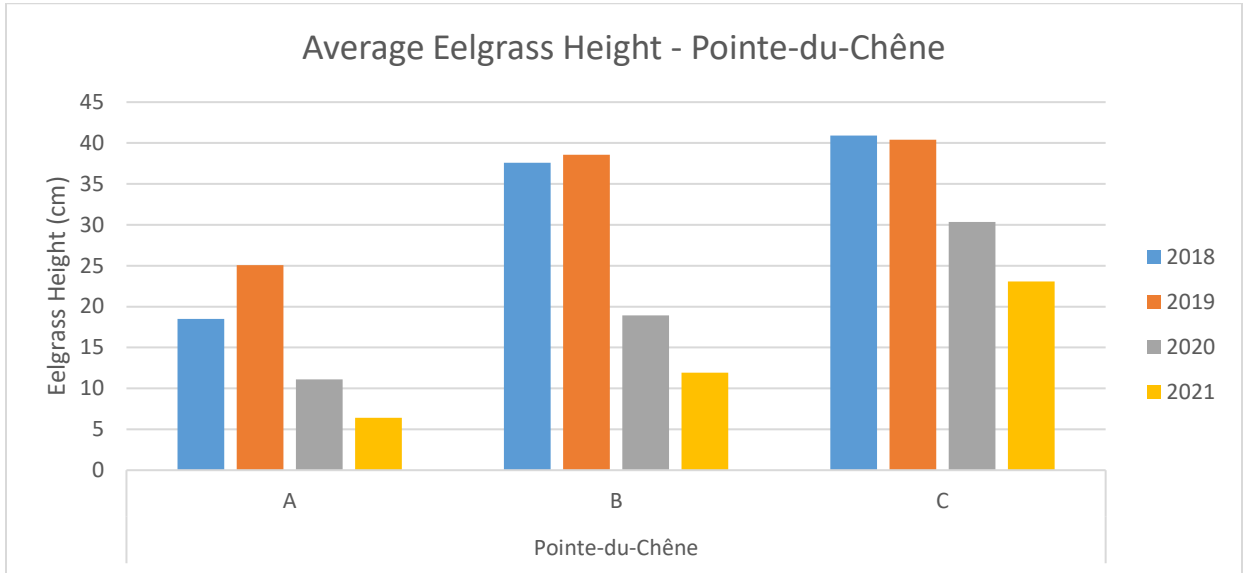
Since Hurricane Dorian in 2019, the average height of eelgrass in all sites has decrease yearly. Average plant height in 2021 is much shorter than in 2018 and 2019. Comparing to 2020, nearshore sites average plant height has decreased 5 cm, middle and offshore sites have both decreased 7 cm (Figure 19).

Figure 19: Average Pointe-du-Chêne eelgrass height in centimeter per transect throughout 2018-2021

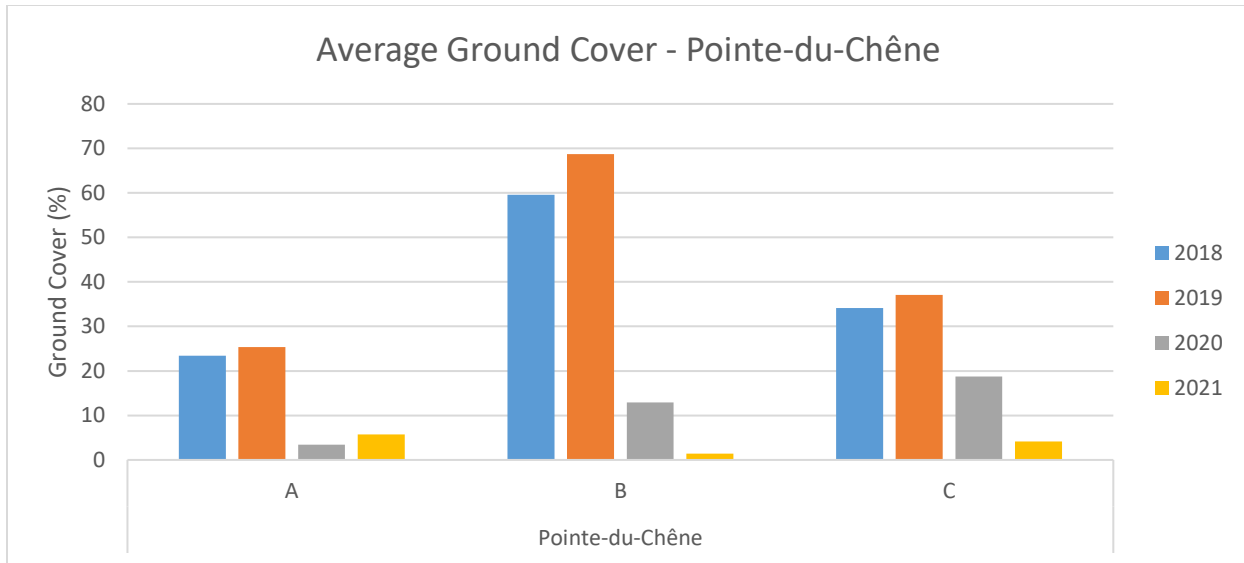
The average percent cover has mostly decreased yearly since 2019. All sites except nearshore sites have had a decrease in their plant cover since 2020. Middle sites had a decrease of 12% and offshore sites decreased 15%. The nearshore sites had a slight increase of 2%, showing slight signs of recovery from the hurricane Dorian (Figure 20).

Figure 20: Average Pointe-du-Chêne eelgrass ground cover in percentage per transect throughout 2018-2021

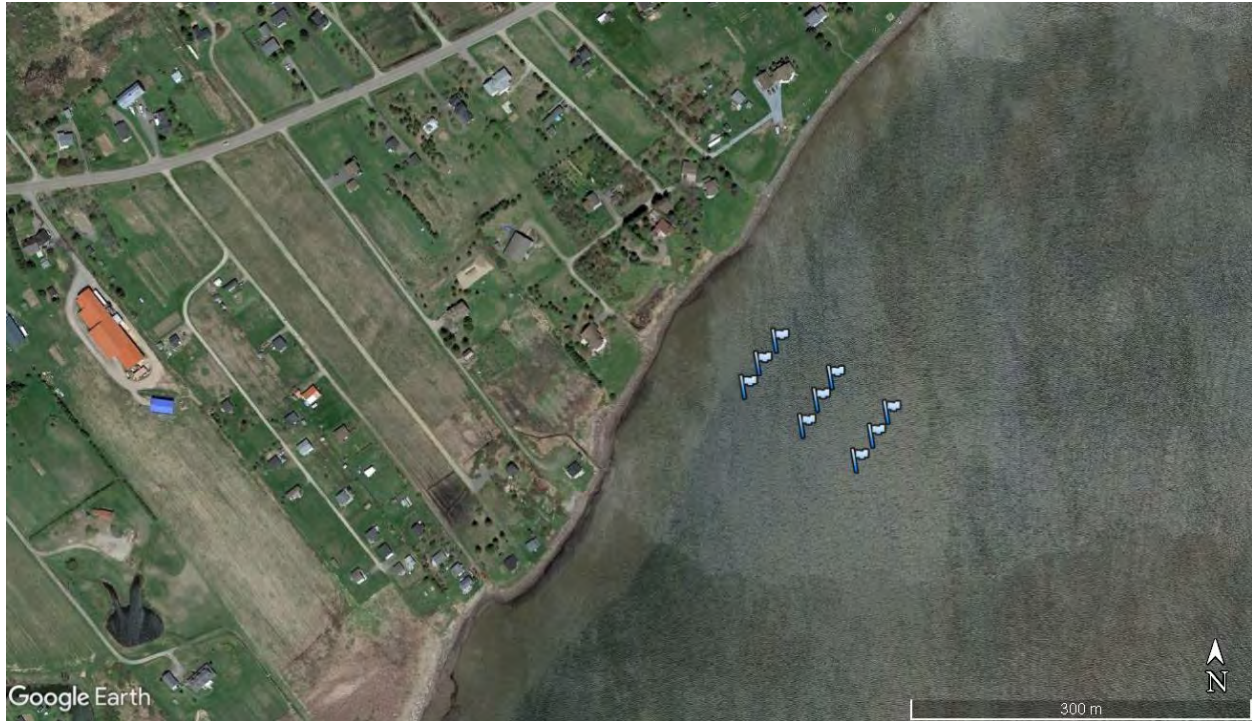
Figure 21: Grande-Digue eelgrass monitoring sites

The Grande-Digue site was established near the Grande-Digue dune at the end of Allée des Faisans Road (Table 29 & Figure 21) Permission was obtained from the owner of the land for parking and access to the shore for the team and the equipment.

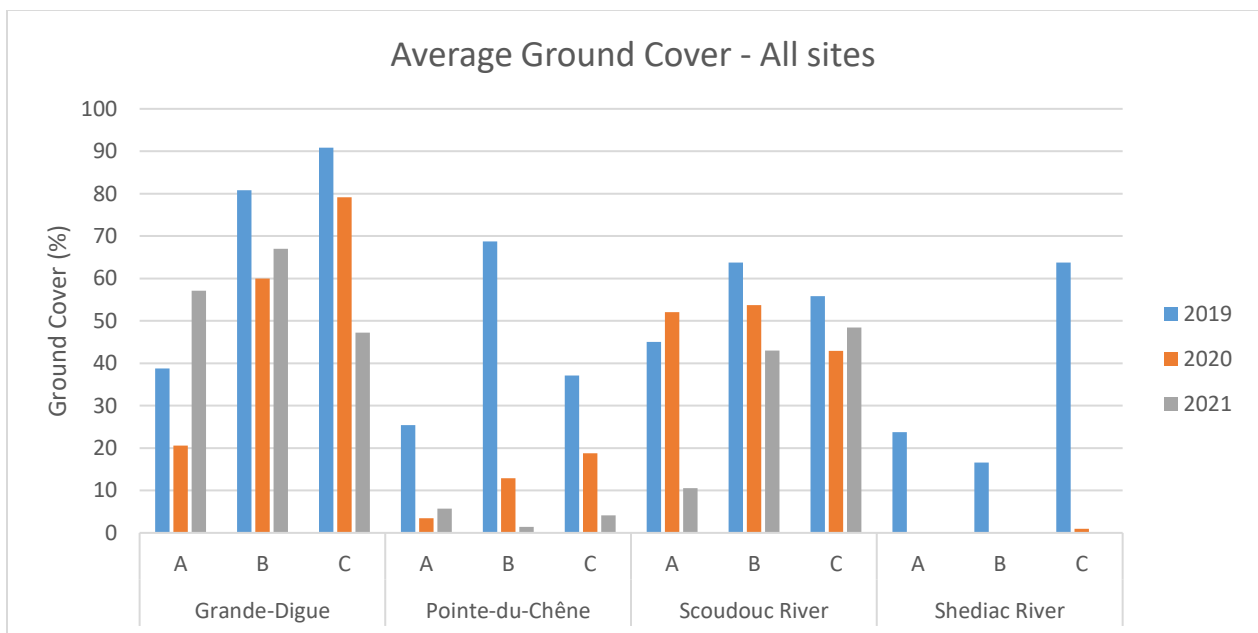
The Grande-Digue site shows the greatest percentage cover and recovery from Hurricane Dorian. The Scoudouc River had second greatest percent cover, however, there has been a slight decrease in both nearshore and middle sites since 2020. The Pointe-du-Chêne site was heavily affected by Dorian and is still having yearly decreases in ground cover, however, the nearshore site has shown slight signs of recovery. Unlike the other sites, the Shediac River has not shown signs of recovery from Hurricane Dorian. This hurricane caused a lot of damage to the coast and appears to have stripped the eelgrass almost entirely this site (Figure 24).

Figure 24: Average monitoring site eelgrass ground cover in percentage per transect throughout 2019-2021

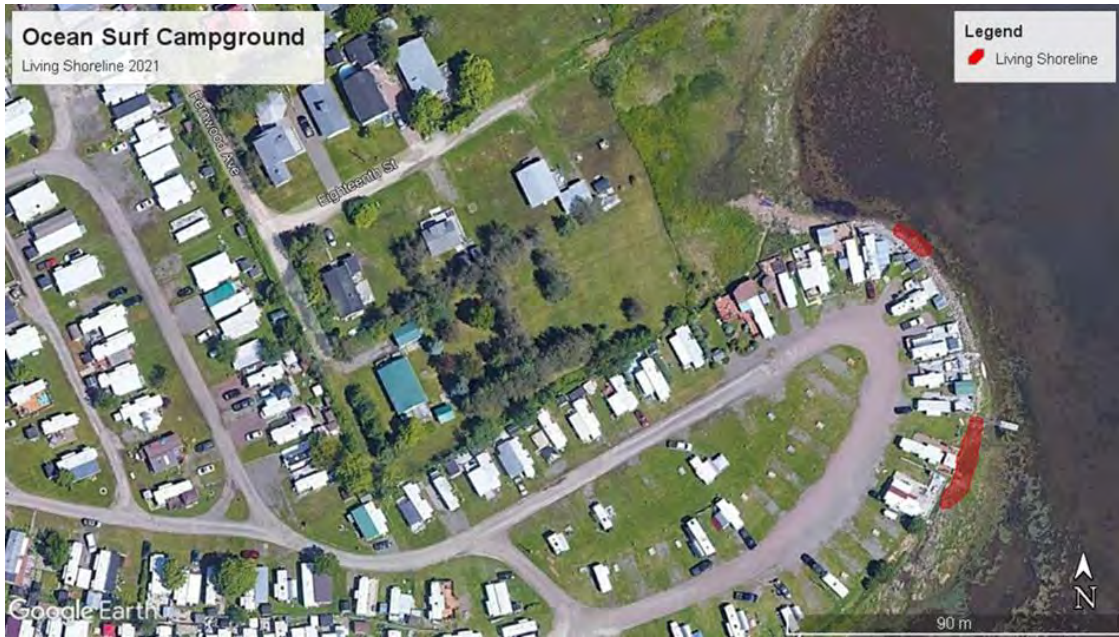
Figure 30: Map of restoration work done at Ocean Surf Campground 2021

- 12 large potted Spartina Grass
- 7 seedling Sumac
- 2 Blue bead lily
- 3 sheep laurel
- 5 Birch
- 4 Pearly Everlasting
- 7 Aster
- 3 Raspberry
- 3 Carex Grass
- 2 Combo pots of sheep laurel & Grass
- 2 large multi pots of Evening Primrose
- 90 Sea Grass
- 3 Golden Rod
- 10lbs mixed seed grains and grasses with HNH pollinator seed mix
- 24 red Osier Dogwood

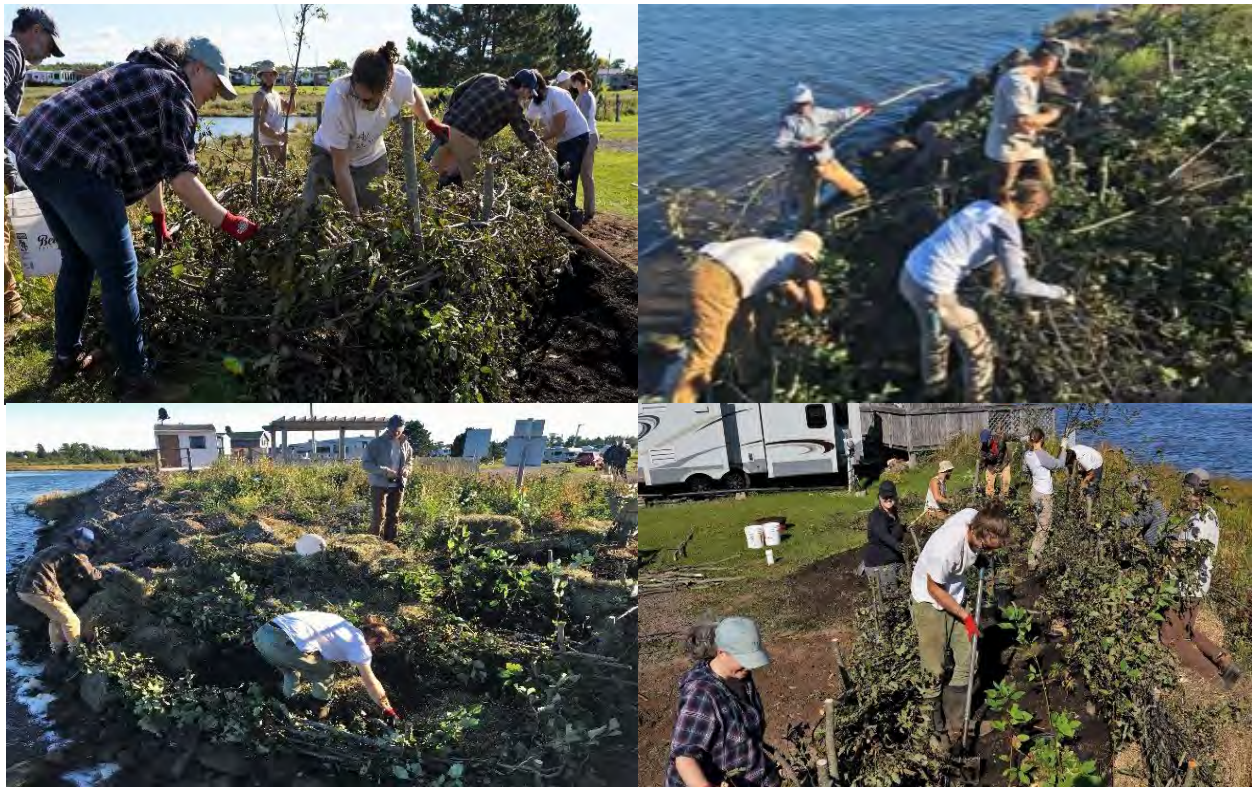
Figure 31: Applying the living shoreline techniques in 2021

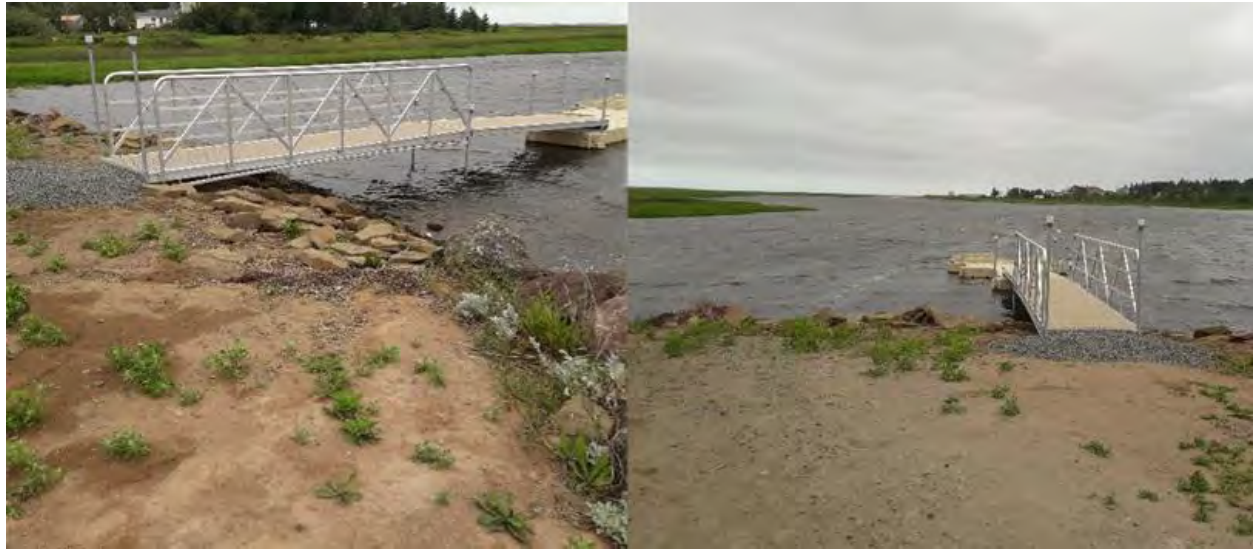
Figure 33: Before photos of the dock area of the restoration site in 2019

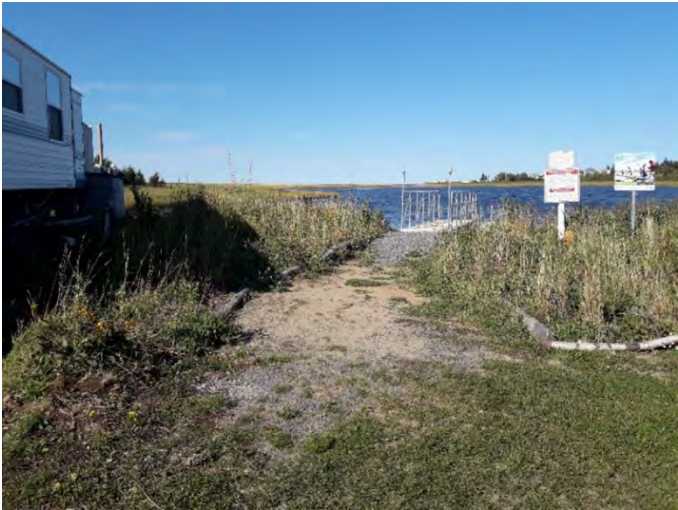
Figure 34: After photos of the dock area of the restoration site in 2021

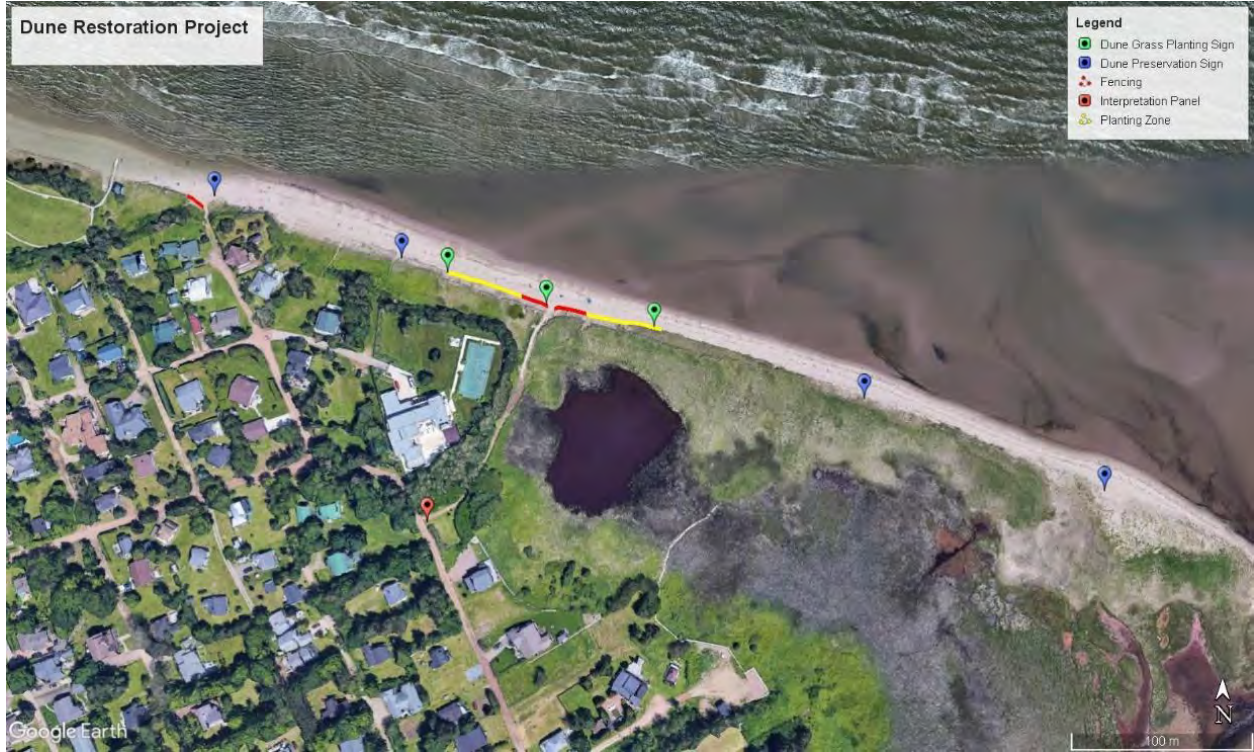
Figure 36: Dune Restoration Map

The message is then repeated on medium sized signs that are placed along the fencing and plantations to inform visitors that may have accessed the beach from other areas. Additionally, smaller signs are installed further along the dune to remind people not to walk on the beach grass.

The aim of the program in 2021 was mostly to educate visitors on the sensitive nature of the dune. The program could be expanded in future years to restore greater surfaces of the dune with snow fences and marram grass plantings. Healthy dunes offer ecosystem services to the community of Pointe-du-Chêne by providing natural erosion control and buffering storm surges. These services would be very expensive to replace with engineered infrastructure.

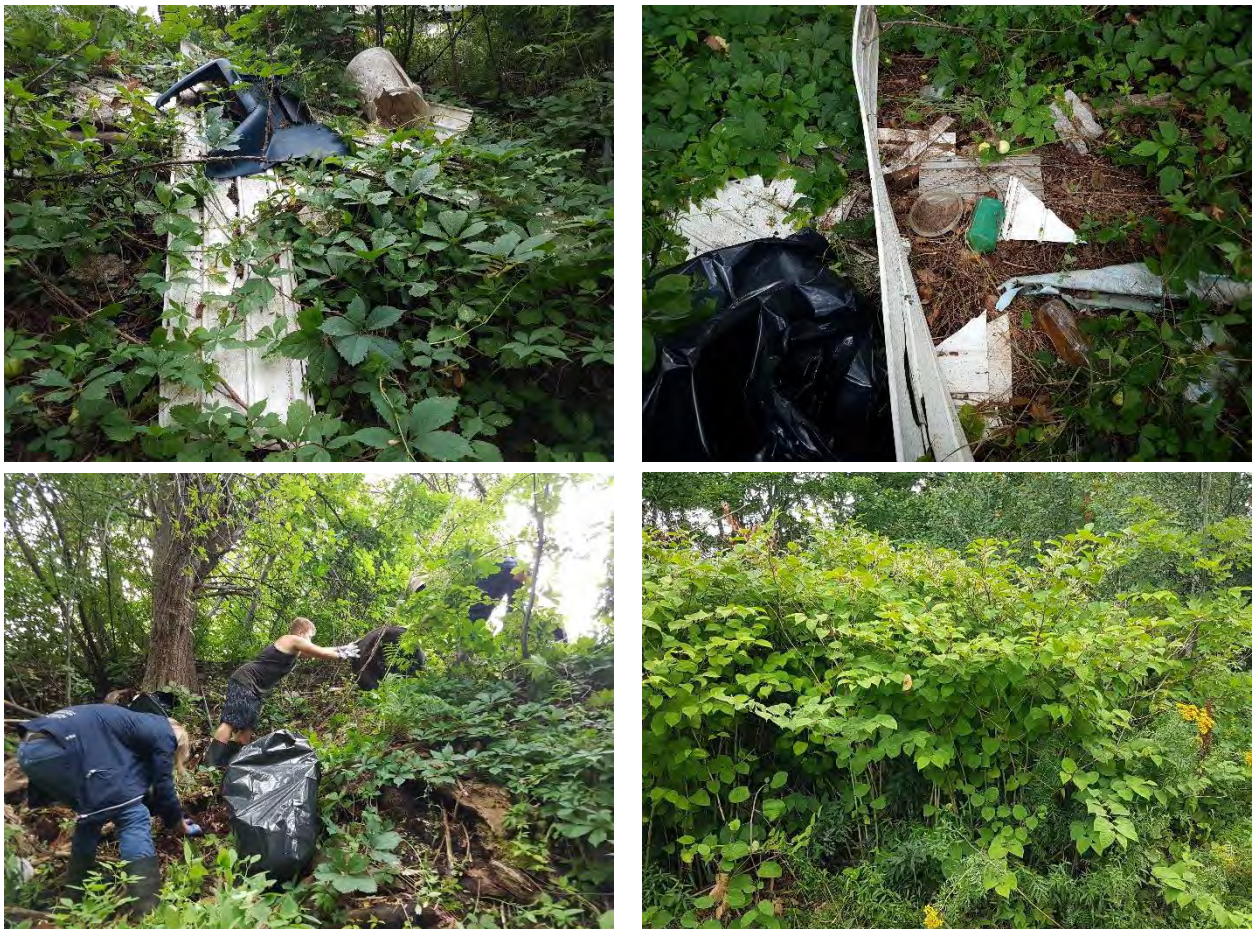
The dump site underwent a first phase cleanup, where the SBWA's staff and volunteers collected over 14 heavy-duty garbage bags and various debris. The Town of Shediac disposed of two truckloads of trash from this cleanup. The next phase of this cleanup will require heavy equipment to retrieve the larger items and is scheduled for the spring of 2022.

In addition, a patch of invasive Japanese Knotweed was discovered in the backyard. A plan is in place target this patch for eradication in 2022.

Figure 37: Trash site cleanup and photo of invasive Japanese Knotweed
