## Integrated Watershed Management in the Shediac Bay Watershed

#### The Shediac Bay Watershed Association Inc.

March 2023

## Report produced for the New Brunswick Environmental Trust Fund

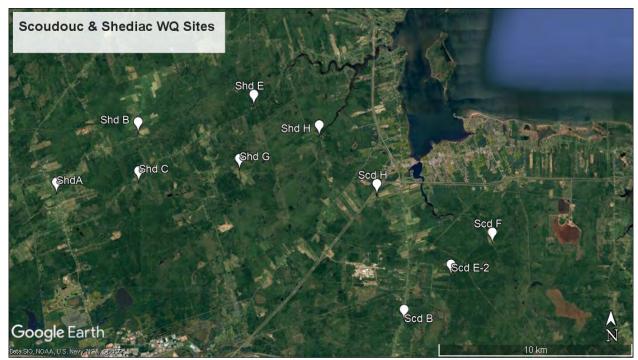
Figure 2: Shediac and Scoudouc river sampling locations.

The following section describes the 10 sample sites for the water classification monitoring established in 1999. Figure 2 shows an aerial view of the location of each site within the watershed. Photographs and coordinates of each sampling station can be found in Appendix B.

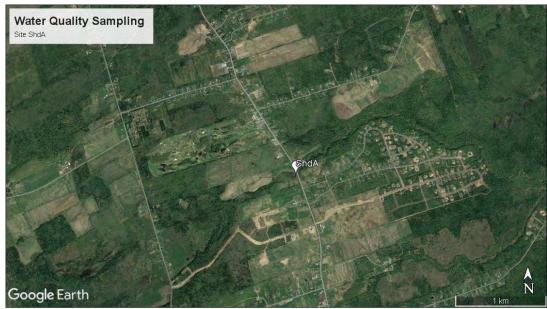
Figure 3: ShdA site location and surrounding land uses.

Next to the orchard is another plot of land (20 ha) that was previously used for agriculture. Records show this land is currently being developed into a subdivision with up to 185 individual lots.

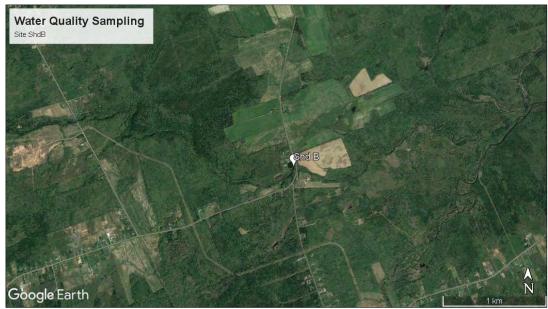
Figure 4: ShdB site location and surrounding land uses.

Most of the runoff from agricultural fields in the area would flow into other small tributaries of the McQuade Brook, converging at a lower point in the system. The gravel/mineral pit is approximately 3 km upstream of the sampling site. The buffer zone in the area of the pit ranges from 20 - 200 m or more in width. The McQuade Brook is made up of lots of small tributaries from around McQuade and Scotch Settlement, which are areas with farms and clear-cuts from past logging activity.

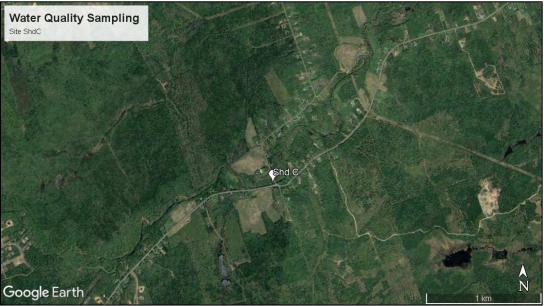
Figure 5: ShdC site location and surrounding land uses.

This water quality site is located on the main branch of the Shediac River at the bridge on MacLean Crossing Road (at the junction of Shediac River Road and Cape Breton Road). The sample is taken upstream of the bridge. The surrounding land use is mainly residences and forested land (Figure 5). This site is located 5.3 km downstream of site ShdA; there is little more than houses and cabins between the two sites. From aerial imagery, there is evidence of an ATV crossing approximately 1.6 km downstream of the site.

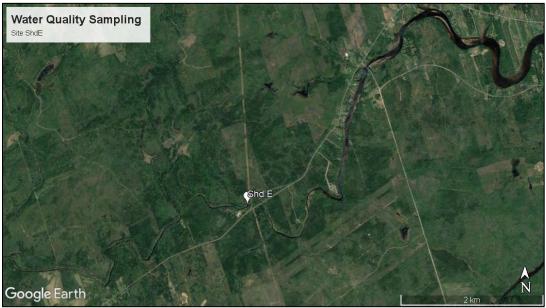
Figure 6: ShdE site location and surrounding land uses.

This water quality sampling site is located on the main branch of the Shediac River, at the Joshua Gallant Covered Bridge. The sample is taken upstream of the bridge. The surrounding land use is mainly residences, forested land and ATV trails (Figure 6). A set of transmission lines cross overhead of the site. There are some clear-cut lots further upstream along the river. This location is popular with individuals; remnants of camp fires are often found and there is usually some trash around the site.

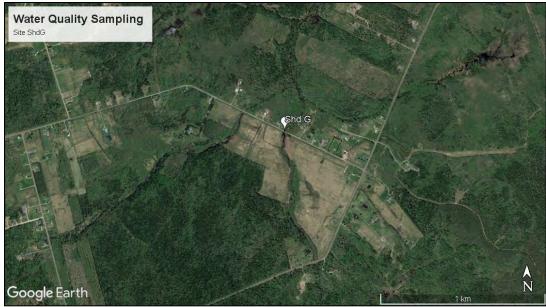
Figure 7: ShdG site location and surrounding land uses.

This site is located on the Weisner Brook, at the small bridge on St Phillipe Road. The sample is taken upstream of the bridge. The surrounding land use include residences, farmlands, forested land and a mineral extraction pit (Figure 7).

Several areas along the brook have thin buffer zones (> 10 m) made up of shrubs. To the left of the sampling site (looking upstream) just above the bridge, is an area that was recently transformed into an agricultural field. In 2017-2018, the buffer zone was cut and the field was tilled in preparation for planting. The clearing reached the riverbank, leaving little vegetation along the 175 m stretch. Alders and shrubs have since recolonized the riverbank area. The SBWA took steps in 2022 to plant trees and create a sediment trap and waddle fence in this area to reduce the amount of sediment and runoff entering the brook.

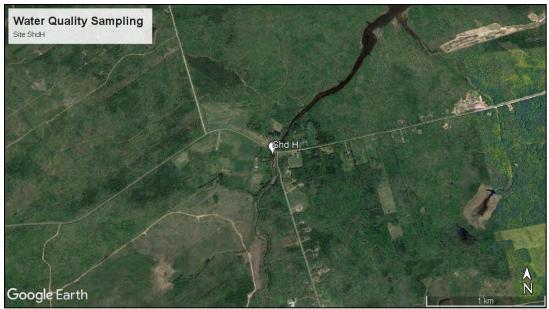
Figure 8: ShdH site location and surrounding land uses.

This water quality site is located on the Batemans Brook, at the culvert on Bateman Mill Road. The sample is taken upstream from the culvert. The surrounding land use includes individual residences and farm fields for both the cultivation of hay and the grazing of cattle (Figure 8). A small pig farm is evident on aerial imagery just upstream of the site, but it is unknown whether there is still any activity. Further upstream are several active and/or recently active logging sites with small buffer zones between the cut area and brook, ranging from 10 - 20 m in width.

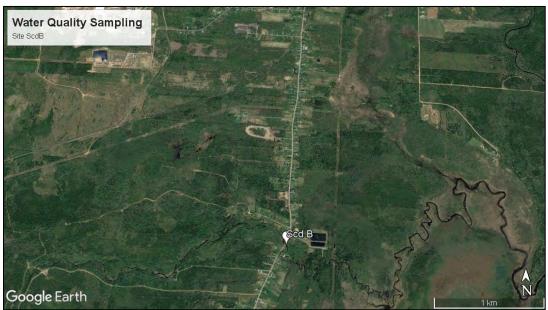
Figure 9: ScdB site location and surrounding land uses.

This site is located on the main branch of the Scoudouc River, at the bridge on Route 132 next to the Waggin' Tale Inn. The sample is taken downstream of the bridge. The surrounding land use includes residences, the Greater Shediac Sewage Commission's aeration lagoons, the Scoudouc Industrial Park, Highway 15 and some forested land (Figure 9).

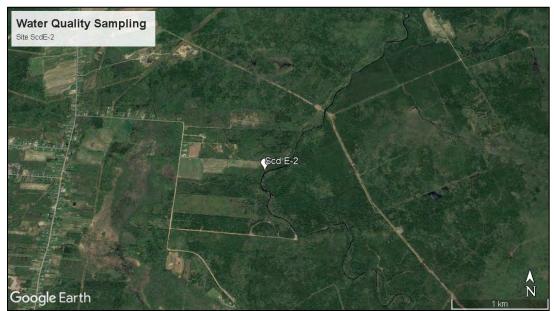
Figure 10: ScdE-2 site location and surrounding land uses.

It was discovered that from 1999-2003 the sample for this site was taken approximately 1 km downstream of the current location. The original ScdE was located under the transmission lines crossing the Scoudouc River, and was most likely reached using an ATV. In 2005-2006, it is believed that staff found a different way of getting close to the area by contacting landowners and gaining permission to access the river. Since it is not in the exact location, the site code was changed to ScdE-2.

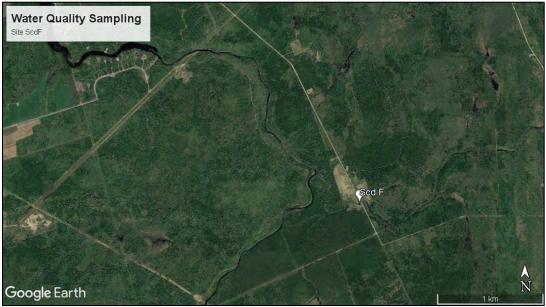
Figure 11: ScdF site location and surrounding land uses.

This water quality sampling site is located on an unnamed tributary of the Scoudouc River, accessed from Pellerin Road, located off Lino Road. The sample is taken downstream of the culvert crossing Lino Road. The surrounding land use includes cottages, forests, wetland, ATV trails, and at the headwaters, a bog being used to harvest peat moss (Figure 11). The peat moss extraction site spans over 200 ha as measured on aerial imagery from 2017.

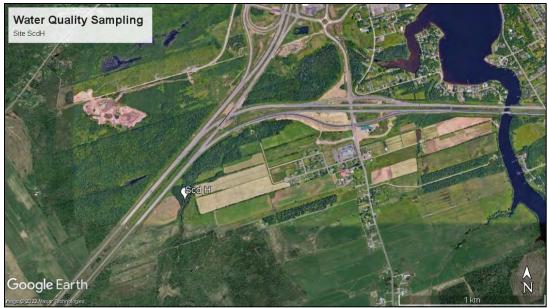
Figure 12: ScdH site location and surrounding land uses.

The farm fields on either side of the sampling site have buffer zones ranging from 10 - 30 m in width. There is a beaver dam upstream of the site, and beaver activity has reduced the density of trees in the area. Clear-cut areas upstream now serve as cattle pastures, and seem to have buffer zones of 25 m or more. The gravel pit upstream has a forested buffer over 400 m, however it does seem there is a drainage near the pit that flows towards the brook. The headwaters of the Cornwall Brook are located near the Scoudouc Industrial Park. There is forested land between the industrial zone and the wetlands, and based on approximate land elevations, there does not appear to be drainage leading toward the brook.

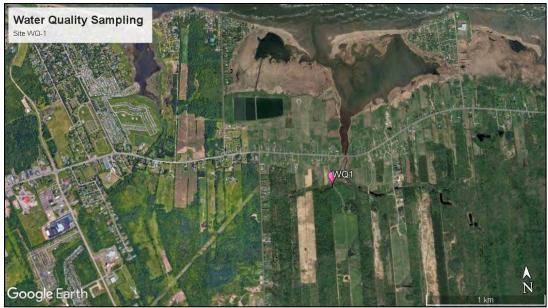
Figure 14: WQ-1 site location and surrounding land uses.

This stream joins the Shediac Bay approximately 1 km downstream of the sampling site. The stream ends with a small estuary surrounded by a salt marsh. Next to this salt marsh is the Greater Shediac Sewage Commission's aeration lagoons, as well as a lift station with an outfall discharge pipe at the edge of the estuary. This water quality station is located higher than the highest tidal zone.

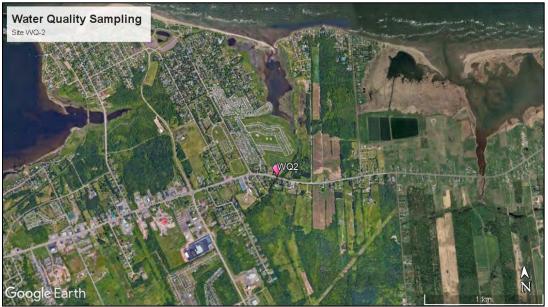
Figure 15: WQ-2 site location and surrounding land uses.

This water quality sampling site is also located in a residential area in Boudreau-West on Route 133. The samples are taken upstream of the culvert crossing Route 133. The surrounding land use is mainly residences, roads, and a drive-in movie theatre upstream of the site (Figure 15). Below the culvert of Route 133, directly below the sampling site, is the beginning of a provincially regulated freshwater wetland. The wetland is approximately 170 m in length. It transitions to a coastal salt marsh at the highest tidal point.

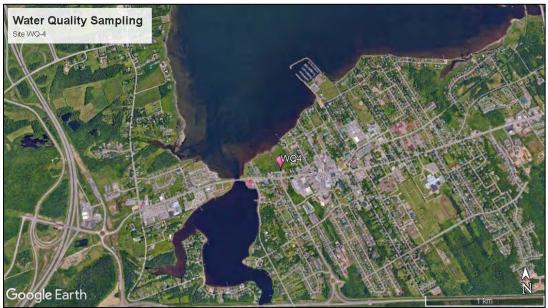
Figure 17: WQ-4 site location and surrounding land uses.

A part of this brook is channelled in an underground pipe somewhere along Chesley Street, before reaching Main Street. There is also a dog park upstream next to a drainage ditch that connects to this brook. The SBWA built its first rain garden below this dog park, in an effort to capture stormwater runoff from the park and surrounding area. The brook flows into the Shediac Bay approximately 200 m downstream from the sampling site.

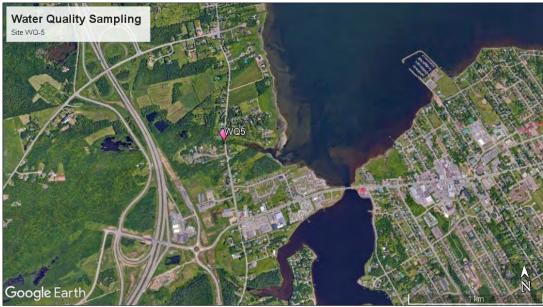
Figure 18: WQ-5 site location and surrounding land uses.

The surrounding land use is mostly residential, with some forested land and farm fields (Figure 18). The riparian area around the residential properties has a thin buffer (< 15 m), but this constitutes only small sections of the brook. There are adequate buffer zones between the farmlands and the head pond of this brook; 25 - 50 m in width. There is a thinner buffer zone where the pond discharges into the brook, approximately 20 m between the bank and a field. Another brook joins these ponds upstream, supplying water from the other side of Highway 11, up to Route 134 (Lakeville Road). In this area there is more cultivated land where the brook passes, but there is no visible buffer zone.

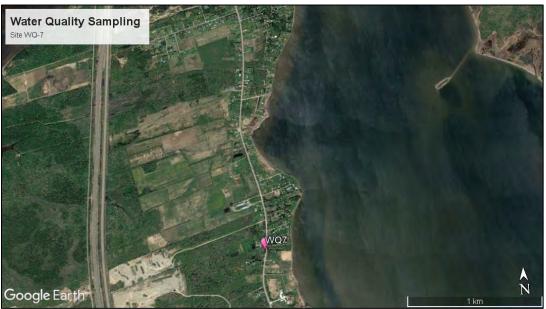
Figure 20: WQ-7 site location and surrounding land uses.

This site is located off of Route 134, on the property of Bay Vista Lodge & Cottages. The samples are taken upstream of the culvert crossing Route 134. The site is located approximately 160 m from the tidal zone and the beginning of a salt marsh. This brook is very short; the only obvious source of water is a pond (1,700m<sup>2</sup>) approximately 200 m upstream behind the cottages. The surrounding land use is mainly residential, however, there appears to be a large gravel pit west of the sampling site (Figure 20).

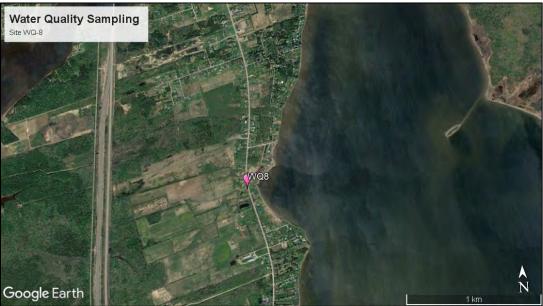
Figure 21: WQ-8 site location and surrounding land uses.

This water quality site is located along Route 134 in Shediac Cape. The site is within the tidal zone approximately 75 m from the outlet into the Shediac Bay. The samples are taken upstream of the culvert.

The surrounding land use includes residences and farmlands, including a chicken farm (Figure 21). The farm fields possess little to no buffer zone or riparian area. Observations taken during the sampling include dark colouration and bad odours in the water.

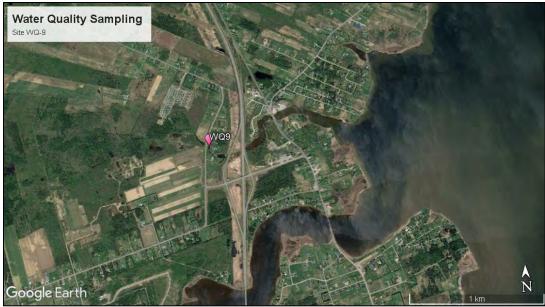
Figure 22: WQ-9 site location and surrounding land uses.

The surrounding land use is mainly residential with several large agricultural fields (Figure 22). There is farmland along the right side of the brook (looking upstream) with no buffer zone along the length of its riverbank (100 m). On the left side is a much larger cultivated field that is 14.6 ha and a small lot that is 5.3 ha. The drainage from these fields flows down to a ditch along Babineau Access Road, and may flow into the brook. There are no trees around any of these farm fields. Bastarache's Auto Salvage is located upstream, but there is approximately 1 km of forested buffer between the salvage lot and the head pond of the brook.

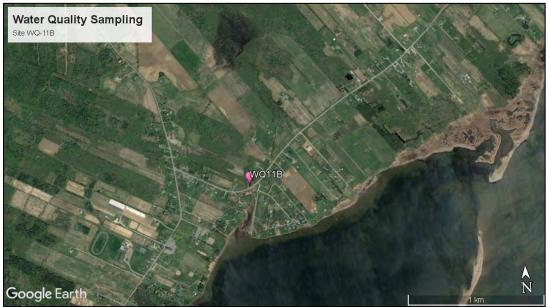
Figure 24: WQ-11B site location and surrounding land uses.

The surrounding land use is mainly residential and agricultural (Figure 24). The farm lands are made up of many parcels, spanning over 58 ha leading up to the watershed boundary. There is little evidence of any tree buffer in this area from aerial imagery, except for one forested parcel and a few thin lines of trees along property lines.

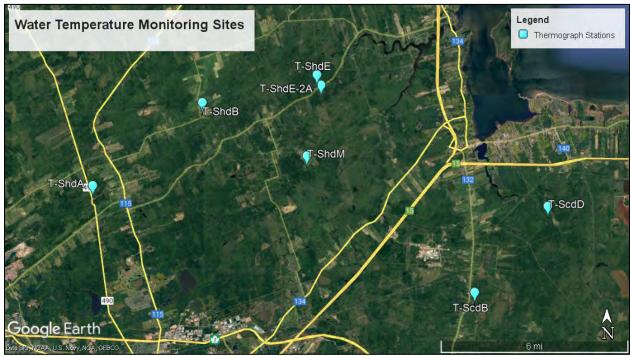
Figure 32: Temperature logger locations in the Shediac and Scoudouc rivers.

Five sites are monitored in the Shediac River and its tributaries; two in the main branch, two in the Weisner Brook and one in the McQuade Brook. Two sites are monitored in the Scoudouc River (Figure 32). The following section reports on temperature logger data for 2022.

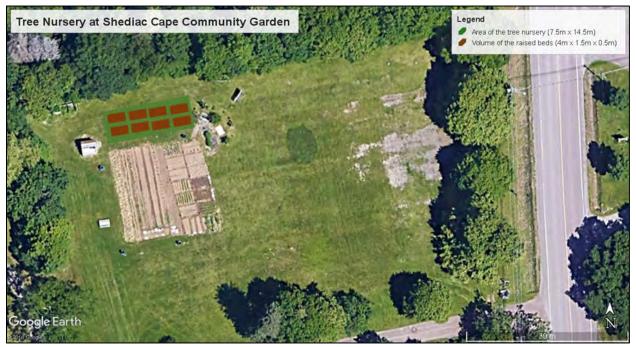
Figure 40: Map of the SBWA tree nursery.

In 2022, a total of 96 trees from the nursery were planted: 18 at the restoration site on the Weisner Brook, and 78 at a site along the Tait Brook within the Town of Shediac. To replenish the nursery, approximately 400 young white spruce plugs were planted at the nursery in late summer. These spruces will be allowed to mature for 1-3 years, thereby increasing their survival rate once transplanted to a restoration site.

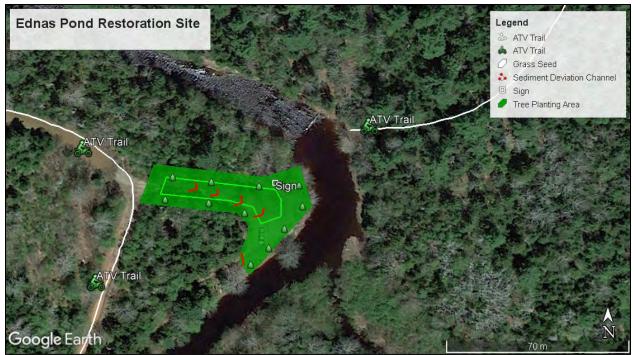
Figure 44: Map of the tree planting area at Edna's pond on the Scoudouc River.

Every year the SBWA continues to maintain our restoration site on the Scoudouc River, in the area known locally as Edna's Pond (Figure 44). This site is an important Atlantic salmon habitat for the Shediac Bay watershed. Assuring that enough trees will take at this location is crucial for the stabilization of the banks and runoff control to minimize sedimentation in the salmon pool.

We have been in contact with a local ATV club who received funding to build a new bridge to cross the Scoudouc River. This bridge was built in 2022, and the ATV crossing at Edna's Pond is no longer needed. ATV traffic will be redirected from Edna's Pond to this new bridge, through the use of signs and further stream restoration techniques.

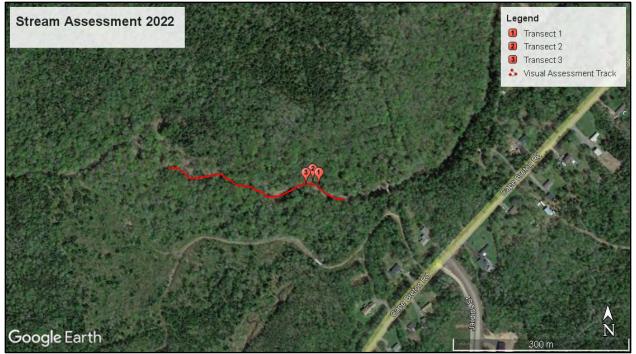
Figure 45: Location of the stream assessment completed in fall 2022.

Following confirmation of Atlantic salmon through electrofishing surveys, a stream assessment was completed along a portion of the Shediac River located in the Cape Breton area (Figure 45). The purpose of this assessment was to determine if any restoration actions may be required along this stretch of river.

The assessment is designed to help determine the degree of harm and the weakness within the habitat in order to aid future restoration planning (Nova Scotia Salmon Association, 2018). The assessment covered a distance of 26 m and was comprised of three transects. A visual assessment was performed in conjunction with the NSFHAP to evaluate approximately 350 m of the Shediac River. Images and GPS coordinates of potential fish habitat and fish passage barriers can be found in Appendix D.

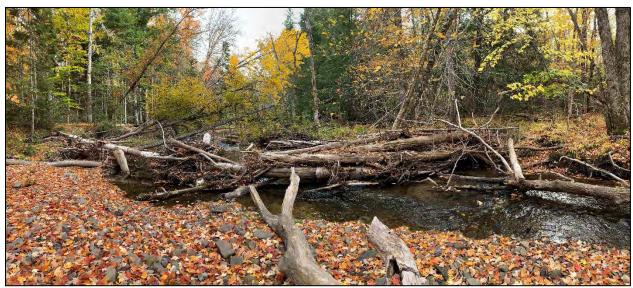
Figure 46: An example of a large woody debris blockage.
