Shediac Bay Watershed Association
Annual Report

Fiscal Year 2022-23

Report prepared by:
The Shediac Bay Watershed Association

June 2023

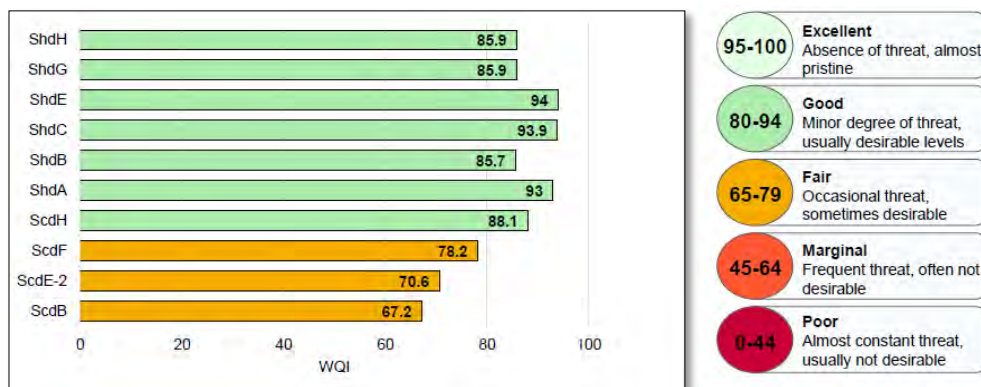
WQI Scores for the Shediac and Scoudouc Rivers 2022 Sampling

In 2022, the water quality data was analyzed using the Water Quality Index (WQI) calculator. Using the Canadian Council of Ministers of the Environment (CCME) water quality guidelines, the Water Quality Index combines multiple parameters into a single value that summarizes water quality at a site. It is calculated based on:

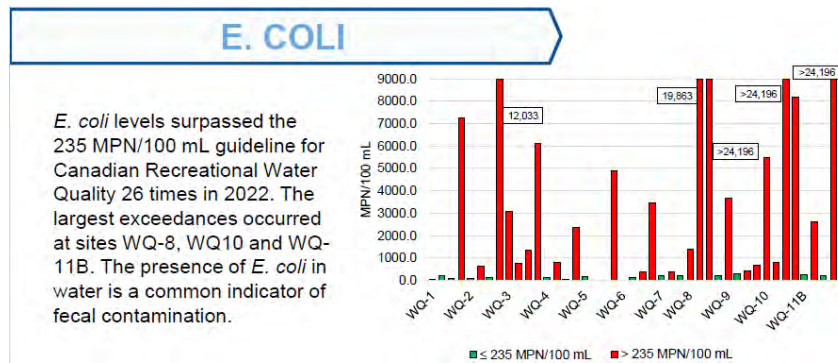
E. coli summary for the Small Streams 2022 Sampling

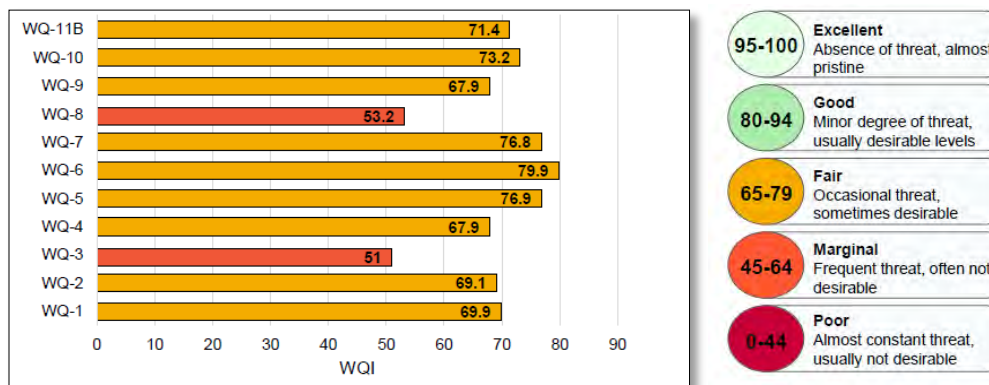
WQI Scores for the Small Streams 2022 Sampling

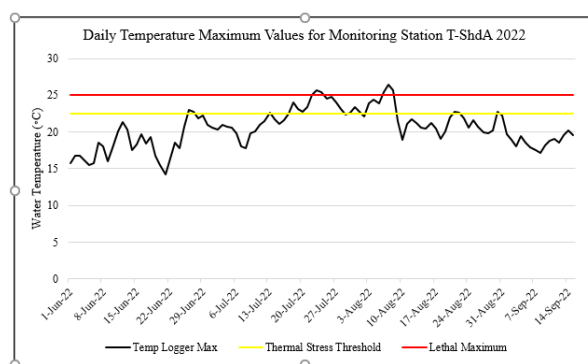
Temperature logger data from a site in the Shediac River, Irish Town area (T-ShdA)

As part of the water management efforts in the watershed, water temperature monitoring also continued in 2022. Temperature loggers were placed in strategic locations from June to September.

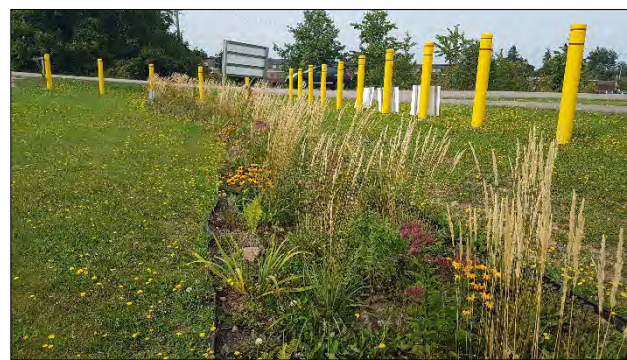
With the help of students from the Environmental Science class at Polyvalent L.-J. R, a 60m² bioswale was built on school ground. This bioswale was maintained by weeding regularly throughout the 2022 growing season and the interpretive sign that was produced the previous winter was also installed. The survival rate of the plants originally planted was 85 percent. The milkweed plants at this site also successfully attracted monarch butterflies; a monarch survey revealed eggs and monarch caterpillars on most milkweed plants.

Bioswale

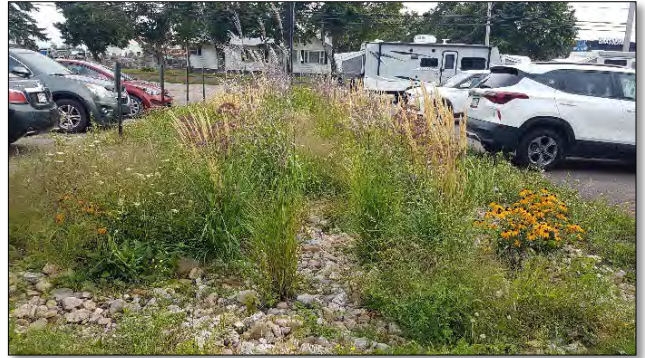
Time2Shine's commercial bioswale in 2022

The bioswale, or bioretention system, installed in fall of 2021, collects a portion of the stormwater runoff from the parking lot of the neighbouring business and part of the rooftop runoff from surrounding buildings, which totals approximately 920 m² of impervious surfaces.

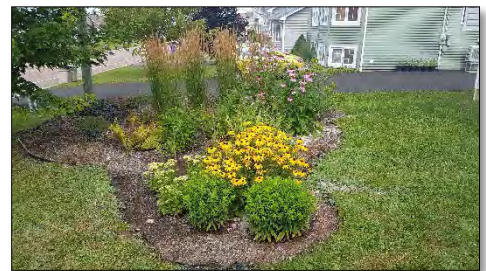
This rain garden is located in the front yard of a resident on Rue Rachel in Shediac. It was the first one completed in 2021. The rain garden was strategically placed in their front yard and intercepts stormwater runoff from going into the storm drain.

Rain garden on Rue Rachel

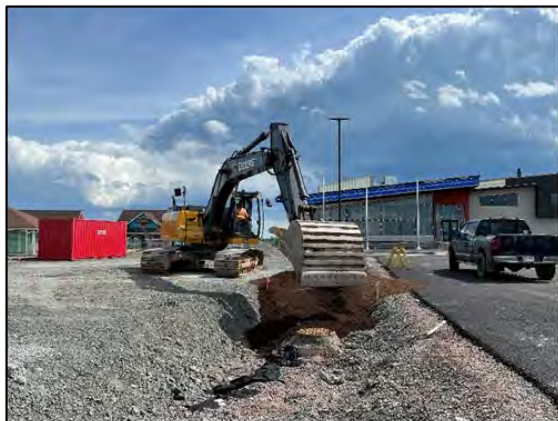
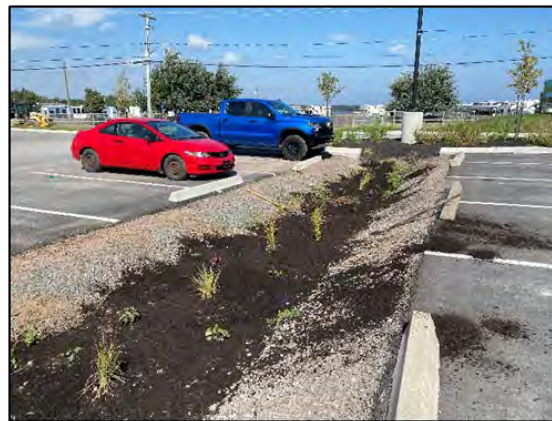
Bioswale #1 - Construction (left) of the bioswale and finished project (right)

Both bioswales have similar components like an outflow drain and bioretention soil mix. The outflow drain will prevent water from overwhelming the bioswales or causing flooding during heavy rainfall events. The bioretention soil mix is designed to absorb, infiltrate, and filter stormwater runoff. A filter fabric separates the bioretention soil from the gravel layer below which allows for storage of stormwater underground and allows time for infiltration into the ground. The bioswale #1 has an additional component, an underdrain system composed of a perforated drainage pipe imbedded into the drainage stone layer. The underdrain system allows for treated stormwater to flow into the storm drain system. These bioswales were planted late fall 2022. We will be monitoring closely the survival rate of the plants

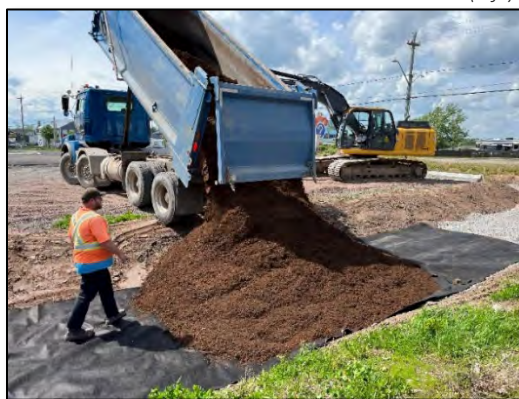
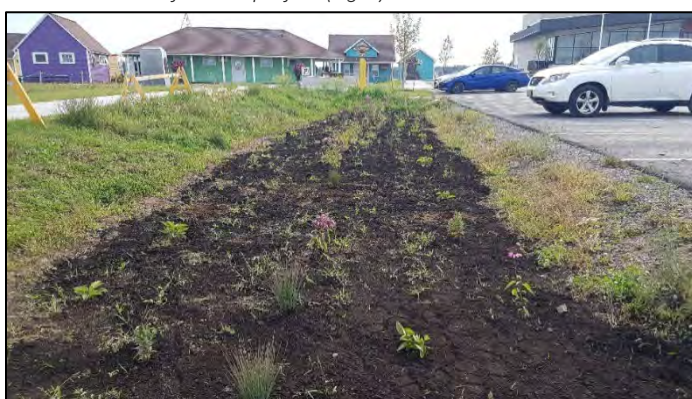
Bioswale #2 - Construction (left) of the bioswale and finished project (right)

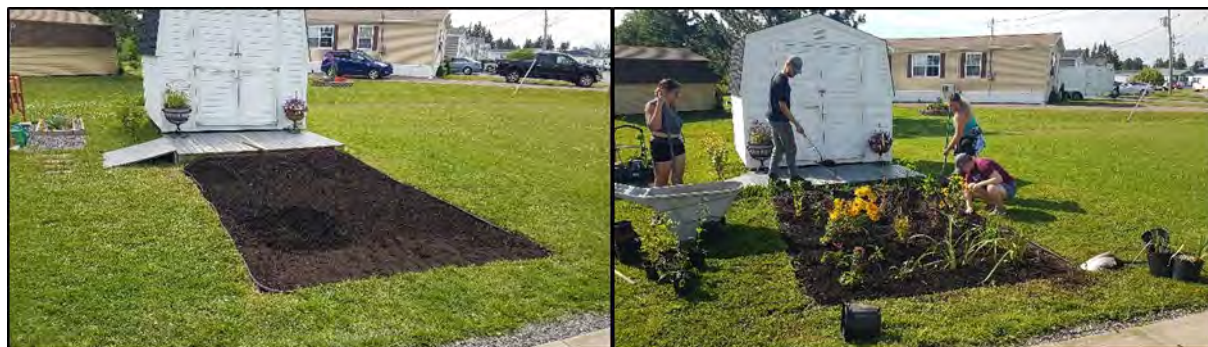
Before (left) and during (right) construction of the rain garden on Rue Grand Pré.

Similar to the other residential rain gardens, a berm was constructed at the back to retain water. This rain garden should make a difference in absorbing and infiltrating larger amounts of runoff, which may also benefit the surrounding properties.

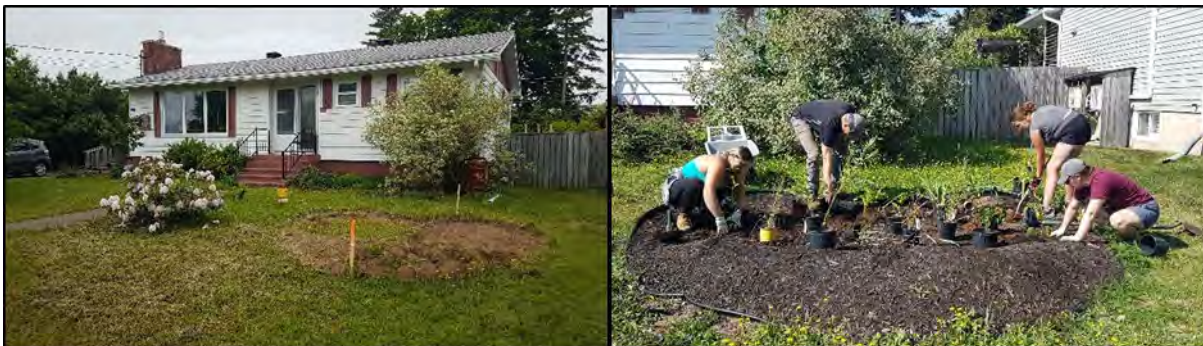
Before (left) and during (right) construction of the rain garden on Rue Louisiane

This kidney bean-shaped rain garden was created in the front yard. The homeowner's sump pump outflow was connected to the rain garden, by digging a trench to install an underground PVC pipe. This will allow the sump pump water to be directed into the rain garden and a berm was constructed to retain as much water as possible. A variety of flowering plants and grasses were selected including milkweed to support the monarch butterfly.

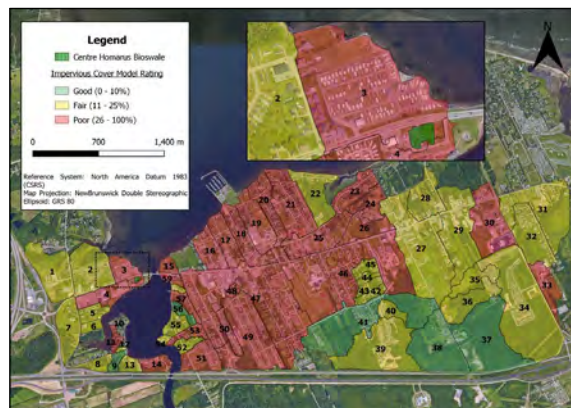
Impervious coverage map of Shediac

This map was created using the 59 stormwater watersheds that were delineated by DELG for the 2019 stormwater study (Hughes 2020), and an impervious cover layer developed by Mount Allison University (updated by SBWA). This map was created using the impervious cover model (ICM), which provides an indicator of the level of impact of stormwater runoff on water quality, based on the percentage of “effective impervious cover” in each sub-watershed.

The percentage of “effective impervious cover” can be reduced when stormwater runoff is managed at the source (i.e. rain gardens, bioswales, retention basins, etc.). For example, the Homarus Centre bioswales capture runoff from a drainage area of approximately 2,600 m², reducing the effective impervious cover of stormwater watershed #3 by 3%.

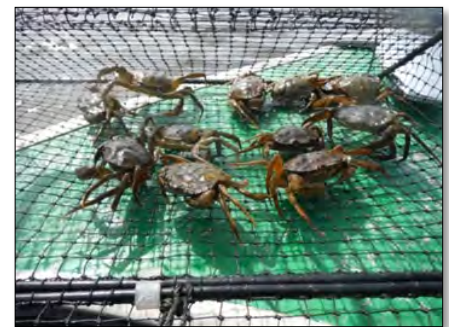
Green crab monitoring has been carried out by the SBWA since 2013. This invasive species is known to disrupt eelgrass beds, a productive habitat for many juvenile fish species and crustaceans. The green crab population monitoring is composed of 10 sampling sites. Sampling is done using Fukui crab traps baited with sardines.

Green crab caught in Fukui trap

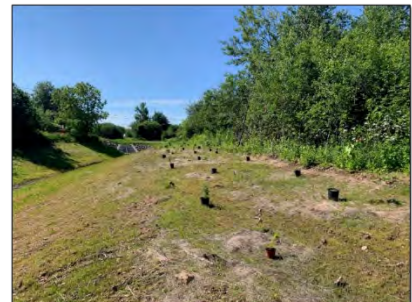
The Tait Brook underwent modifications as part of a flood protection plan; the area was cleared of trees so that the stream could be widened. This created a stormwater retention system to protect neighbouring infrastructure from flooding. The SBWA partnered with the Town of Shediac to restore the Tait Brook by replanting native trees and shrubs. The restoration took place on an approximate 200-metre section of the stream, between Donat and Clarence Street. A total of 78 trees were planted.

Tait Brook Restoration 2022

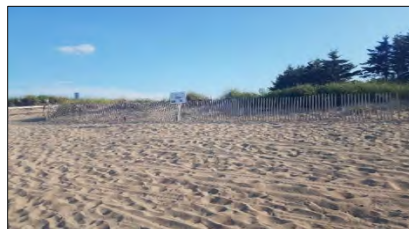
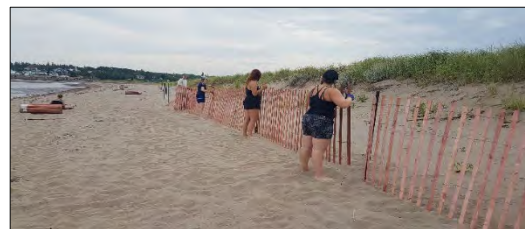
In the summer of 2021 and 2022, snow fencing was installed at beach access points and along the dunes to prevent further damages by foot traffic (trampling). Unfortunately, the entire dune fencing was destroyed by hurricane Fiona and the dunes were severely damaged.

Snow fencing (left) and marram grass planting (right) at Belliveau Beach

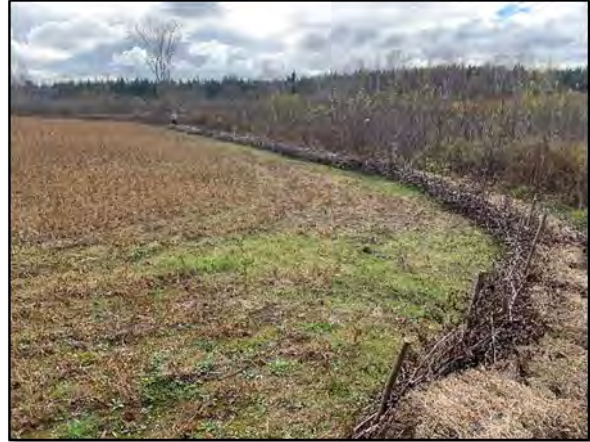
In 2017-2018, the buffer zone next to the brook in this area was cut and the field was tilled in preparation for planting but alders and shrubs have since recolonized the riverbank area. The SBWA took steps to reduce the amount of sediment and runoff entering the brook in this area through the creation of a sediment catch, a 50 m line of hay bales secured with wooden stakes with a line of native trees, which were provided by the SBWA tree nursery, behind the hay bales to avoid losing them due to agricultural activities. A section of wattle fencing made with alder branches was built on the field side of the hay bales. The tree species include four pines, six maples, and eight spruces.

Weisner Brook restoration site

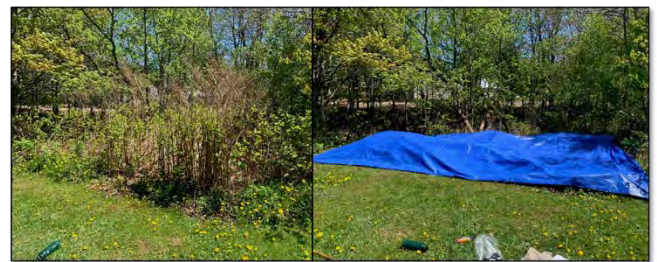
In 2022, two patches of invasive Japanese knotweed were targeted for eradication. The Japanese knotweed patches were discovered in the south cove marsh and on a private property in the town of Shediac. Both were approached with the same eradication measures, cut the previous year’s growth, cover sites with tarps to prevent new growth and to perform monthly cutting on new growth from May through October.

The tarps and regular cutting prevent the plants from performing adequate photosynthesis. This method does not produce immediate results, however, overtime the Japanese knotweed patches might be weakened enough that they are eliminated.

Japanese knotweed patch on private property (left) and during eradication (right)

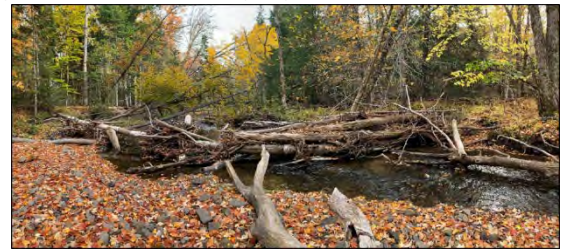
An example of a large woody debris blockage

Following confirmation of Atlantic salmon through electrofishing surveys, a stream assessment was completed along a portion of the Shediac River located in the Cape Breton area. The purpose of this assessment was to determine if any restoration actions may be required along this stretch of river. The assessment covered a distance of 26 m and was comprised of three transects. This section of the Shediac River was found to be suitable for fish, with an abundance of instream cover such as undercut banks and large woody debris. The substrate type was also suitable for fish species such as brook trout and Atlantic salmon. In certain areas, fallen woody debris has become a partial or potentially complete barrier to fish passage. Some clearing of the fallen debris should be considered in future restoration actions for this stretch of the Shediac River.

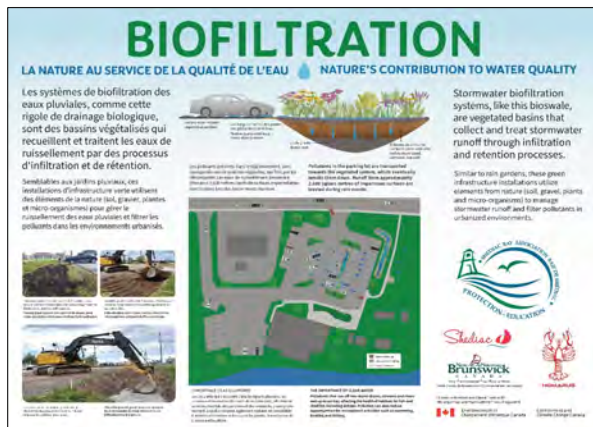
Homarus Centre interpretive panel

For the newly constructed bioswales at the Homarus Centre, a bilingual interpretation sign that explains the purpose and construction process of the bioswale was developed over the winter.
