# Water Quality Report – WQ-6

2023 Field Season

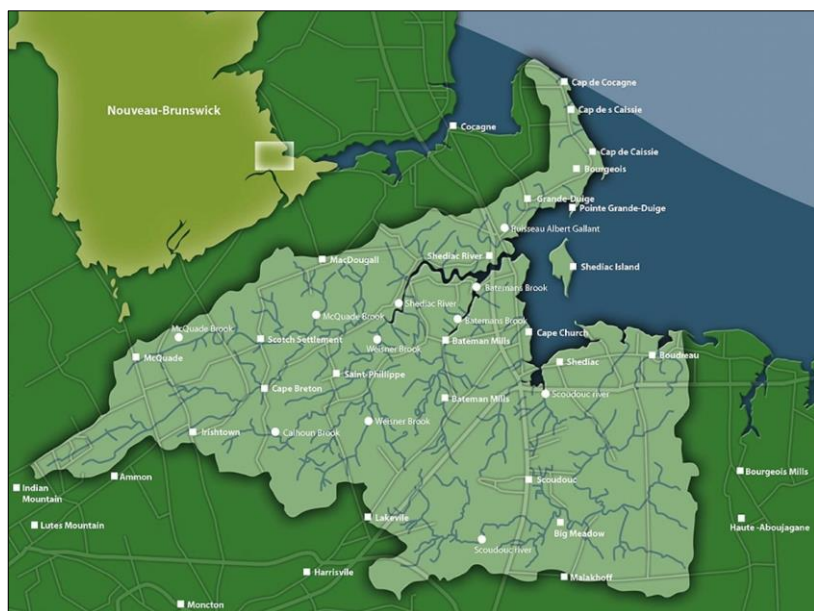
## OUR WATERSHED

The Shediac Bay watershed covers 420 km<sup>2</sup> of land area and stretches along 36 km of coastline, from Cap Bimet to Cap de Cocagne. The Shediac Bay watershed is composed of two major river systems emptying into Shediac Bay: the Shediac River and the Scoudouc River. The Shediac and the Scoudouc rivers are characterized by dendritic patterns of small tributaries covering watersheds of 201.8 and 143.3 km<sup>2</sup>, respectively.

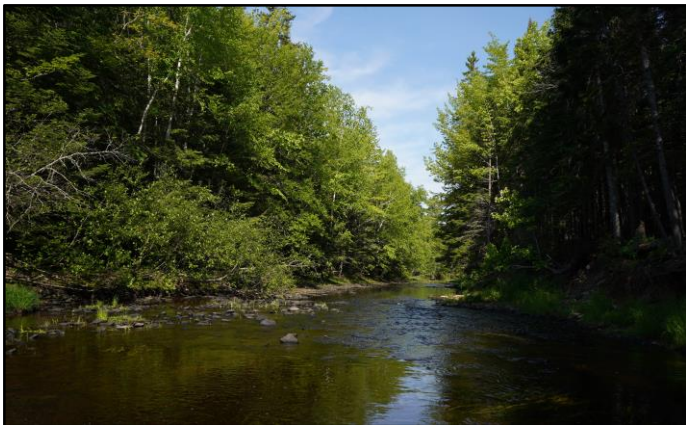
## THE WATER QUALITY INDEX

Using the Canadian Council of Ministers of the Environment water quality guidelines, the Water Quality Index (WQI) combines multiple parameters into a single value that summarizes water quality at a site.

It is calculated based on:

- the number of parameters that exceed guidelines,
- the number of times guidelines are exceeded,
- and the amount by which they are exceeded.

For an accurate WQI, a site is required to have 4 samples per year with at least 4 parameters measured.

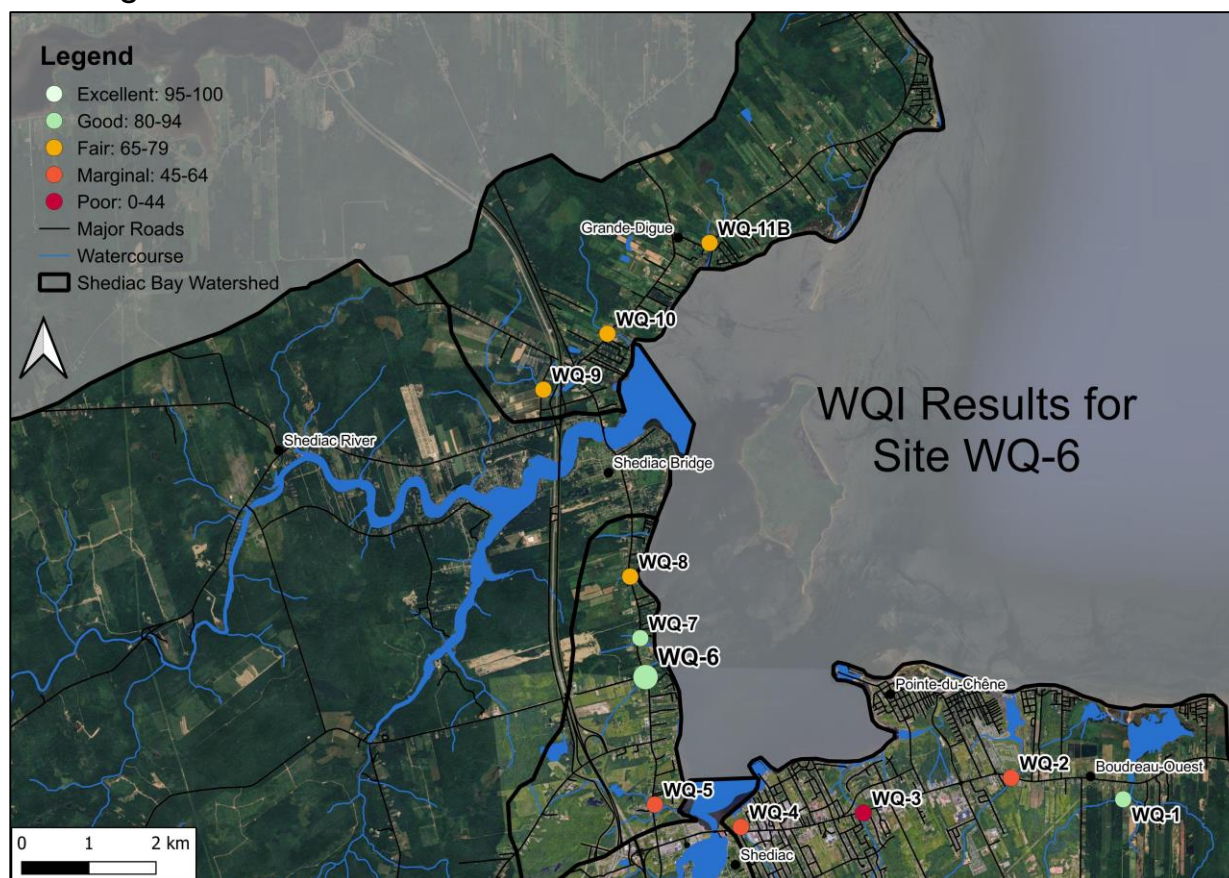
# SITE INFORMATION

This water quality site is located off Route 134, next to Old Mill Road. Samples are taken downstream of the culvert crossing Route 134 to capture water coming from both Old Mill Road and along Route 134.
