Identifying Habitat of the Brook Floater (*Alasmidonta varicosa*) in the Shediac Bay Watershed

Prepared for:
NB Wildlife Trust Fund
Habitat Stewardship Program for Species At Risk

March 2019

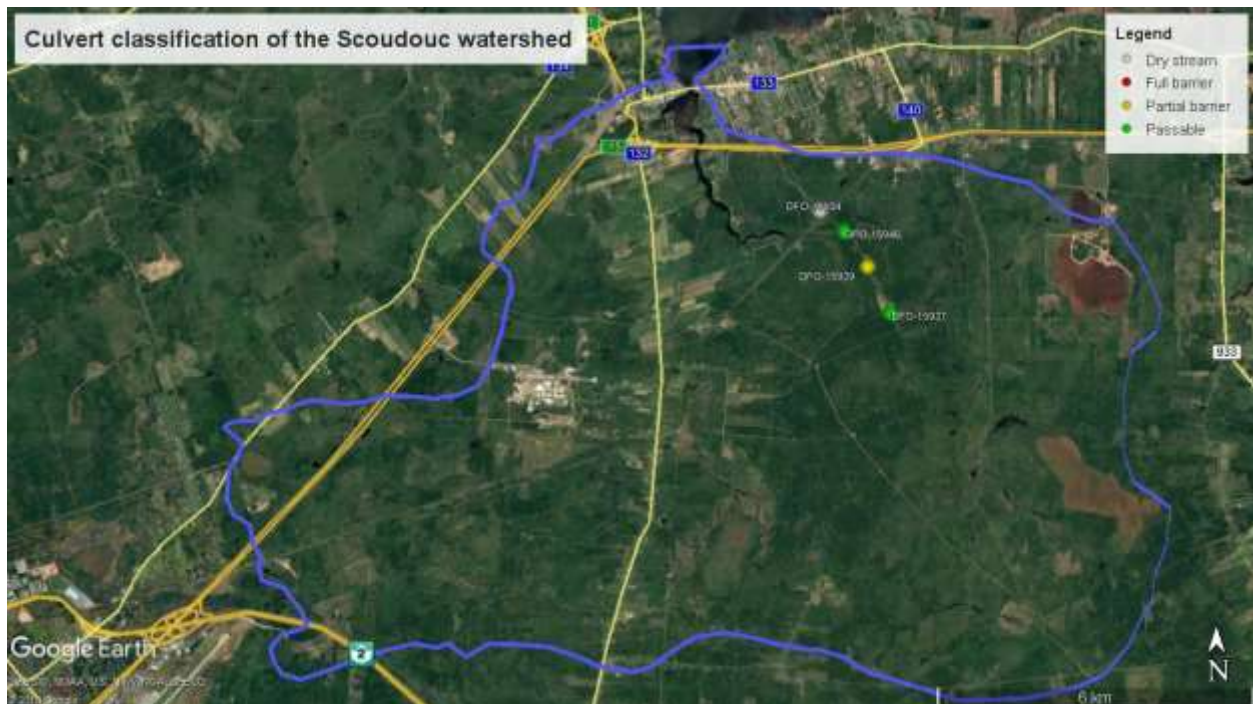
Figure 45 : Culvert classification for the Scoudouc River, 2018

Four culverts were evaluated in the lower Scoudouc River watershed, as they have the most potential to block large areas of upstream habitat. The Scoudouc River's surrounding land uses is mostly forested land, and has relatively low number of stream culvert crossings. Two culverts were identified as passable, and one culvert was considered a partial barrier. The last culvert crosses a seasonal stream that was dry.

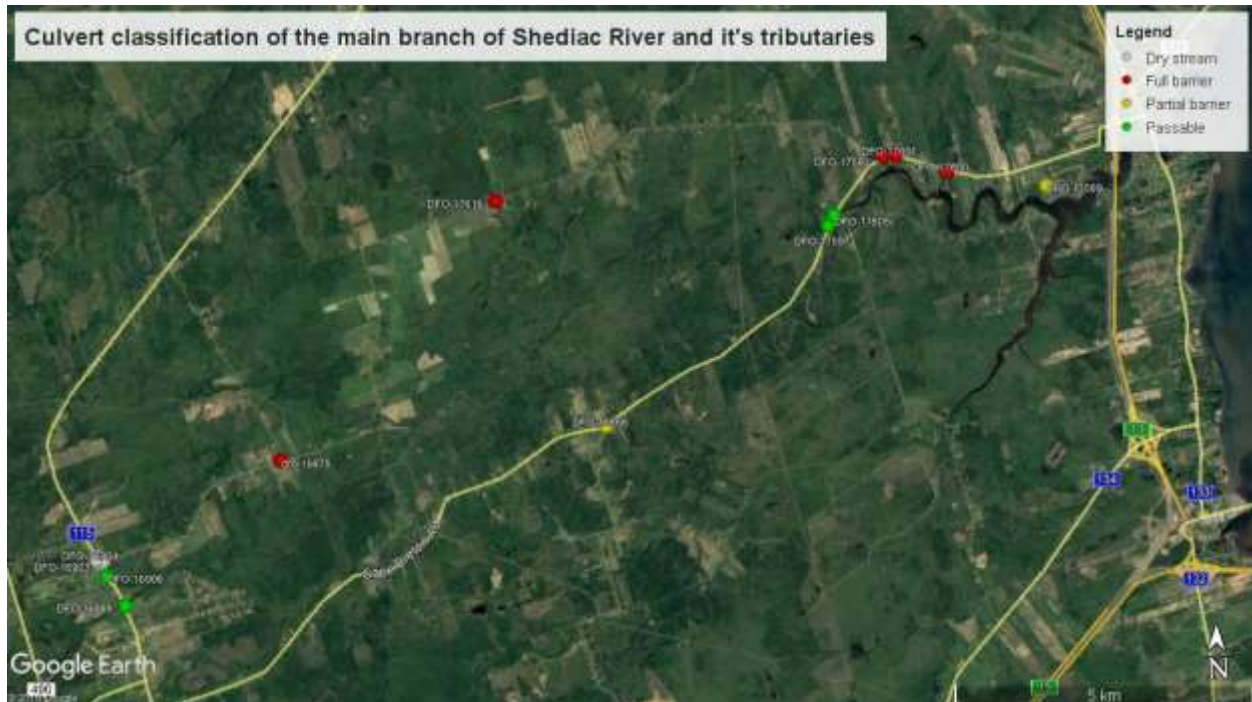
Figure 46: Culvert classification for the Shediac River, 2018

The lower Shediac River is mostly crossed by bridges. The culvert assessments were mostly conducted on smaller tributaries as they join the main branch. Of the 12 culverts assessed, 5 were determined to have full barriers, one was a partial barrier and 4 were passable. Two culverts crossed streams that were dry during the site visits.

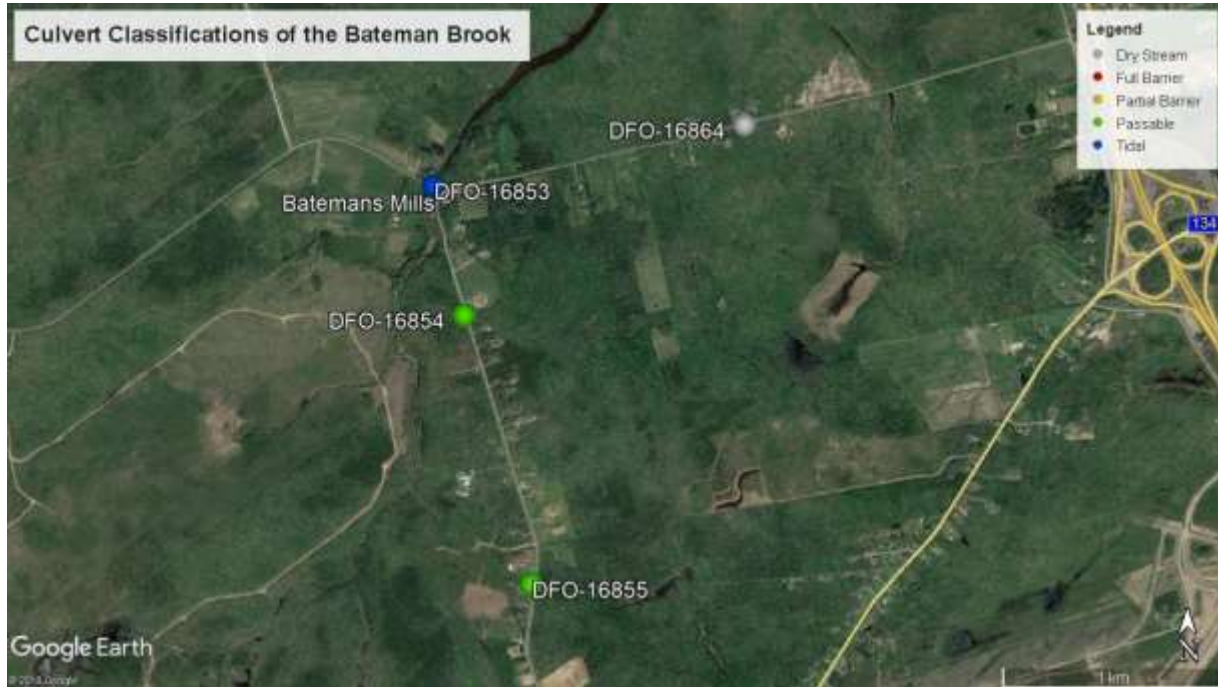
Figure 48: Culvert classification for the Bateman Brook, 2018

Five culverts were assessed on the Bateman Brook. Two culverts were considered passable, two culverts crossed a dry stream and could not be classified, and the fifth is a tidal site and cannot be classified under the ACCAT protocol.

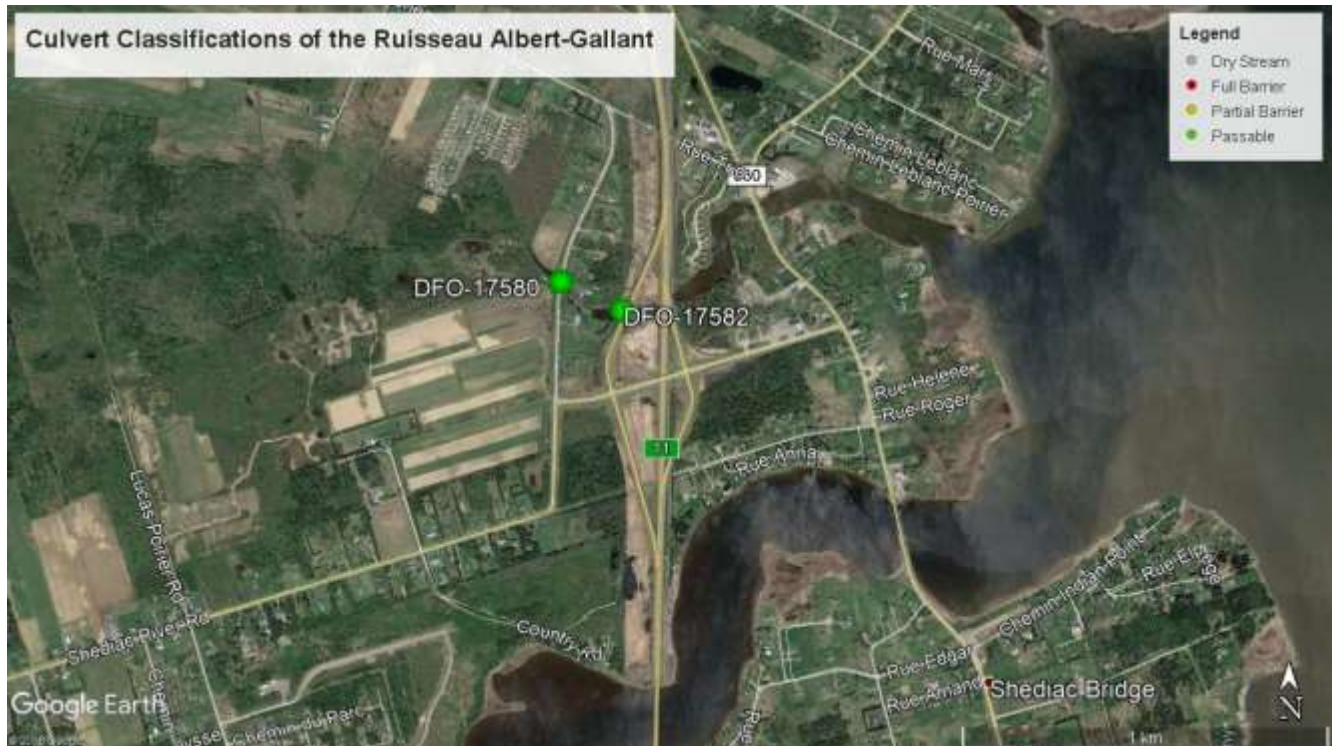
Figure 51: Culvert classification for the Ruisseau Albert-Gallant, 2018

Three culverts were rapidly assessed on the Ruisseau Albert-Gallant, a tributary of the Shediac Bay. Two of those culverts were classified as passable and the third was a seasonal stream that was dry at the time.

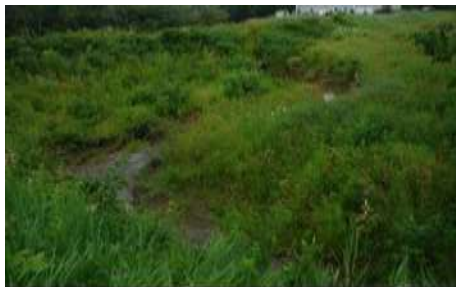
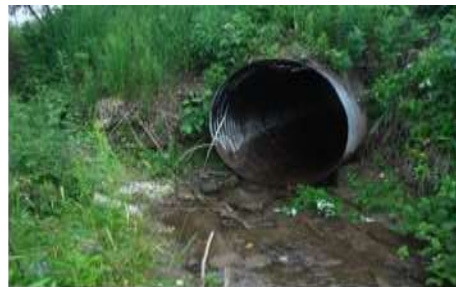
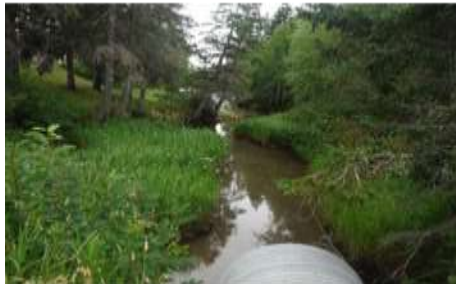
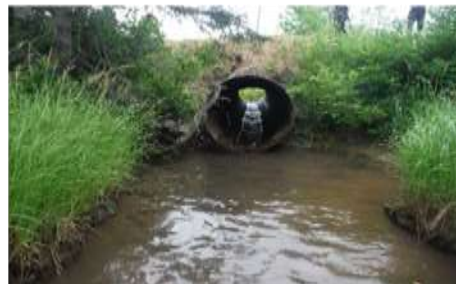
DFO -17589

Top: upstream of culvert and inlet

Bottom: downstream of culvert and outlet
