Water Quality Report – WQ-2

2022 Field Season

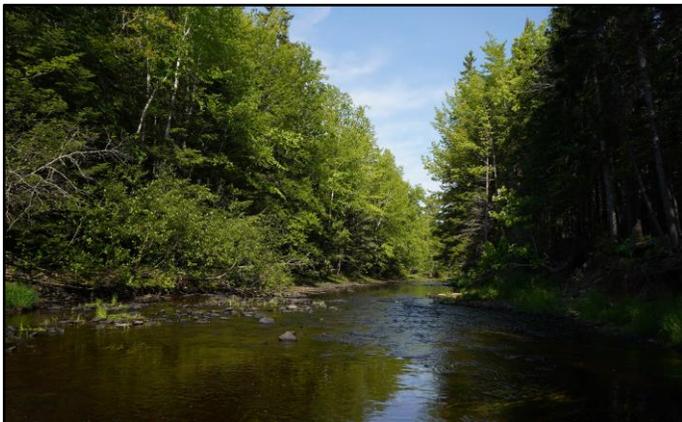
THE WATER QUALITY INDEX

Using the Canadian Council of Ministers of the Environment water quality guidelines, the Water Quality Index (WQI) combines multiple parameters into a single value that summarizes water quality at a site. It is calculated based on:

- the number of parameters that exceed guidelines,
- the number of times guidelines are exceeded,
- and the amount by which they are exceeded.
