# Water Quality Report – WQ-8

2023 Field Season

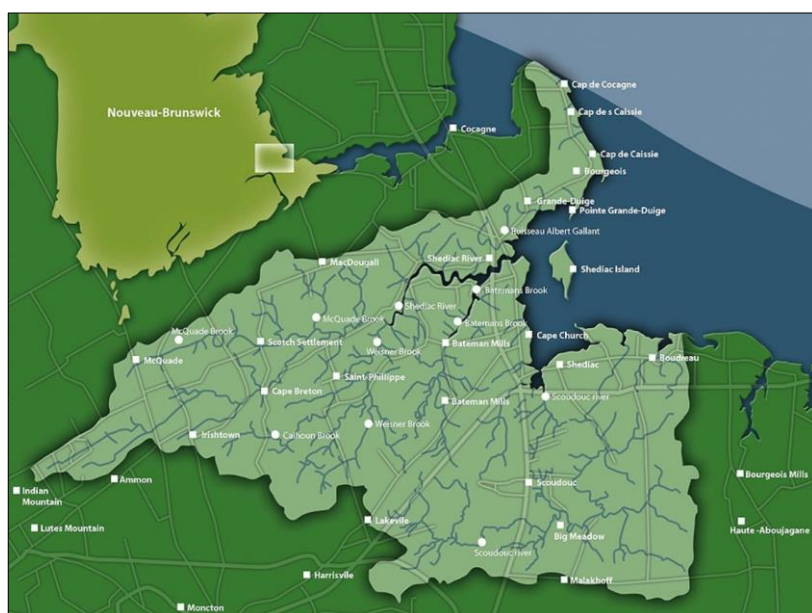
## OUR WATERSHED

The Shediac Bay watershed covers 420 km<sup>2</sup> of land area and stretches along 36 km of coastline, from Cap Bimet to Cap de Cocagne. The Shediac Bay watershed is composed of two major river systems emptying into Shediac Bay: the Shediac River and the Scoudouc River. The Shediac and the Scoudouc rivers are characterized by dendritic patterns of small tributaries covering watersheds of 201.8 and 143.3 km<sup>2</sup>, respectively.

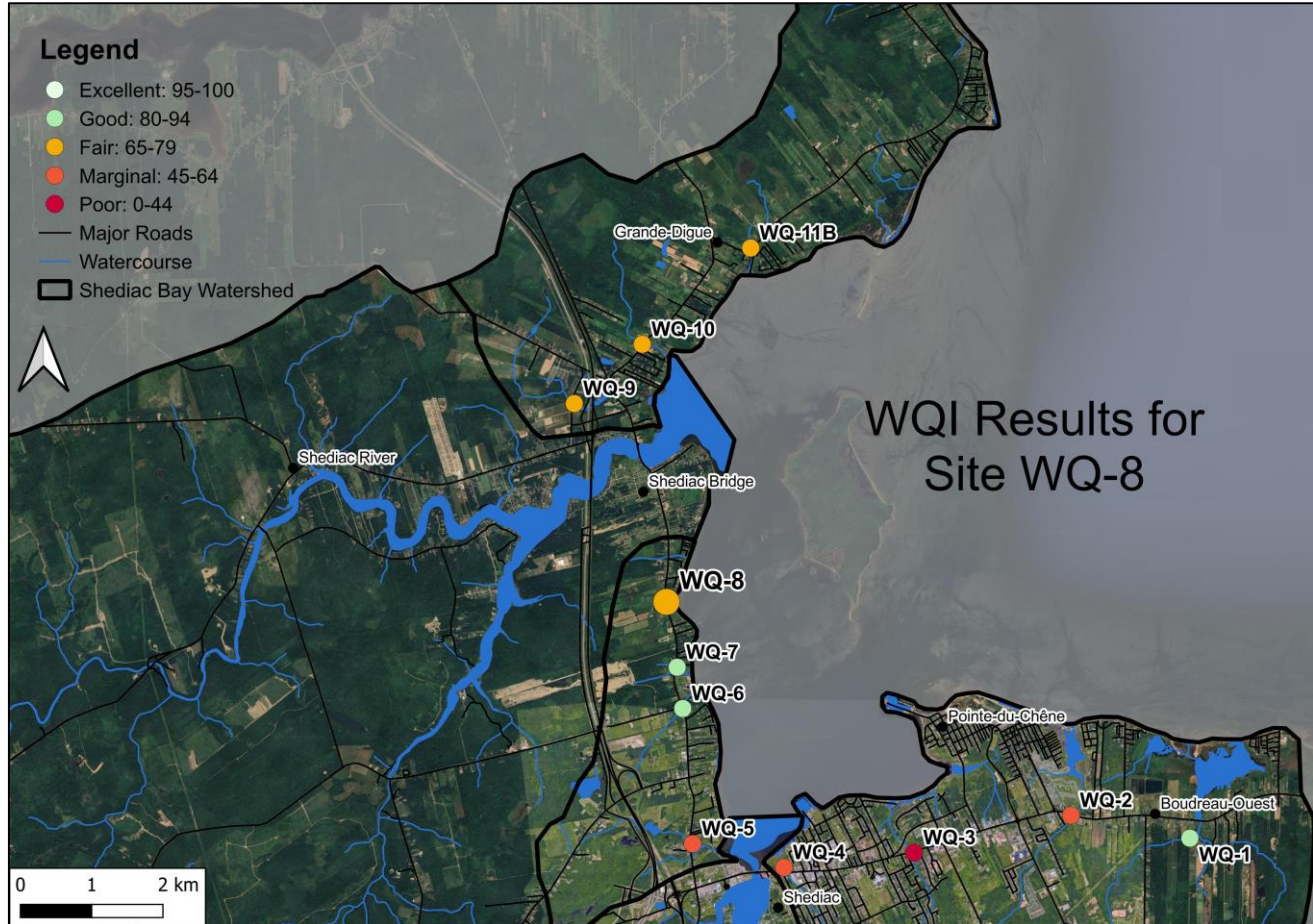
# SITE INFORMATION

This water quality site is located along Route 134 in Shediac Cape. The samples are taken upstream of the culvert. The surrounding land use includes residences and farmlands.
