# Water Quality Report – WQ-7

2023 Field Season

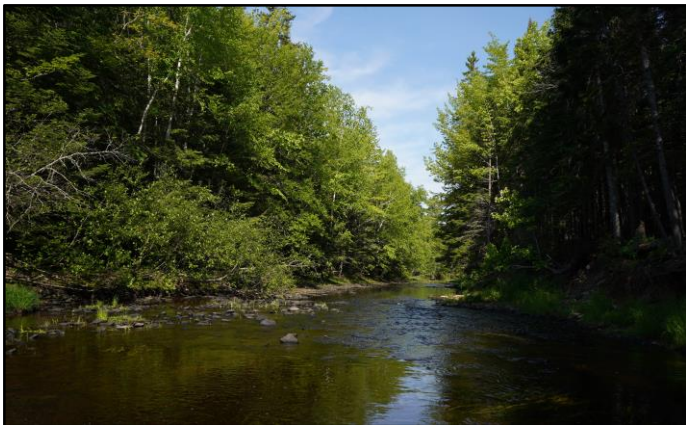
## THE WATER QUALITY INDEX

Using the Canadian Council of Ministers of the Environment water quality guidelines, the Water Quality Index (WQI) combines multiple parameters into a single value that summarizes water quality at a site. It is calculated based on:

- the number of parameters that exceed guidelines,
- the number of times guidelines are exceeded,
- and the amount by which they are exceeded.

For an accurate WQI, a site is required to have 4 samples per year with at least 4 parameters measured.
